The influence of clay wetting on geomembrane-clay interface strength

Tomislav Ivšić, Franjo Verić & Hrvoje D. Zlatoper

Department of Geotechnics, Faculty of Civil Engineering, University of Zagreb, Kaciceva 26, HR-10000 Zagreb, Croatia

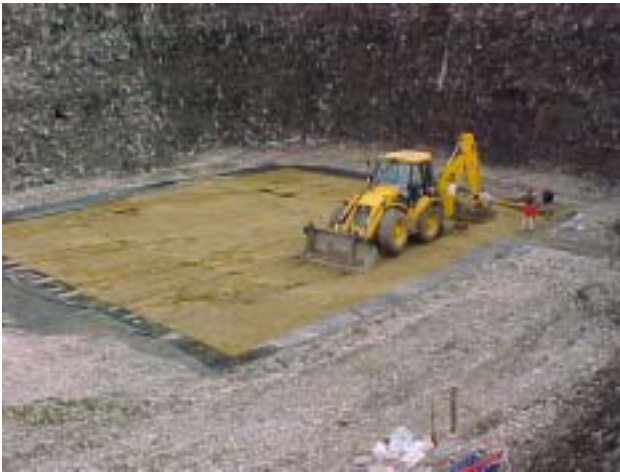
In order to reach the damaged area, the corridor in the width of 30m (expected length of damage) was excavated into the slope of waste body. The excavation of waste ended in July 2003, then the protection and drainage layers were removed and the area approx. 25x15 m was examined (Fig 1).

Figure 1. Investigation area inside the waste body

Samples of clay and geomembrane were taken for further testing. After completion of the inspection, the damaged part was remediated, the snapped cables of leak detection were repaired and pit was filled with waste to required height.

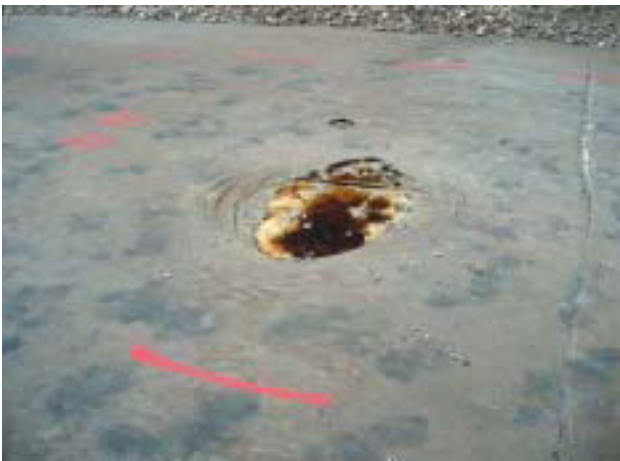
- the geomembrane was damaged in a zone of few meters wide in the direction perpendicular to the main waste slope. The damage consisted of several ruptures and cracks. Maximal crack width was about 50 cm. One of the smaller ruptures is shown on Fig. 2.
- in some places the uncracked geomembrane was still under tension force and soon after cutting the fissure of 40 cm opened
- some smaller defects were also observed near welded connections
- clay underneath the geomembrane was somewhere very soft which indicates excessive water content
- the slip plane was observed in the superficial clay layer 1-3 cm under the geomembrane (Fig. 3). When the geomembrane was removed this surface layer mostly remained “stuck” to it

Figure 2. Smaller geomembrane rupture in damaged zone

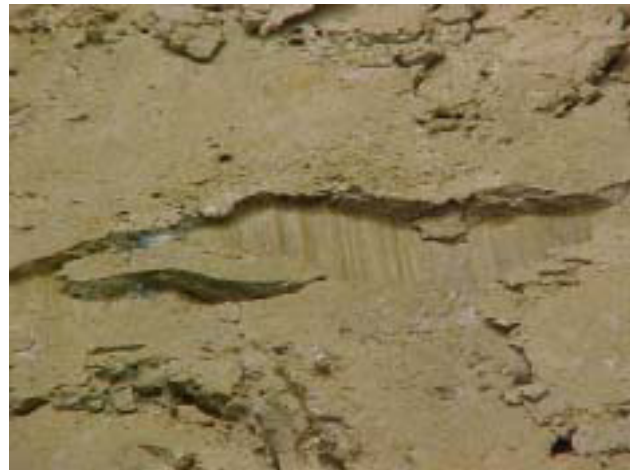
In damaged area the surface layer (0-5 cm) had significantly higher water content (27 to 30.4%) and in other depths varied from 19 to 23.3% (still in acceptable range).

Since the investigation took place several months after indicated damage, the leachate was leaking through the cracks in ruptured geomembrane, and possibly contributed to higher water content values at clay surface.

Figure 3. Slippage of softer clay layer over firm clay base

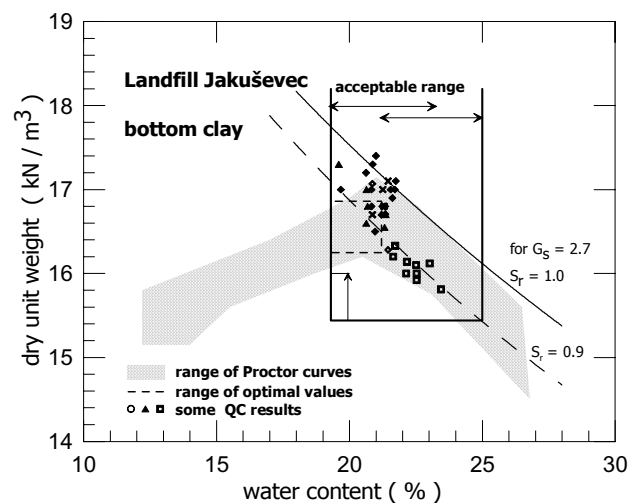
Figure 4. The range of field compaction conditions on Cell 4

The range of clay compaction conditions on site is presented on Fig. 4, using data obtained from quality control (QC) program. The design specifications defined the acceptable field range with dry unit weight greater than 95% of optimal value and field water content, w , between w_{opt} and $w_{opt} + 4\%$. The optimal values were defined individually for each part of clay borrow pit and relevant liner construction sections.

The bottom clay liner was constructed in four layers of 25 cm. Also presented are some control results for top layer of liner (beneath the geomembrane) made by nuclear probe. Other testing methods showed similar results. The results are within acceptable range, although some results show unlikely saturation over 100% when compared with theoretical curve for average clay specific gravity of 2.7.

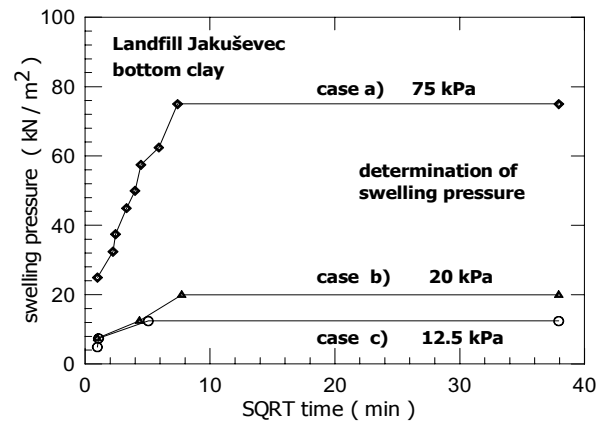
The results are presented in Fig. 6. The range of swelling pressures from 12.5 to 75 kPa means that the heave of bottom clay liner (when wetted) could be prevented by weight of 0.5m of drainage gravelly layer and at least 1m of compacted waste for the loosest compaction conditions. For the densest state the heave would be totally prevented with several meters of waste overburden.

Figure 6. Determination of swelling pressures

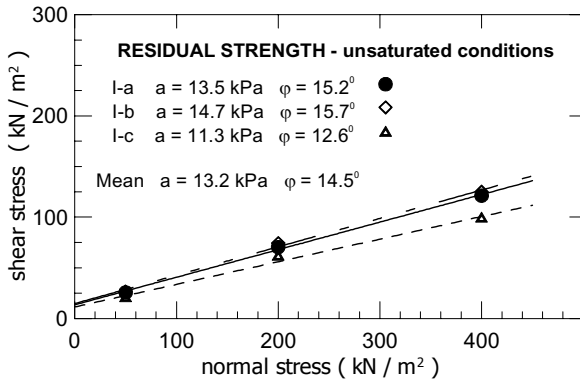
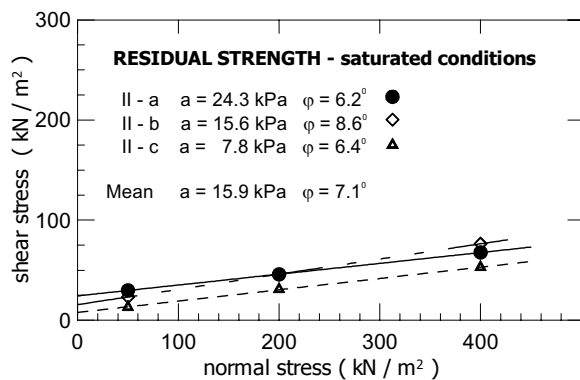
Figure 10. Residual interface strength – unsaturated specimen

Figure 11. Residual interface strength – wetted specimen

The pre-treatment gave significantly lower strength parameters. The difference is obvious in friction angle which for wetted specimen has value about half the value of “as compacted” specimen. Also, in the same test series the values of friction angle are about the same, while some differences could be found in values of apparent adhesion.
