# LARGE DISTURBANCE IN CROATIAN POWER SYSTEM RESULTING IN TRANSIENT INSTABILITY AND OUTAGES OF THREE MAJOR THERMAL UNITS

M. Stojšavljević\*, D. Nemeć\*, Š. Radić\*\*, Z. Čerina\*\*, R. Rubeša\*\*, N. Cvjetković\*\*

\*Energy Institute, Croatia

\*\*HEP - Croatian Electricity Utility, Croatia

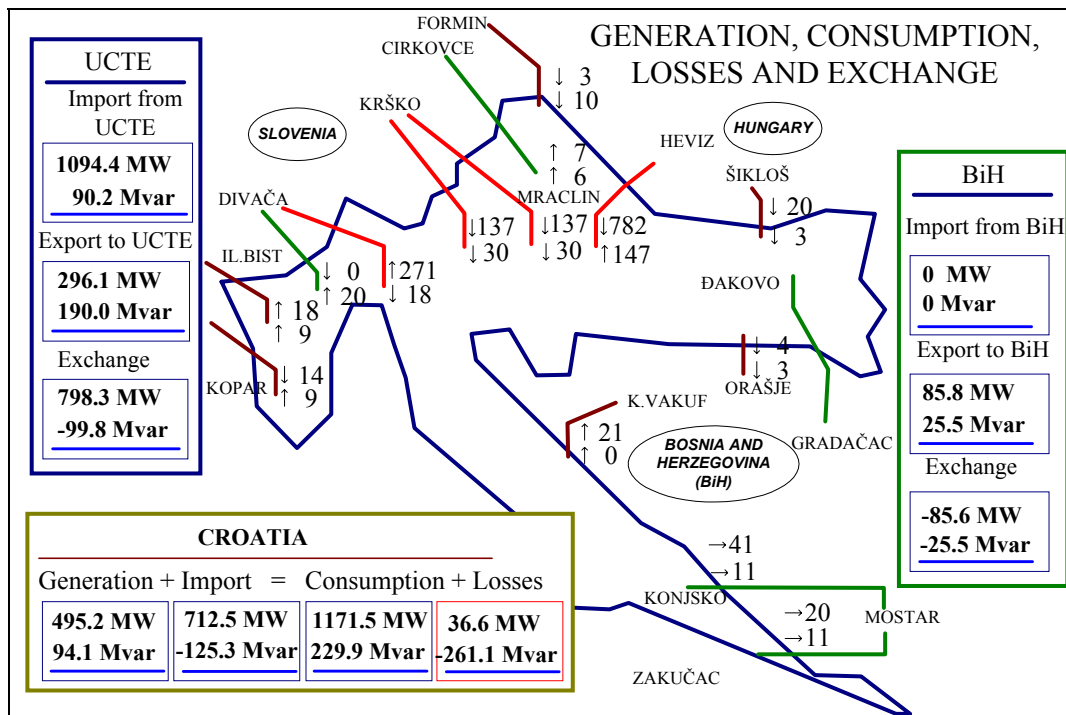
**Figure 3** Totals and tie-line power flows of Croatian power system after loss of three thermal units with total generation of 505 MW (on 20th September 2002 at 00:30:05)

first moment covered mainly by drawing the primary regulation reserve from UCTE. During next couple of minutes several hydro units in the southern part of the system were started which helped to restore the balance of Croatian system. Totals and tie-line interchanges of the Croatian system at the steady state immediately following the tripping of the generating units at TPP Rijeka, TPP Plomin 1 and TPP Plomin 2 are shown in fig 3 (system snapshot was taken by DAM on 20th September at 00:30:05). At that moment the Croatian system was still being importing approximately 400 MW of unscheduled (emergency) power from the UCTE.

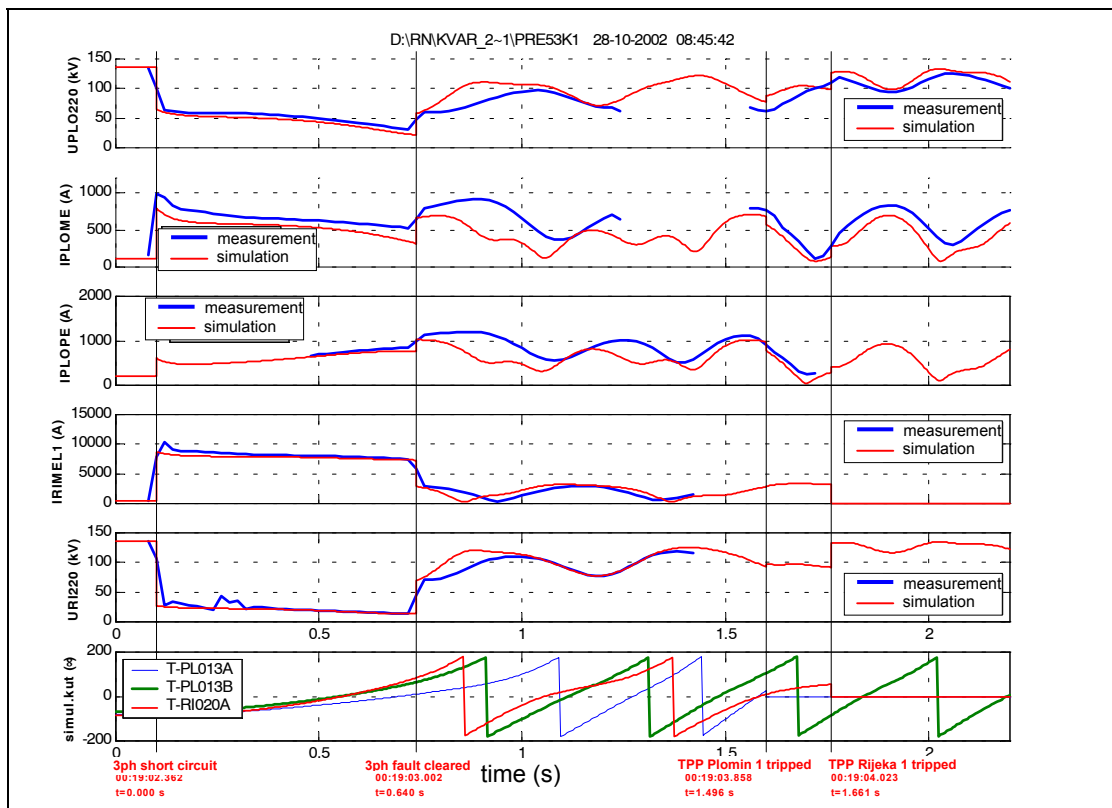
**Figure 4** Comparison of simulated and recorded characteristic quantities during disturbance of 20th September 2002, with rotor angle dynamics from the simulation (T-PL013A=TPP Plomin 1; T-PL013B=TPP Plomin 2; T-RI020A=TPP Rijeka)

A comparison of simulation results with measurements (RMS values) is shown in Fig. 4. (shown quantities are designated as follows: UPLO220 – 220 kV voltage at TPP Plomin; IPLOME – current in the 220 kV line TPP Plomin – S/S Melina; IPLOPE – current in the 220 kV line TPP Plomin – S/S Pehlin; IRIMEL1 – current in the 220 kV line TPP Rijeka – S/S Melina 1; URI220 – 220 kV voltage at TPP Rijeka). Since the match between simulation and measurements was pretty good it allowed us to use simulation model results to estimate response of other quantities that had not been recorded, such as rotor angle of the generators (Fig. 4 at the bottom) or representative variables for all three generators shown in Fig. 4 ( $U_g$  – generator voltage;  $P_g$  – generator active power;  $Q_g$  – generator reactive power;  $I_g$  – generator current;  $I_{fd}$  – field current;  $U_{fd}$  – field voltage,  $\delta$  – rotor angle with respect

to the synchronous reference axis). Rotor angles clearly shows that the units at TPP Rijeka, TPP Plomin 1 and TPP Plomin 2 lost transient stability. Phase voltages at the 220 kV buses Plomin and TPP Rijeka indicate that voltage stability was also endangered.

As can be seen in fig. 4 the units at TPP Rijeka and TPP Plomin 1 were disconnected after two pole slips while the TPP Plomin 2 unit remained in asynchronous operation for nearly 9 seconds (note that only first three seconds are shown in Fig. 5). Operation of loss-of-excitation protection RAGPC (ASEA) at TPP Rijeka was correct and in accordance with its settings. The unit at TPP Rijeka is not equipped with a separate out-of-step protection but the loss-of-excitation protection is supposed to detect out-of-step conditions.

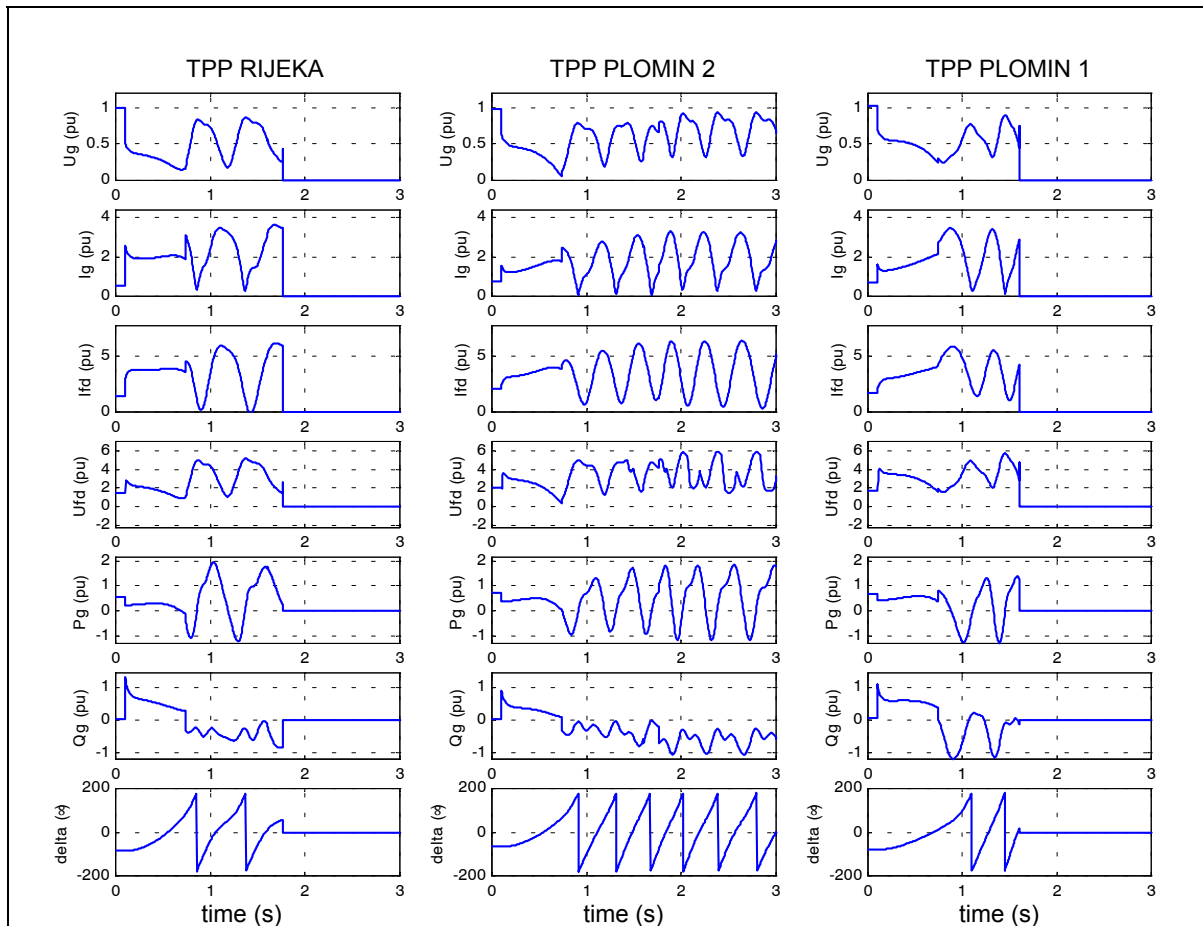
**Figure 5** Variables of generating units at TPP Rijeka, TPP Plomin 1 and TPP Plomin 2 during the disturbance of 20th September 2002 (simulation results)

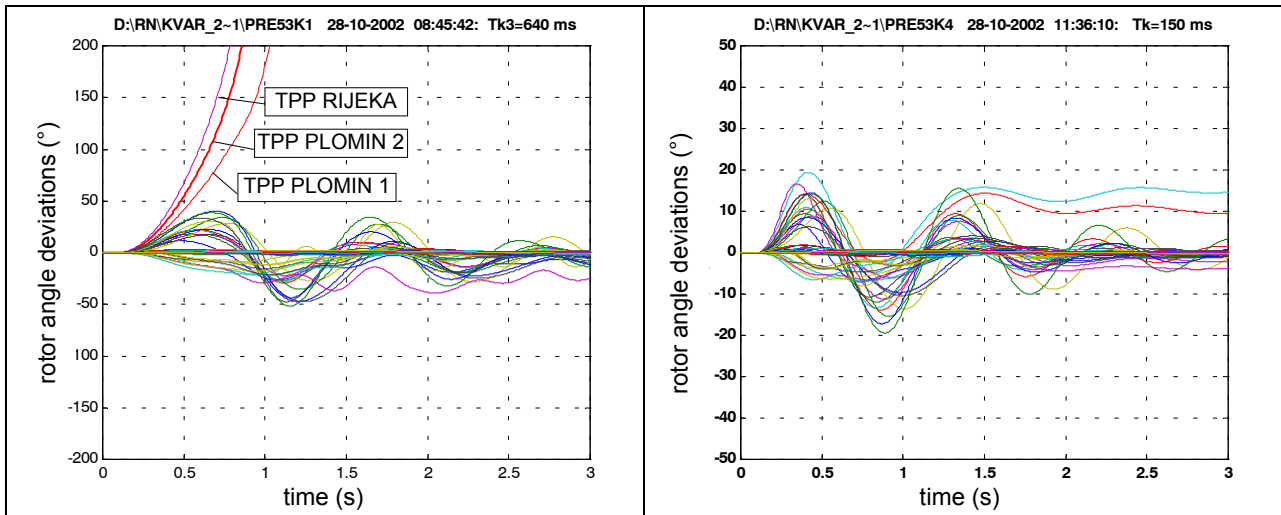
**Figure 6** Rotor angle deviations w.r.t. synchronous axis for the case of simulated real fault with duration of 640 ms (left), and for the same type of fault but with duration of 150 ms (right)

Rotor angle dynamics for all generators in the model is comparatively shown for the fault duration of 150 ms (fig. 6 on the right) and for the fault duration of 640 ms (fig. 6 on the left). As expected, transient stability would have been preserved had the distance protection operated in the first zone with assumed clearing time of 150 ms.

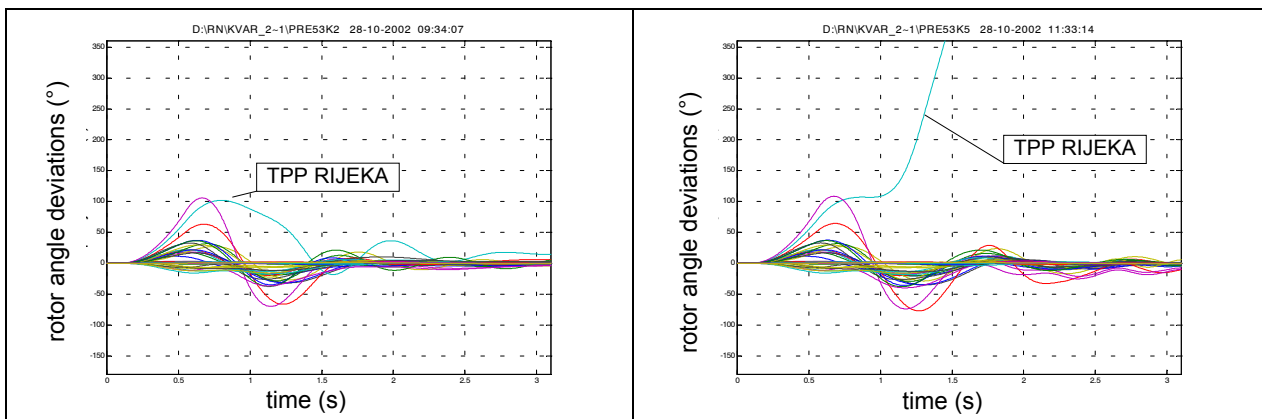
**Figure 7** Rotor angle deviations w.r.t. synchronous axis for critical clearing time of three-phase short circuit for the same initial steady state, type and location of fault as during disturbance of 20th September 2002

time (CCT) equal to 445 ms is shown in fig. 7 (left), while for the fault clearing time of 450 ms the unit at TPP Rijeka becomes unstable (fig. 7, right) and, by definition, transient stability of Croatian system is not preserved. It follows that for this specific case the second-zone time delay of the distance protection should have been reduced from 500 to 300 ms in order to avoid transient instability. But requirement for time coordination with circuit breaker failure protection (1<sup>st</sup> step: 150 ms; 2<sup>nd</sup> step: 300 ms) inhibits reducing second zone time delay of the distance protection to 300 ms. Other way to solve the problem is to protect these short transmission lines with line differential protection and this was chosen as final solution.

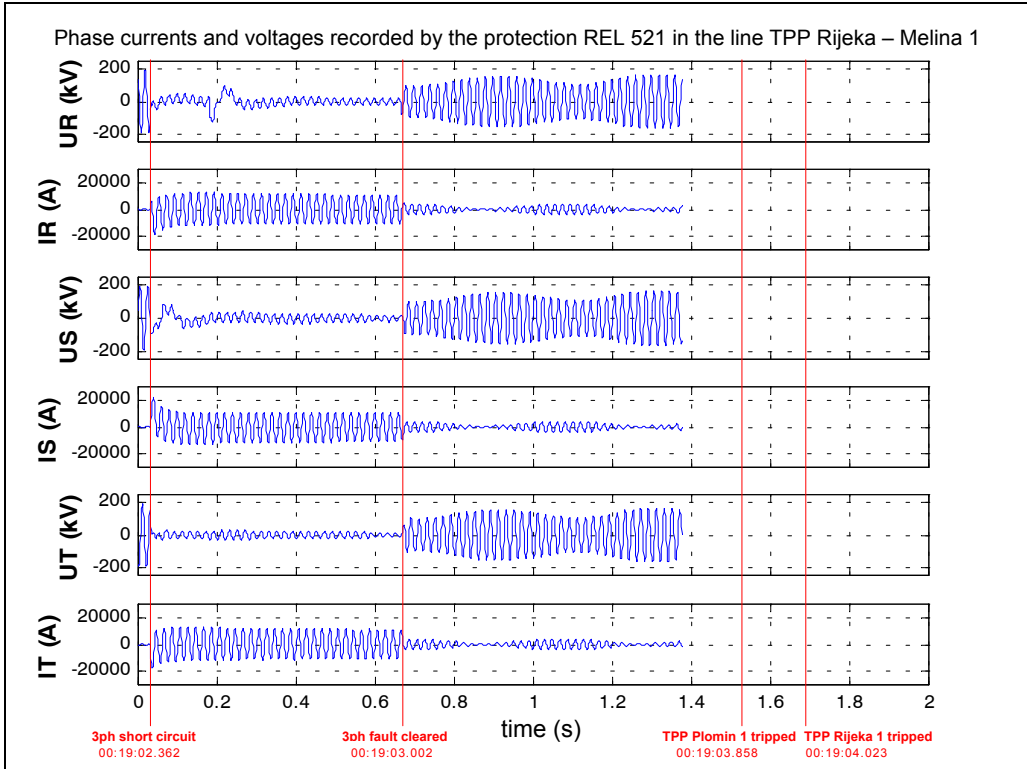
**Figure A-1** Current and voltage waveforms recorded by the line protection at 220 kV transmission line TPP Rijeka – S/S Melina 1 (at TPP Rijeka)

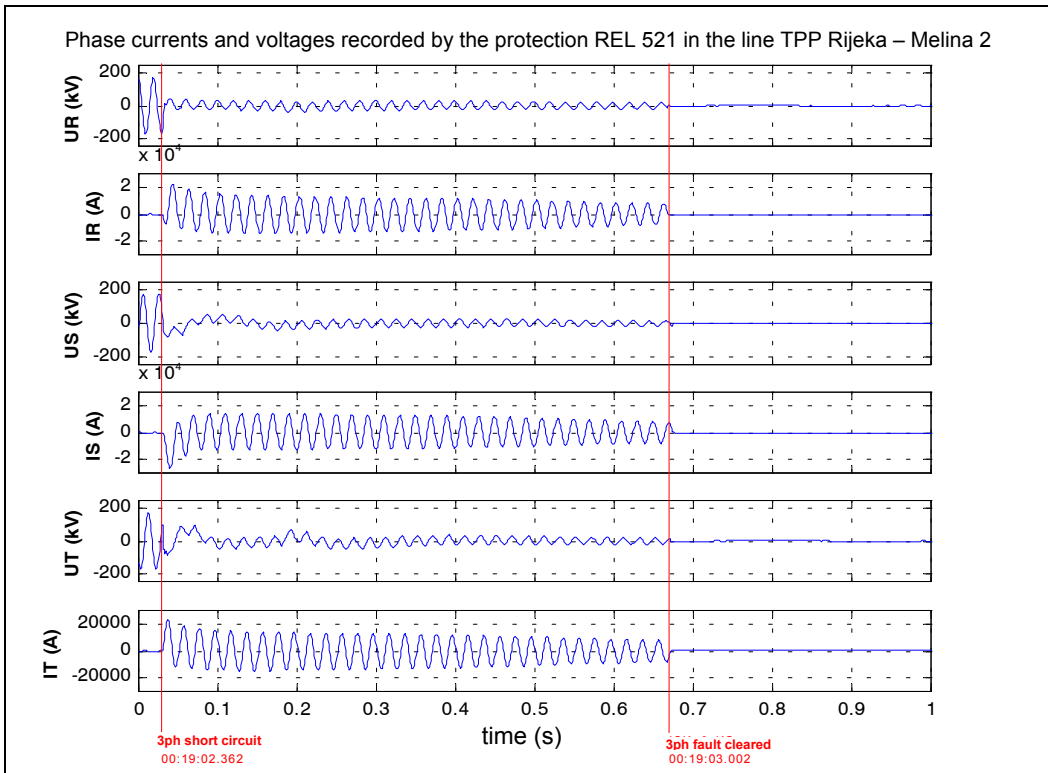
Once the records were reconstructed and synchronised the characteristic events such as occurrence of the fault, clearing the fault and tripping of the generating units could be marked on the time axis. Close inspection of current and voltage waveforms recorded by the relay in the 220 kV line TPP Rijeka – S/S Melina 2 shows that the three-phase short circuit on that line occurred practically instantaneously in all three phases (see App. Fig. A-2). Recorded waveforms clearly show the dynamics of currents and voltages during fault while their envelopes in the post-fault period reflect the power swings in the system caused by

**Figure A-2** Current and voltage waveforms recorded by the line protection at 220 kV transmission line TPP Rijeka – S/S Melina 2 (at TPP Rijeka)

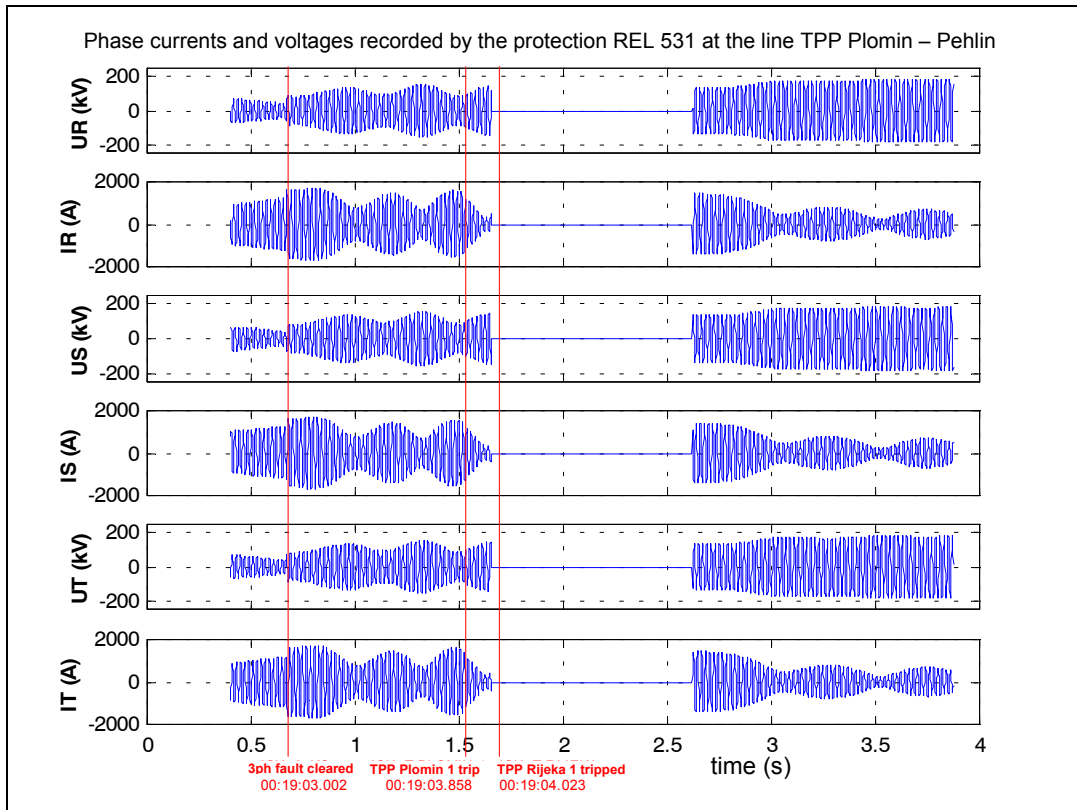
Fault disturbance facilities of line protections are designed for recording of power frequency transients and not for power swings and similar slower phenomena. The whole time span of the disturbance which in this case lasted for nearly 10 seconds (i.e. till tripping of the last generator) was not recorded by relays as contiguous waveforms. It was necessary to „patch“ the records in order to reconstruct the entire period of observation. This was not easy because the relays were not synchronised with a common time base. First the proper time relationship between consecutive records ("segments") had to be established for data recorded by each individual relay. When this was done for all relays, the completed ("reconstructed") records from different relays could be time-aligned. The just described reconstruction process is illustrated by waveforms recorded by relays in the 220 kV lines TPP Plomin – S/S Pehlin (two segments, see App. fig. A-3) and TPP Plomin – S/S Melina (three segments, see App. fig. A-4).

**Figure A-3** Current and voltage waveforms recorded by line protection at 220 kV transmission line TPP Plomin – S/S Pehlin (at TPP Plomin)

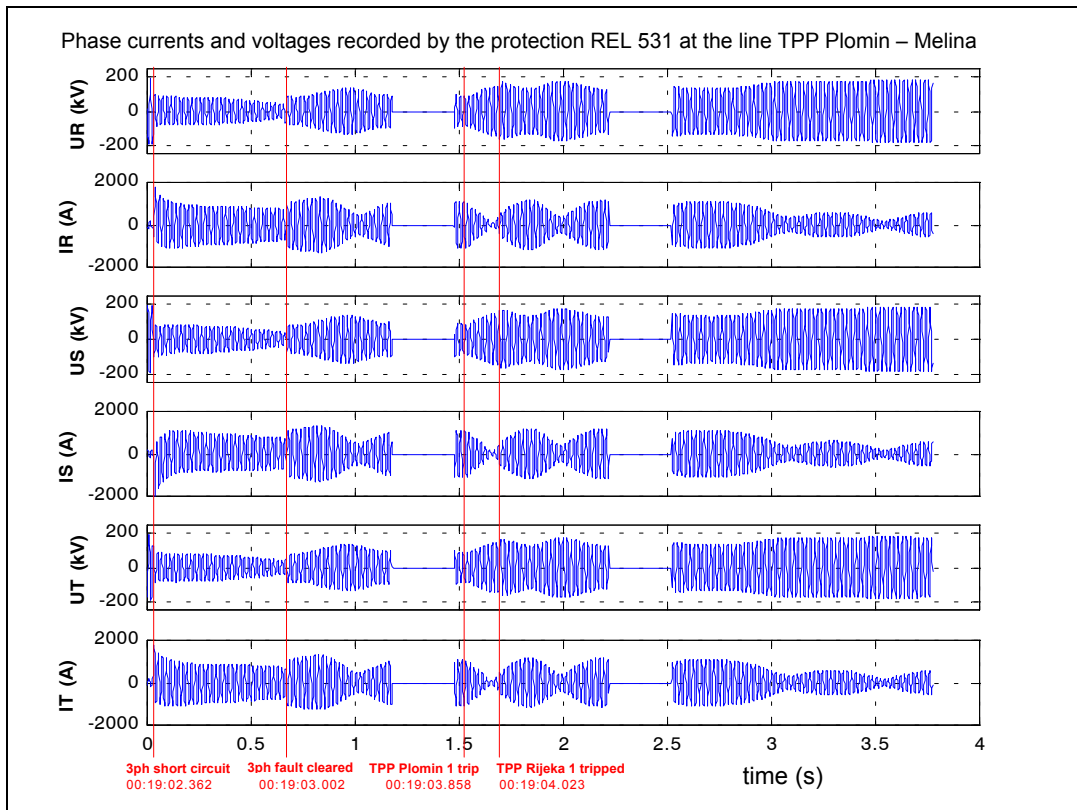
**Figure A-4** Current and voltage waveforms recorded by line protection at 220 kV transmission line TPP Plomin – S/S Melina (at TPP Plomin)
