Damage Assessment of Concrete Column using Combination of Nondestructive Methods

Dalibor Sekulic, Irina Stipanovic Oslakovic and Emilija Barisic³

Civil Engineering Institute of Croatia, Department for Concrete and Masonry Structures
J. Rakuse 1, 10000 Zagreb, Croatia, Europe, (+385) 6125-134, dalibor.sekulic@igh.hr

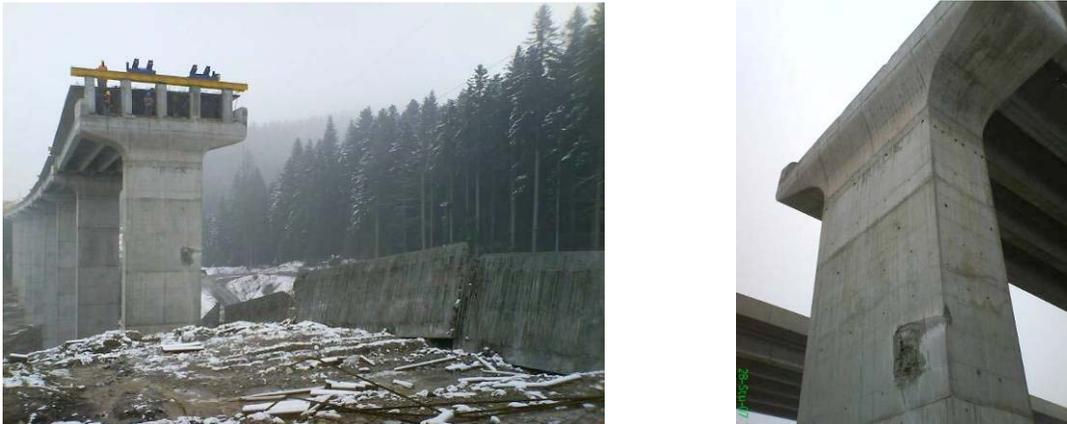
Paper describes condition assessment with the application of NDT methods during nondestructive damage investigation on the 18 m high reinforced concrete column on highway Zagreb - Rijeka in Croatia (Figure 1). Column was damaged by sudden fall of prestressed prefabricated beam girder of about 30 meters long and 100 tons weight, caused by carelessness during construction works. During the fall the girder hit the column which caused significant damage of column at the upper third of height.

Figure 1: (a) Failure on viaduct Stara Susica on Zagreb – Rijeka highway (b) Damaged column.

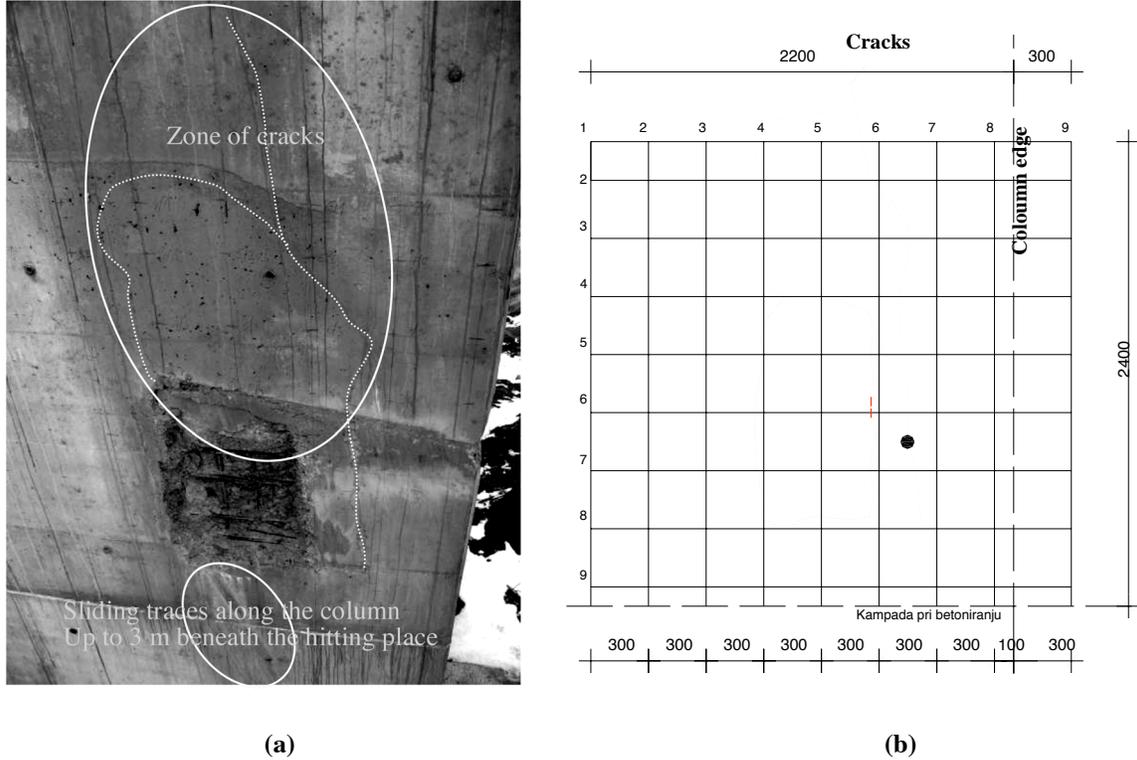
First insight into damaged column state was obtained by visual inspection. Visual inspection gave local damage on surface concrete, of the about 10 cm depth and of (120 x 80) cm² area. Two cracks of 0,1 mm width, and of about 1 m length, were visible above damage. Also, sliding traces along the column were detectable and visible up to 3 m beneath the place of impact.

Figure 2: Visible column damages (a) on photograph (b) indicated on measuring mesh.

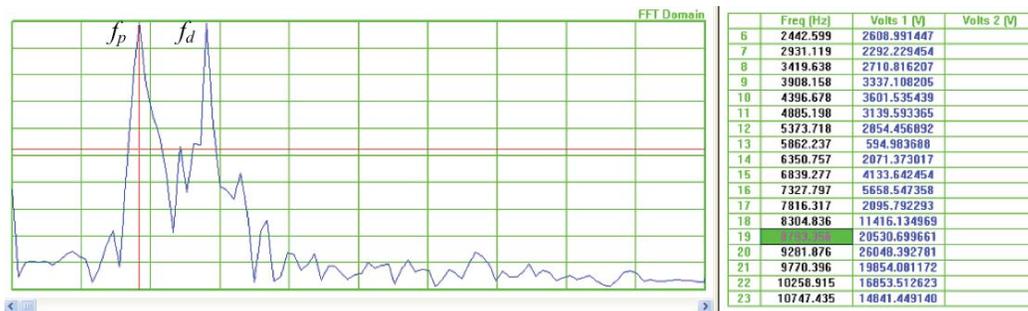
Figure 7: Example of waveform for damaged concrete with one significant flaw (point (1,1)).

Figure 7 shows example of waveform for damaged concrete with one significant flaw, positioned on the depth of 18 cm, calculated from frequency of second maxima applying Equation 1. First maxima correspond to thickness of structural

element (27 cm). Thickness is detectable which means that flaw isn't large and acoustic energy can propagate beside flaw. Second possibility is that wave propagates directly from the impactor to the bottom plane of element, but flaw is situated apart [2]. These type of measurements was characterized as damaged concrete.

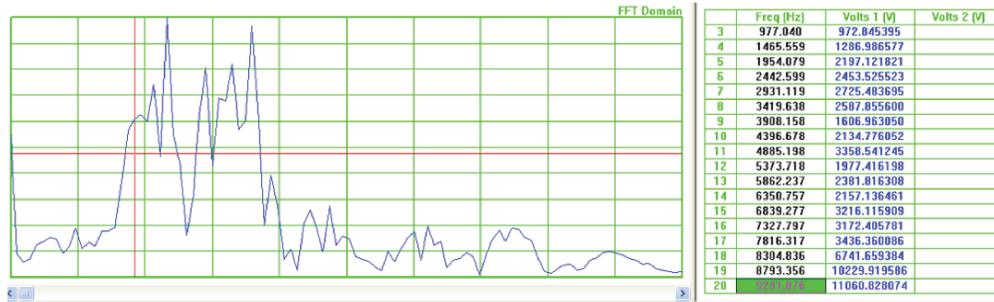
Next example, shown in Figure 8 represents situation of rather poor condition of investigated concrete. Thickness is hardly detectable, because small portion of wave is reflected from bottom boundary, and several cracks are detectable. This measurement is performed on the coordinate (6, 3) near the crack visible from the surface.

Figure 8: Example of waveform for considerable damaged concrete with several significant flaws (point (6, 3) on a measuring mesh).

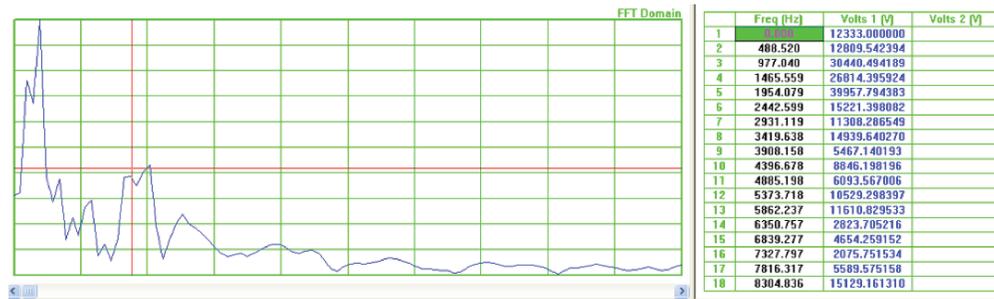
Figure 9: Example of waveform for concrete delaminated near the surface (point (4, 3) on a mesh).

For the example in Figure 9 frequencies are lower than the frequency which determines element thickness, so calculation of depth according to equation 1 gives values greater than structural element thickness, hence cannot be applied. Sources of low frequency maximum are flexural vibrations of delaminated area. Conclusion is that an area of unbonded layers from other concrete exists, which is at small depth allowing low-frequency vibrations.

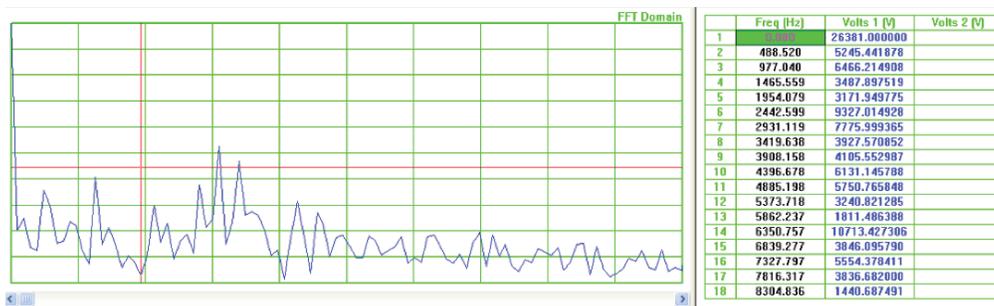
Figure 10: Example of waveform for concrete delaminated near the surface (point (6, 6) on a mesh).

Measurement giving waveform shown in Figure 10 is performed near the visible crack and drilled core.

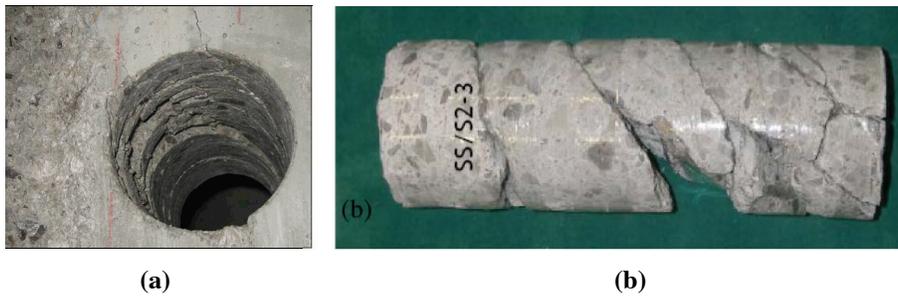
Figure 11: (a) Drilled hole near the position (6, 6) and (b) corresponding core.

Drilled core (Figure 11) shows seriously damaged concrete, which is affirmed by signal pattern (Figure 10). Thickness of element isn't detectable because all acoustic energy is reflected from many cracks and fragments. Also, Figure 10 shows frequencies smaller than frequency which represents thickness of structural element, which leads to flexural oscillations of larger rebounded areas situated near the concrete surface.

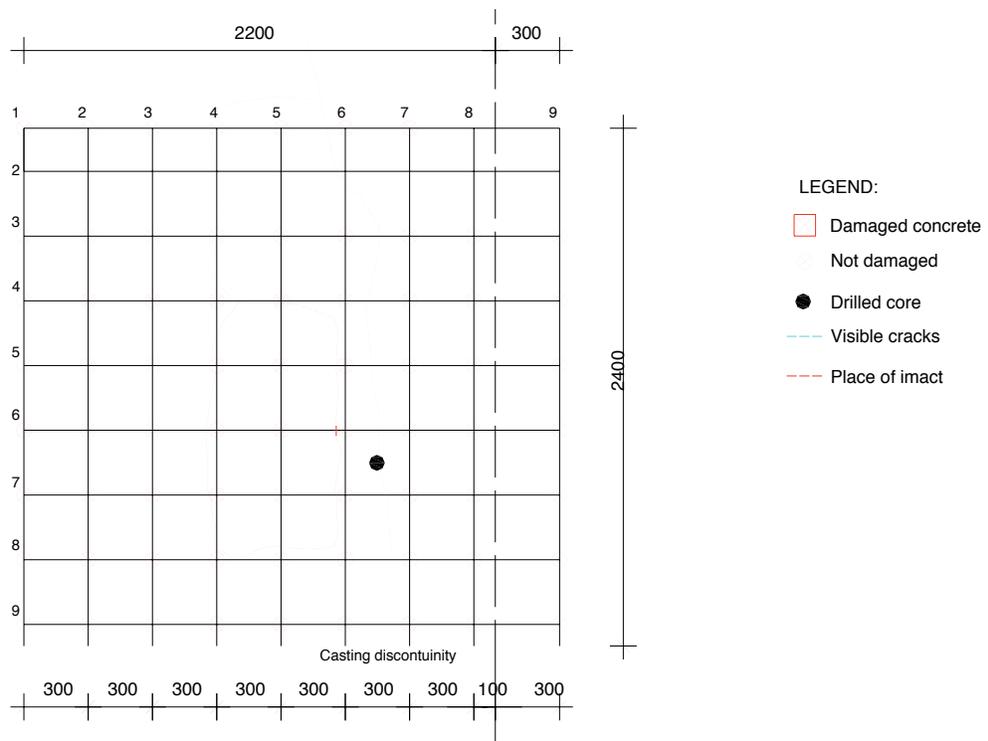
Impact-echo results for overall investigated area are represented in Figure 12. Damaged places are marked red and undamaged places green. From Figure 12 it can be seen that damaged area spreads outside of visible damage. It is estimated that on the right side of column damages spreads up to 40 cm from column edge.

Damages are spreading above the measured area on the left side and below, where concrete girder slipped during falling. Figure 12 also shows visible cracks indicated by blue dotted line, visible deterioration indicated by red dotted line, and position of drilled core indicated with black dot.

Figure 12: Impact echo test results for investigated surface.

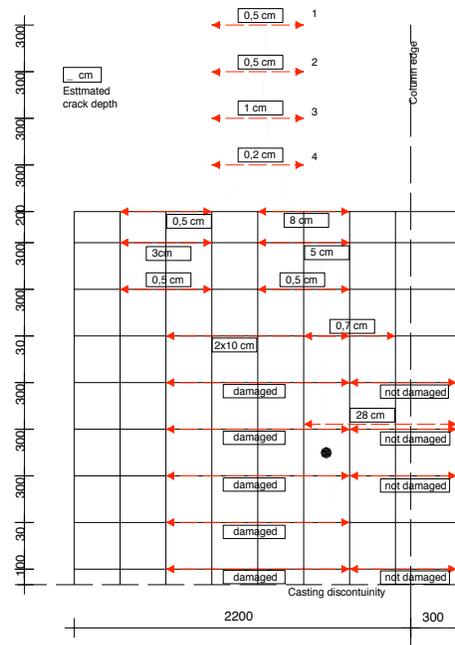
Figure 14: Results of ultrasonic pulse transit time measurements.

Near the drilled cylinder, a crack which spreads through overall column wall depth is detected, while in the upper part of measurement mesh depth of crack is smaller, from 0,5 cm to 8 cm. Measurements were performed also along the whole crack, which spreads about 1 m upper from the mesh. For these positions small crack depth was indicated (0,2 to 1 cm). Another series of measurements was performed by semi-direct method around the right column edge. Results of these measurements indicated non-damaged concrete. Measurements were performed also across the visible damaged area and these results indicated high decrease of ultrasonic pulse velocity (from 5300 m/s for sound concrete to 2000 m/s) which is an indication of several damages under the visible damaged area.

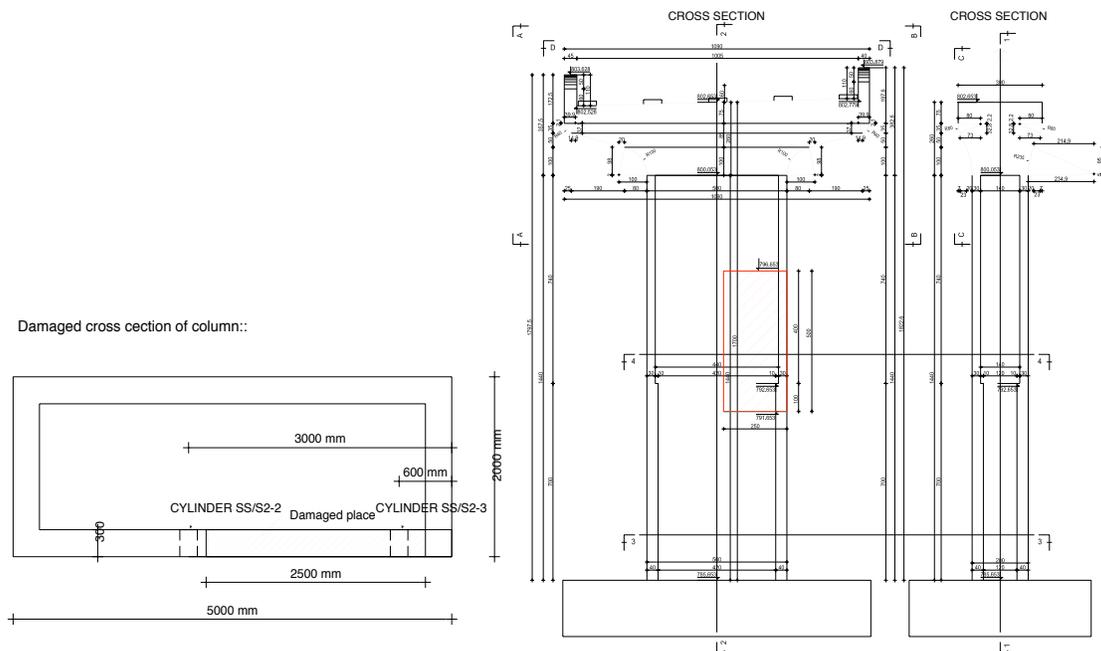
On the basis of the performed investigation works it was estimated damaged area spreads on the maximal possible width of about 2,5 m and height of about 5 m, which is 20 % of total column cross section (Figure (5(a))).

Figure 15: (a) Damaged cross section of column (b) Damaged area (red indicated).

Figure 15(b) shows estimated damaged area in respect to whole column.

As result of investigations proposal for repair project was given, including statically analysis of column load bearing capacity caused by cross section decrease during damaged concrete removal, removal of damaged concrete by hydro demolition; loosen formwork inside the column body montage, reinforcement repair, exterior formwork montage, implementation of new concrete and finally testing of quality of performed works.
