# REHABILITATION OF CONCRETE BEAM BRIDGES IN CROATIAN STATE ROAD NETWORK

Danijel Tenžera, Krešimir Futivić, Boris Ukrainczyk

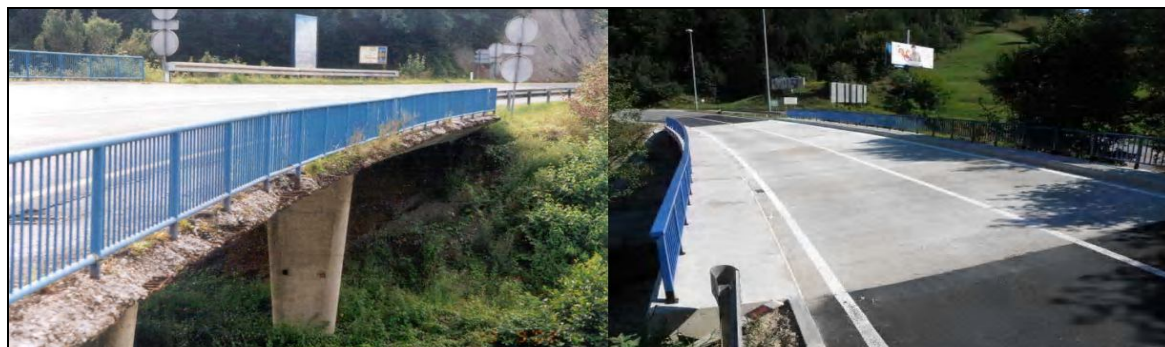
Macelj Overpass, built in 1969, is located on the state road D1 just in front of the border crossing with Slovenia. Overpass that is 36.3 m long in total consists of three spans having vertical clearance of 9,57 m+14,13 m+9,52 m. The overpass is 10.80 m wide, with two sidewalks 1.2 m each. The span structure is a continuous reinforced concrete beam, fixed on the piers and abutment beams, designed and constructed in compliance with legislation in force at that time, PTP 5 [3]. The inspection noticed damages of the road formation under the overpass and the upper structure had become overburdened by multiple resurfacing layers that raised the pavement level and even covered the curbs. The estimated scope of rehabilitation works included removal of the existing asphalt layers, removal of the concrete on sidewalk brackets and deck slab by hydro-modelling, reinforcement of the new deck slab, installation of new railings, construction of reinforced concrete sidewalk brackets, fascia beams and deck slab by placing of special polymer modified concrete, repair of cracks in the existing concrete, reconstruction of abutments and installation of new expansion joints.

Fig. 1 Macelj Overpass before and after rehabilitation

Special polymer modified concrete has been designed with the purpose to provide strengthening of the span structure, to increase resistance to freezing and salt activity, to increase resistance to wear and tear/abrasion, to renew waterproofing, to increase skid resistance and non-deformability or resistance to rutting. The construction of concrete deck slab that also has a function of a concrete pavement (Fig 1) is rather complex in the preparation of works and it demands stricter quality control during the works, however, the result is considerably increased durability of the structure.

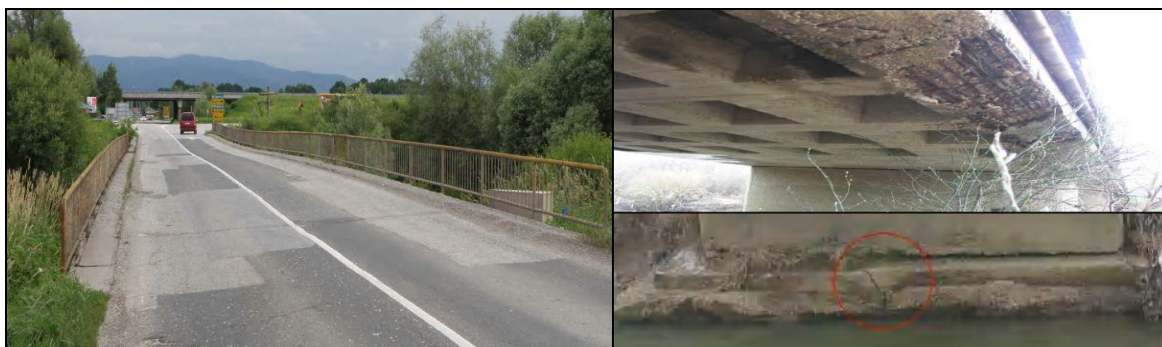
The Mokrice Bridge across the Krapina river on state road D1 was built in 1962. The bridge has spans with vertical clearance 14,20 m+17,50 m+14,20 m. Total bridge width before the reconstruction was 8.05 m [4]. The span structure of the bridge is a continuous two-hinged frame, supported on two piers on rocker bearings with foundations in the riverbed. The bridge degradation process had already started during construction of the bridge with subsidence of piers which caused delevelling of pavement (Fig.2). A damage worth mentioning was a crack in the foundation of the south pier and a subsidence of structure in that cross section. The pier had an inclination that deviated 4,5 % from the vertical axis, and the pier moved towards the river bed by 23 cm approximately.

**Fig. 2** View of the old bridge Mokrice with details of damages in edge beams and pier foundation

Subsidence of the pier resulted in cracks in the deck slab stretching across 2.0 m at each side of the south pier and in deformation of deck slab that measured as much as 15 cm with additional deformations caused by dynamic loads imposed by vehicles. Edge beams of the deck slab were in the worst structural condition. About 30% of the concrete surface in protective layer of the reinforcement was dislodged and the corrosion reduced the cross section of reinforcement by as much as 50%.

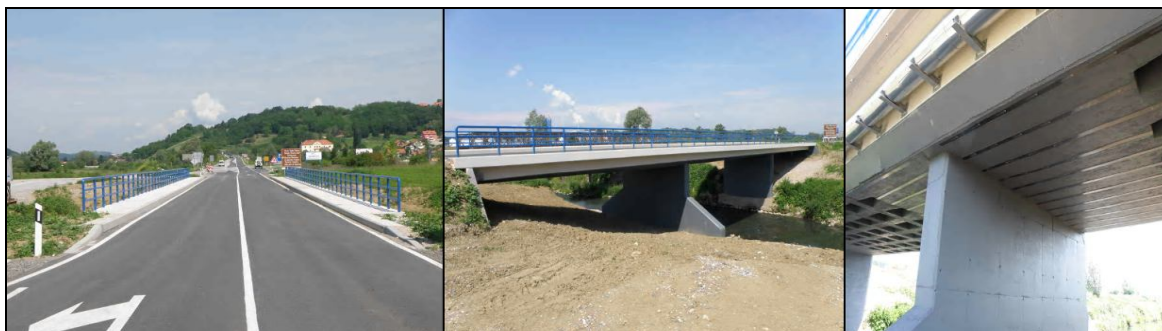
**Fig. 3** Reconstructed bridge with details of strengthening by fiber reinforced polymer

Reconstruction of the Mokrice bridge carried out in 2012 included removal of the existing deck slab edge beams, sidewalks and fascia beams by hydro-demolition, the widening of the bridge to 9.6 m, levelling of deck slab subsidence, waterproofing, drainage, asphalt surfacing, construction of bridge accesses, reconstruction of north pier and construction of the new south pier that consisted in two groups of five piles having length of 10.0 m. Deck slab soffit has been reconstructed and deck slab reinforced using fiber reinforced polymer sheets in places where cracks had appeared along the south pier.

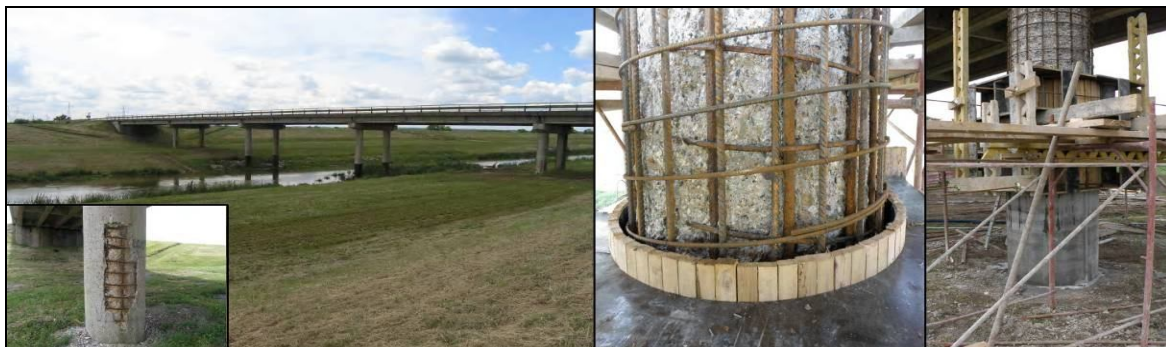
The Vukovina II bridge, built in 1954 across the Sava-Odra Channel on the state road D30, has five spans 21,5 m each, supported on four pairs of columns. Each column pair has two columns with diameter 100 cm each that are connected by a head beam. The column base is covered by a steel sheet 4 m high that had corroded completely in the parts located in the channel bed. Total length of the bridge is 121.5 m, while the total width is 10.4 m. The bridge inspection carried out in 2007 [5] recorded damages showed as dislodging of large areas of protective concrete from the reinforcement, appearance of cracks and corrosion of reinforcement.

**Fig. 4** The Vukovina bridge with details of column damages and strengthening by steel

Upon the removal of damaged parts by hydro-modelling, disintegrated surface of abutments, cross girders and main girders were rehabilitated by mortar modified polymer, while the surface of head beams was repaired by shotcrete. After removal of steel sheets and hydro-demolition, the columns were repaired by new reinforcement and additional concrete layer 20 cm thick.

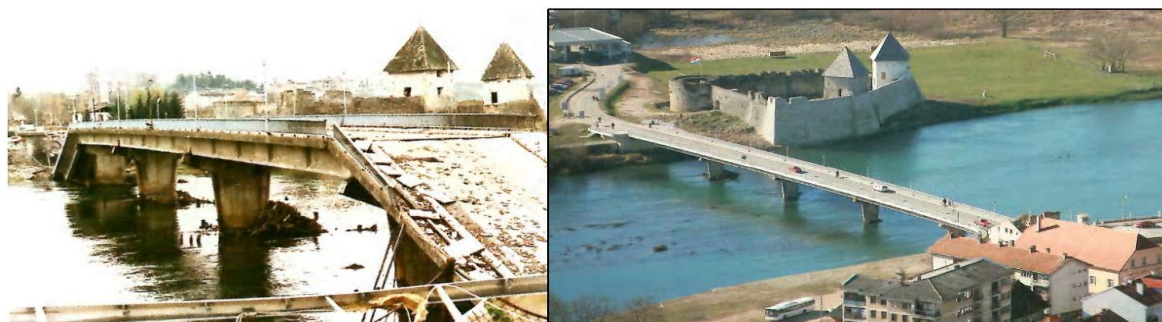
**Fig. 5** View of the bridge across the Una at Hrvatska Kostajnica, before and after reconstruction.

The reconstruction of bridges destroyed in war happenings during the Homeland War required specific approach because the explosive devices that had been placed on bearings and supporting structure of the bridge often damaged piers. A good example of such reconstruction is the bridge across the Una river on state road D47 in Hrvatska Kostajnica (Fig. 5). The bridge, built in 1968, has total length of 148 m and it consists of five spans (16 m+4 x 33 m). In the period before 1995 during the first and the fifth span had been demolished in war activities and abutments and piers had been damaged. Reconstruction of the bridge carried out in 2002 included construction of destroyed spans and reconstruction of the existing spans, reconstruction of abutments, piers, expansion joints, drainage and bridge pavement.
