Performance of the Line Surge Arresters of the 110 kV Overhead Lines on the island Brač

M. MESIĆ, S. PILIŠKIĆ

**Croatian Transmission System Operator Ltd. (HOPS), Zagreb
Croatia**

SUMMARY

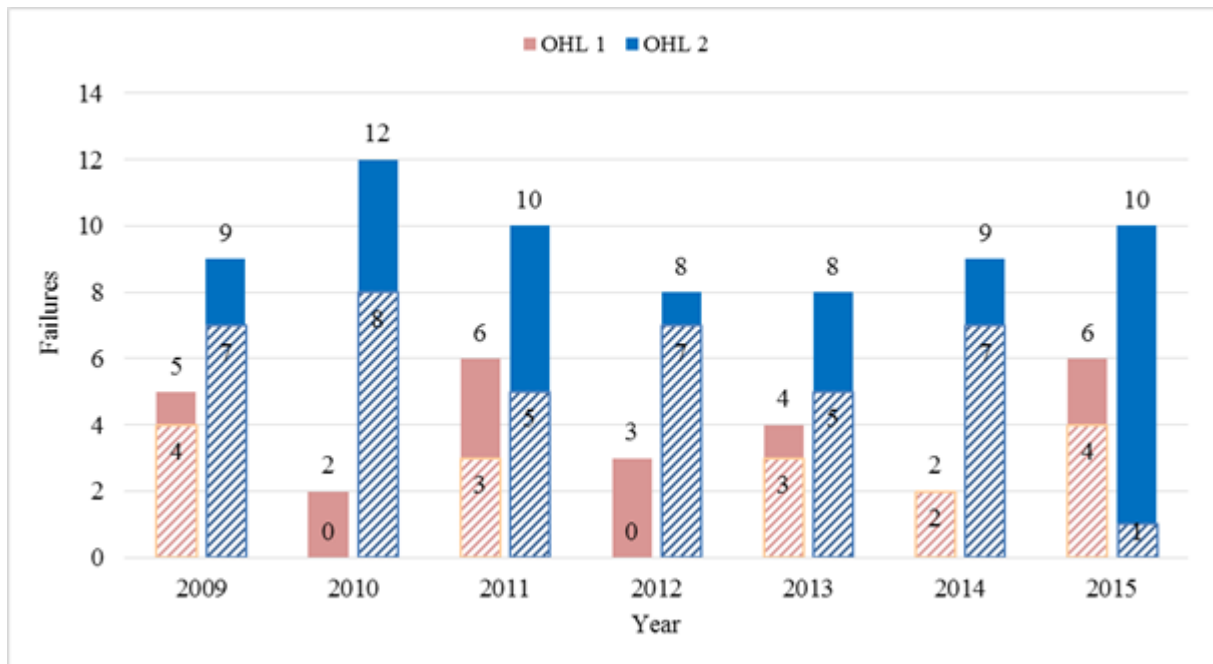
Fig. 1. Number of outages caused by the lightning (2009-2015)

Fig. 1 shows the yearly distribution of total number of outages and those caused by lightning on the observed OHLs.

In [4] it has been shown that all of the outages caused by lightning in 2014 occurred after LSAs installation. The analysis of the lightning activities in the observed area showed that the 2014 was extremely lightning active and provided reasonable explanation for increased number of outages caused by lightning.

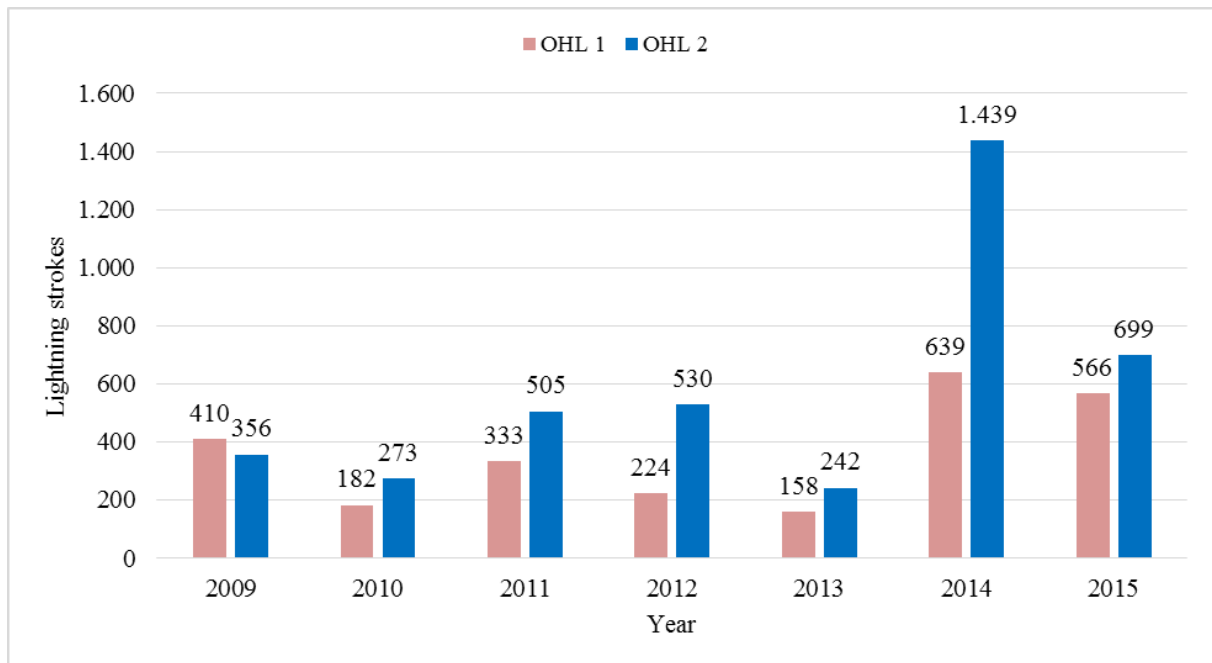
Fig. 2. Number of the lightning strokes within the OHL alarm zones (2009-2015)

For calculation of lightning statistics, LLS data for the last seven years (2009 – 2015) were available. Fig. 2 represents the lightning stroke distribution registered by the LLS within the alarm zones around the observed overhead lines for the period 2009-2015, while Fig. 3 shows the lightning stroke distribution within the alarm zones for the year 2015.

According to the distributions of the lightning strokes represented in the Figures 2 and 3 conclusions about the influence of lightning to the operation of the OHLs are possible. During the 2015 there was less lightning than in year 2014 in the observed area, but still above the yearly average (based on the seven year measured period).

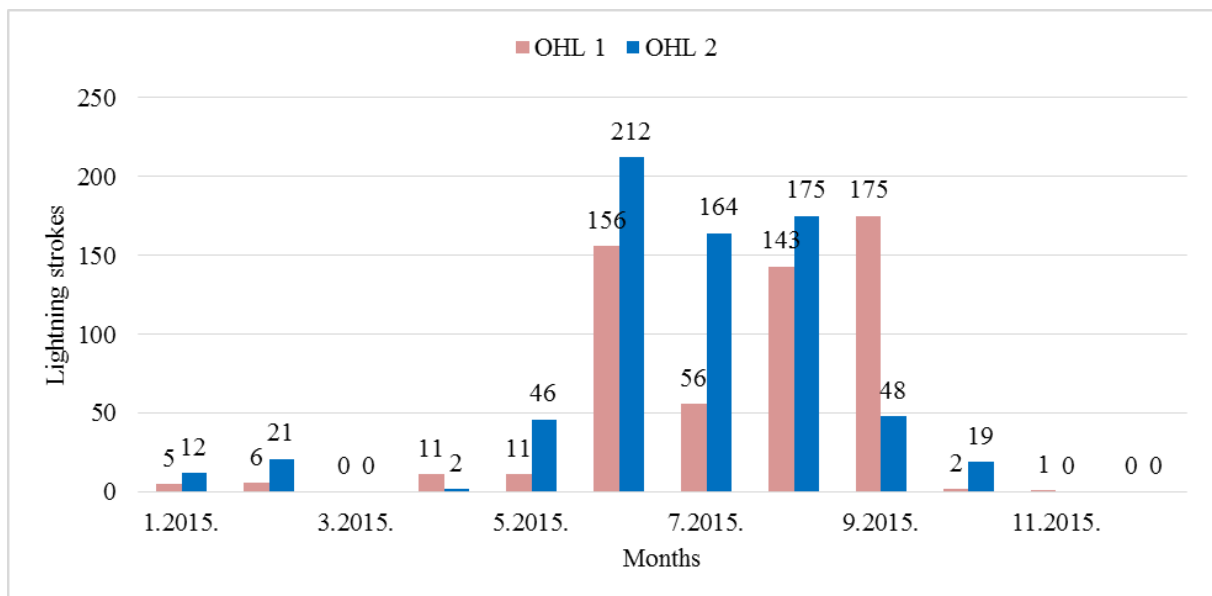
Fig. 3. Number of the lightning strokes within the alarm zones (2015)

For the OHL 1, the increased lightning activity during the year 2015 resulted with the increased number of outages in comparison to previous years. Moreover, the some of the towers within the affected line section are equipped with the LSAs in the bottom phase. Analyses showed that all of the outages of the OHL 2 occurred due to the lightning during the summer period which corresponds with the increased lightning activities in the same period (Fig. 3).

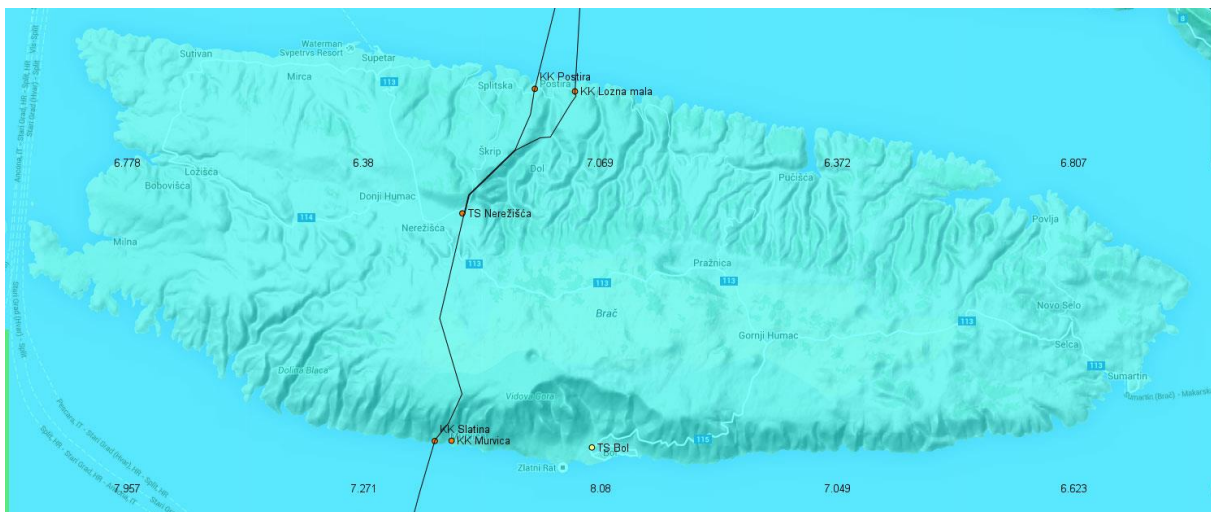
Fig. 4. Low resolution Ground stroke density [stroke/km²/year] map of the observed area (2009-2015)

Fig. 4 shows the low resolution map of cloud to ground stroke density for the observed area. The values on the map correspond to the values of 4.23 – 5.36 flashes/km²/year. The majority of lightning flashes comprises multiple strokes which strike a few milliseconds from each other. According to the LLS data, the observed area had an average stroke multiplicity of 1.508 strokes per flash. The ground stroke density varies between 6.38 – 8.08 strokes/km²/year.

By comparing these statistical values with the ones from previous years [3], [4], it is possible to conclude that after seven years statistics are not influenced by the climatologically extreme year [4] anymore and that the statistical values started to converge, unlike it is the case with the outages of the overhead lines.

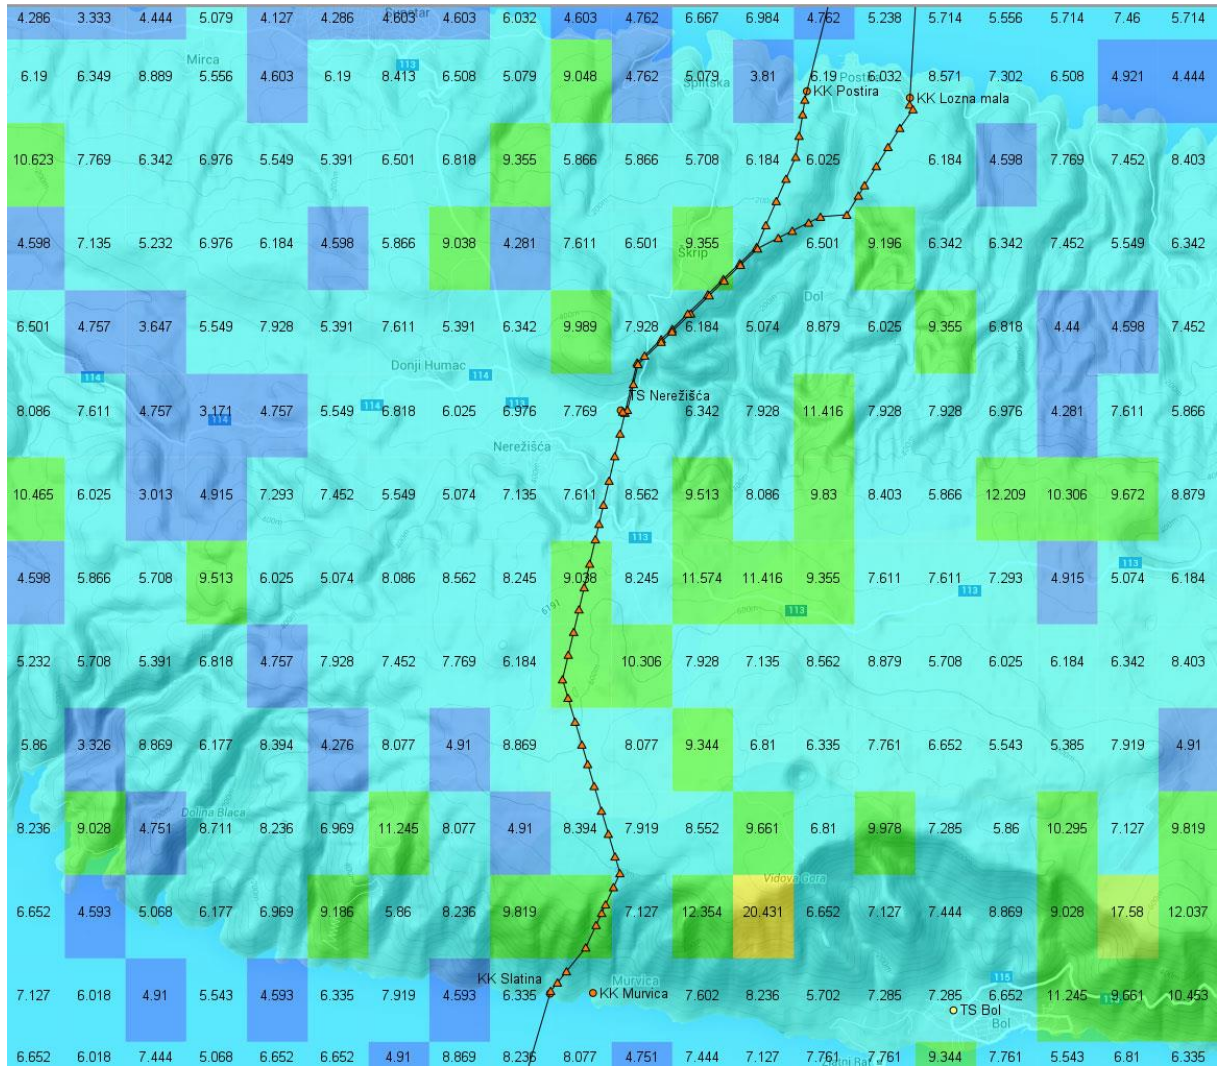
Fig. 5. High resolution ground stroke density [$\text{stroke}/\text{km}^2/\text{year}$] map of the observed area (2009-2015)

For the purpose of detailed analysis of the causes of OHL outages due to lightning high resolution ground stroke density [stroke/km²/year] map of the observed area was obtained from the LLS database as represented in the Fig. 5. In addition the locations of OHL towers were added to the map in order to be able to identify the level of their exposure to the lightning.

Moreover, the high resolution ground stroke density map of the overhead line (Fig. 5.) shows that there is a part of the overhead line 2 which was also significantly exposed to the lightning activities in the same period and no outages due to the lightning were registered on this particular line section. There were LSAs installed on towers of this OHL section as described in [4].

High resolution ground stroke density map of the observed overhead lines obtained by the LLS (Fig. 5) indicates that the area around tower number 5 was significantly exposed to the lightning strokes in the observed period. According to the data obtained from LLS database ground flash density value for the tower number 15 is 3.049 flashes/ km²/year.

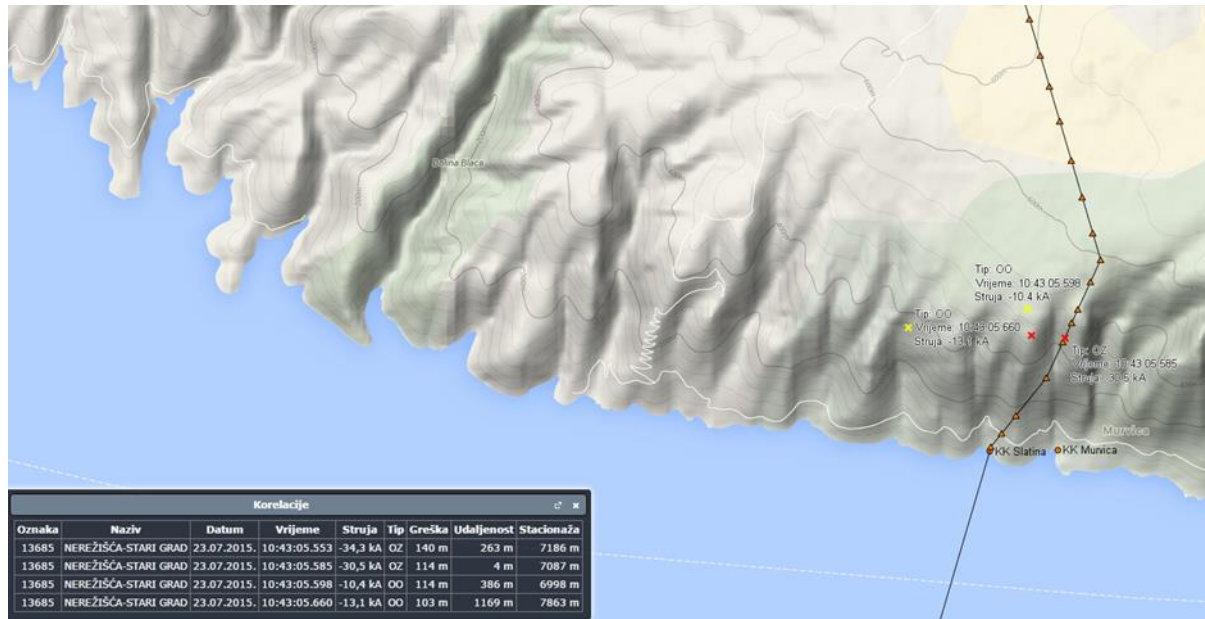
Fig. 6. Time and spatial correlation between relay protection system and LLS data, Case 1

The first case is the correlation of the only outage which occurred due to the lightning on the OHL 2. The relay protection system and corresponding LLS data for the Case 1 are given in Table I, while the time- spatial correlation between relay protection system and LLS data are shown on the Fig. 6.

In Fig. 6 it is shown that a multiple stroke flash with two ground strokes of lightning current of 34.3 kA and 30.5 kA was detected by LLS near the tower number 26. Measured tower's footing resistance was 21.3Ω . No LSAs were installed to the observed tower.

As shown in the Fig. 6 a flashover occurred on the tower located on the highest and most exposed part of the transmission line corridor extending over mountain area on the south side of the island towards the sea. This corresponds to the results of correlation performed in [4] where all outages registered in the period after the LSAs installation occurred on the highest and most exposed towers without LSAs. High resolution ground stroke density map of the observed overhead lines obtained by the LLS (Fig. 5) shows that this line section was extremely exposed to the lightning discharges in the observed period. According to the data obtained from LLS database ground flash density for the tower number 26 is $8.945 \text{ [flash/km}^2\text{/year]}$ which indicates that this particular tower is the most exposed to the lightning activities among all of the towers of the observed overhead lines.

It has been identified that there is a line section of the OHL 2 without LSAs which is exposed to the lightning influence due to its specific location. In the continuation analysis will be exceeded with data coming from the counters and possible installation of additional LSAs to the towers of this line section might be considered. Because of their location and terrain surrounding these suspension towers the access to them is difficult and LSAs installation could require significant costs. Since the number of outages of this overhead line due to the lightning has decreased significantly, the decision about LSAs reconfiguration will be postponed.

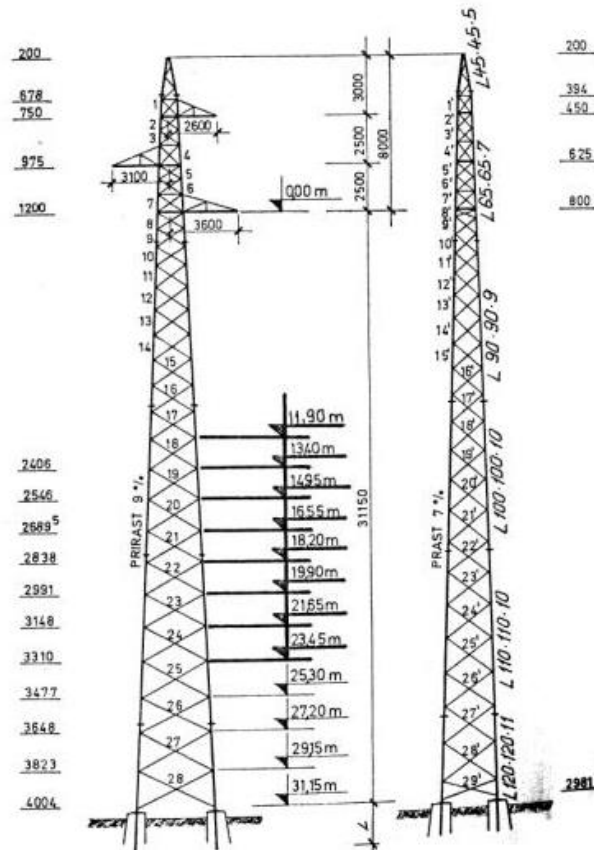
Fig. 7. Suspension tower Nc7-T

Critical current i.e. maximal lightning current which could strike the phase conductor according to electro-geometric model was calculated for the highest conductor of the suspension towers of the overhead line 2 (Fig. 7). Calculation showed that critical current value for the towers of the OHL 2 is from 6.0 kA to 14.8 kA. For the tower number 26 the calculated critical current is 13.5 kA which is lower than the lightning current of the analysed case. This indicates that the lightning strike could be to the shielding wire.

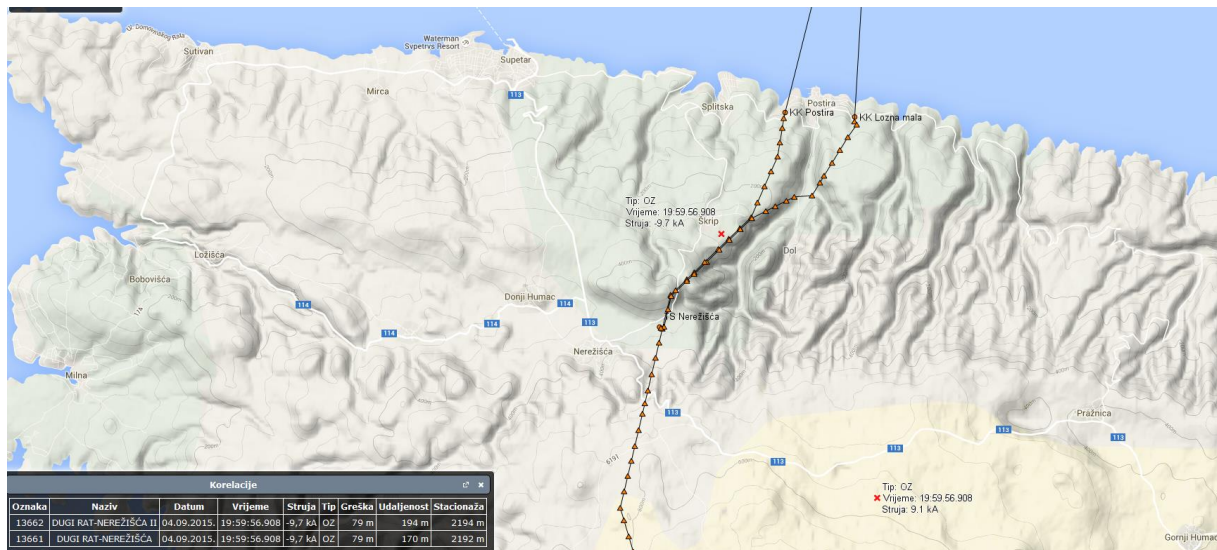
Fig. 8. Time and spatial correlation between relay protection system and LLS data, Case 2

The relay protection system and corresponding LLS data for the Case 2 are given in the Table II and the time and spatial correlation between relay protection system and LLS data are shown in the Fig. 8.

In Fig. 8 it is shown that the tower number 15 was the closest one to the location of the lightning stroke detected by the LLS. Measured tower's footing resistance was 20.8Ω .

According to the relay protection report data and correlations with LLS data it is visible that two outages occurred on the tower number 15 in the period after the LSAs installation to the OHL 1. Tower number 15 is located on the highest and most exposed part of the overhead line and no LSA is installed to it. Similarly, correlations showed that in the period after the LSAs installation to the OHL 1 two outages occurred on the tower number 13 and one outage occurred on the tower number 5 with LSA installed to the bottom phase of both towers. It is important to stress that both of the towers, number 13 and number 5, are exposed to the lightning influence due to their location.

Calculation showed that critical current value for the towers of the OHL 1 is from 7.6 kA to 19.3 kA. For the analysed outages that occurred on the tower number 15 the lightning current was 9.7 kA while the calculated critical current for the tower number 15 is 11.6 kA. This indicates that the lightning strike could be to the phase conductor.

Similarly as for the OHL 2, there is a line section of the OHL 1 without LSAs installed which is exposed to the increased lightning influence. In addition some outages occurred to the tower with LSA. This would indicate a reconfiguration of LSAs might be advisable, but the further analyses including data from the counters are needed.
