# Landslide affected with an open pit excavation in flysch deposit

Ž. Arbanas<sup>1</sup>, S. Dugonjić, M. Vivoda & V. Jagodnik Faculty of Civil Engineering, University of Rijeka, Rijeka, Croatia

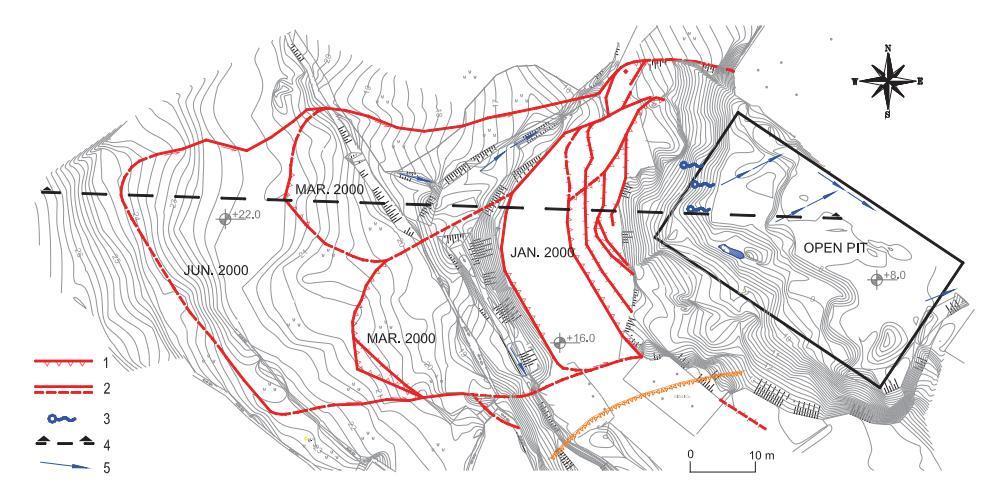
The initial sliding body was occurred in the January 2000, and buried excavated pit with sliding material. Two secondary sliding bodies incurred up the slope in March 2000. The final landslide body by retrogressive widening was attained in June 2000 (Fig. 1).

Figure 1. Schematic engineering-geological map of landslide (1.Open scarps; 2.Landslide borders; 3.Springs; 4.Trace of cross-section; 5.Temporary surface flows).

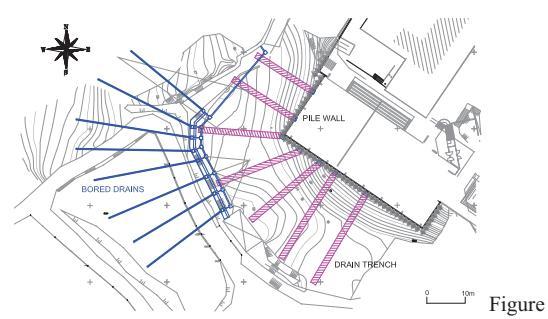
3. Schematic map of landslide position of pile wall, drain trenches and bored drains.

To enable further construction of planned sport hall, as an adequate retaining construction anchored pile wall in the toe of the landslide was chosen. The pile-wall consisting of bored piles with 1.50 m diameters, length of 18 m, and 10 m bored in siltstone flysch bedrock below future toe of the cut was designed. Head beam was designed to connect piles in firm unit construction. To ensure additional horizontal forces on construction, pile wall construction was supported by ground anchors. Capacity of anchors was 600 kN, 16 to 20 m long with 8 m long bond section in siltstone. Drains between the piles were predicted to ensure dewatering from the drain trenches behind the wall. To ensure ground water lowering in upper zone of the slopes, drilling of bored drains was predicted (Fig. 3).

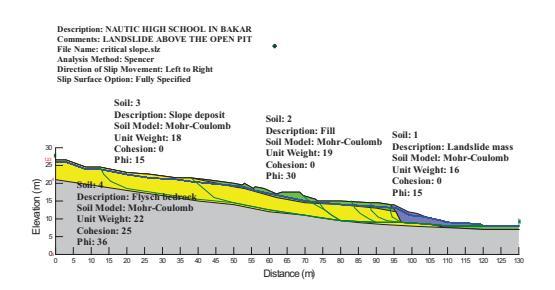
To confirm this solution, the stability analyses were performed using parameters of soil and rock masses in geotechnical model obtained from back analyses so as usual values for support construction (Fig. 4).

Figure 4. Geotechnical model of the slope.

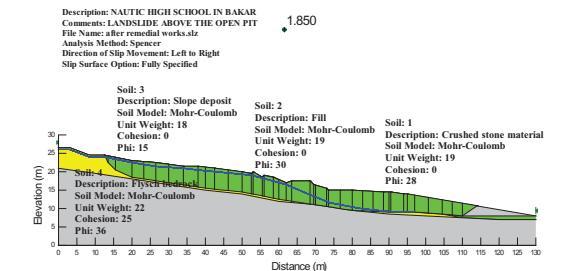
Figure 5. Critical slip surface after buttressing,

Stability analyses on competent geotechnical cross-section were done in order to define satisfying stability of the slope after constructing the first stage of remedial works: buttressing in the toe of the slope and deep drain trenches. For those conditions of slope, factor of safety for the whole slope provides satisfying value of 1.85 (Fig. 5). In analyses for final stage of remediation works in geotechnical model was included anchored pile wall construction and additional water level lowering in upper part of the slope due to boring drain system installation. Analyses were conducted in combination of stress-strain analyses of anchored pile wall behavior during excavation ahead of wall and limit equilibrium slope stability analyses using GEO-Slope Sigma/W and Slope/W software package [2]. The final factor of safety for the whole slope after second stage of remediation works offered satisfying value of 2.91 (Fig. 6).

First stage was constructed in autumn 2000. As appropriate stabilization method buttressing technique was chosen. Semi liquid clayey material from accumulation zone was removed and replaced by crushed rocky material to increase the loads in the toe of the slope. Rocky material allows drainage of the groundwater from landslide body and lowering of water level in lower part of the slope is enabled. To speed up dewatering of the slope, drain trenches down the slope was constructed with bottom below slip surface. Combination of these types of remediation methods stopped further movements of landslide body and ensured conditions for further construction.

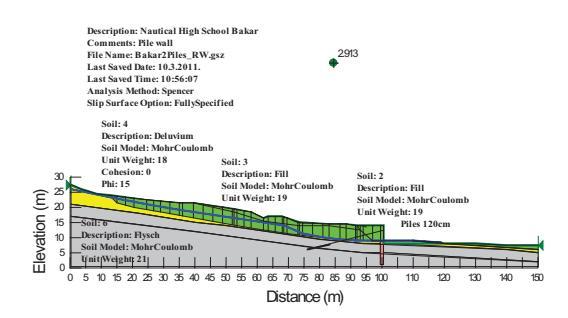
Figure 6. Critical slip surface after pile wall construction.

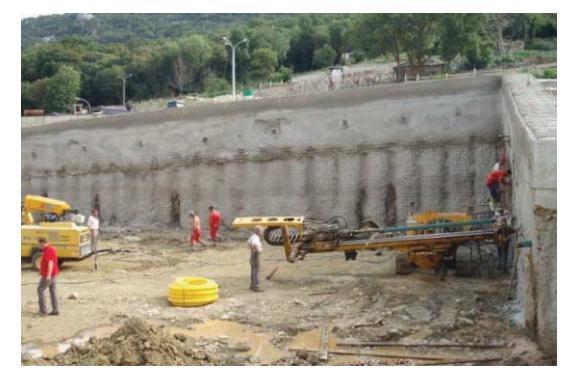
Figure 7. Drains drilling trough pile wall construction.

During the construction of the open pit for the Sport Hall in Bakar, Croatia, the landslide on the slope above the pit occurred, and the sliding mass buried excavated pit and broken built-up parts of construction. Complex geotechnical investigation works were carried out for drafting a landslide remediation project. Based on the results of these investigation works, a two stage landslide remediation design was made. Stabilization of the occurred sliding and dewatering of slope were designed as the first stage. In the second stage was predicted construction of anchored retaining pile wall structure. The first stage of remediation was successfully finished in January 2001. The second stage of landslide remediation works started in the winter 2006. The design of anchored pile wall was based on observational method. The measured data on installed monitoring equipment enabled the control stress-strain back analysis to confirm parameters for describing the real behavior of construction. Based on the results of these back analysis, an active design procedure was established that made possible the required changes in the pile wall construction during excavation ahead of wall if the observations indicates on unacceptable deformations. Measured strain on installed monitoring equipment showed relatively good match with the predicted calculated strains and construction was successfully finished without significantly construction changes in summer 2007 (Fig. 7).
