Article

Identification and Mapping of Soil Erosion Processes Using the Visual Interpretation of LiDAR Imagery

Keywords: soil erosion; recognition features; visual interpretation; delineation; LiDAR DTM; topographic derivatives; erosion inventory; Vinodol Valley

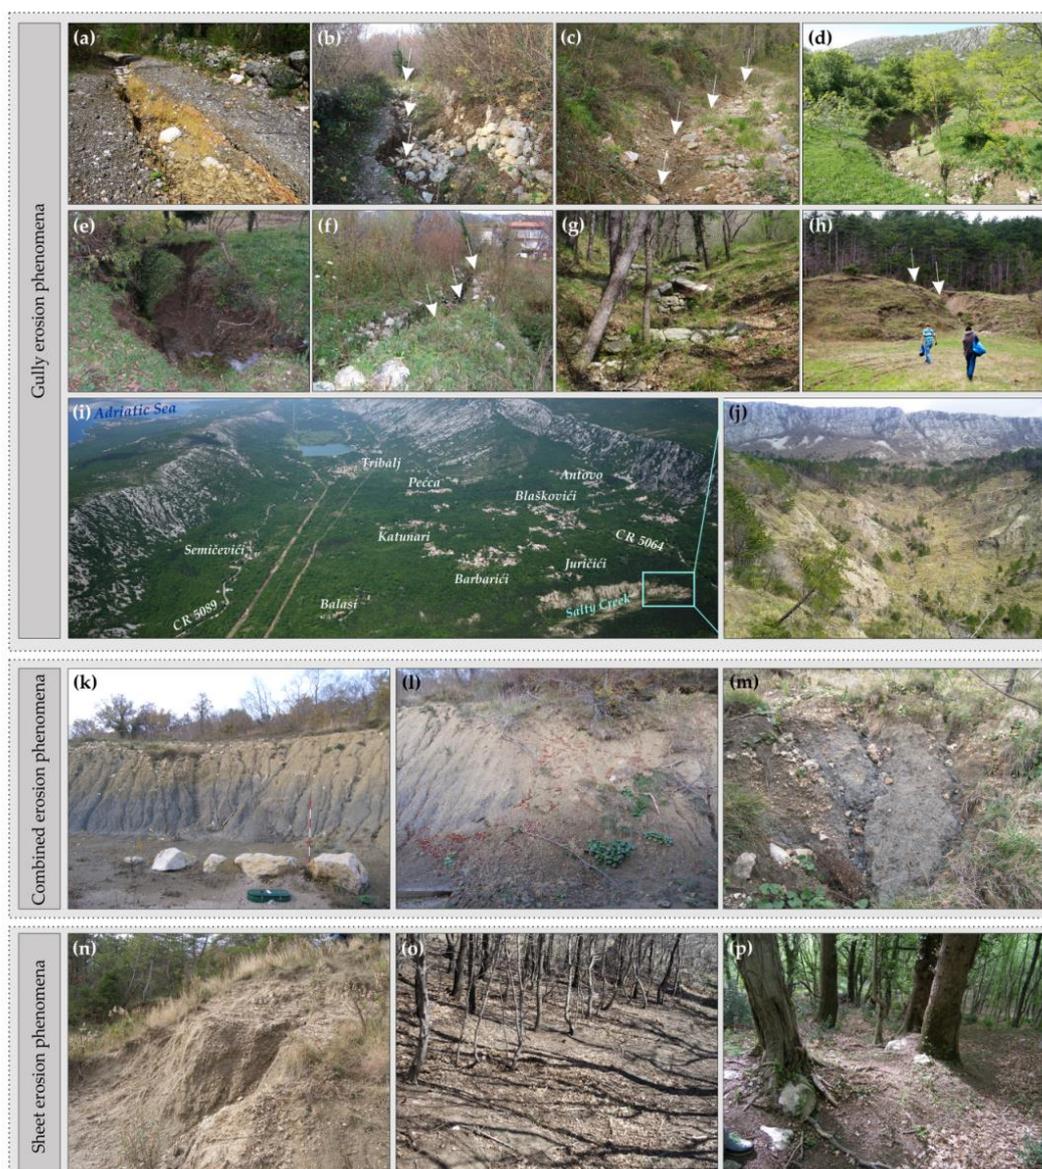
Figure 2. Photographs of erosion phenomena identified in the Vinodol Valley. The gully erosion phenomena formed along: (a) the local road, (b, c) pathways, (d, e) agricultural terraces, and (f) their boundaries; (g) an example of the stone check dam built to control the gully erosion; (h) a gully formed under the forest; (i) a view from the air of the central part of the Vinodol Valley, with depicted detail of the Slani Potok gully, shown in (j). (k–m) The combined erosion phenomena characterized by the small drainage network associated with colluvial deposits; (n) the sheet erosion phenomena formed in eluvial deposits, and in (o) the forest, as indicated by the exposed tree roots (p).

Superficial deposits and flysch outcrops have also been affected by associated action of rill and sheet erosion [55]. The combination of these processes can be recognized in the field by way of a small drainage network, associated with sediments transported by the sheet wash (Figure 2k and 2l). In such small drainage networks, rills are being formed at the head of the concave drainage systems (Figure 2m). For the purpose of this study, these interrelated erosion processes were designated by the term of combined erosion. In the Vinodol Valley, the combined erosion phenomena mostly occurs within the relief concavities covered by sparse vegetation, along the surface of which the convergence of the running water increases the erosion potential [66]. Sheet erosion can be recognized in the field predominantly on the surface of eluvial deposits (Figure 2n). It is also active in some forest areas during the autumn and winter periods (Figure 2o), as it is evidenced by the exposed tree roots (Figure 2p).
