## **Structural analysis in the research of the construction history – A case study**

## The cathedral of St. James' in Sibenik (Croatia)

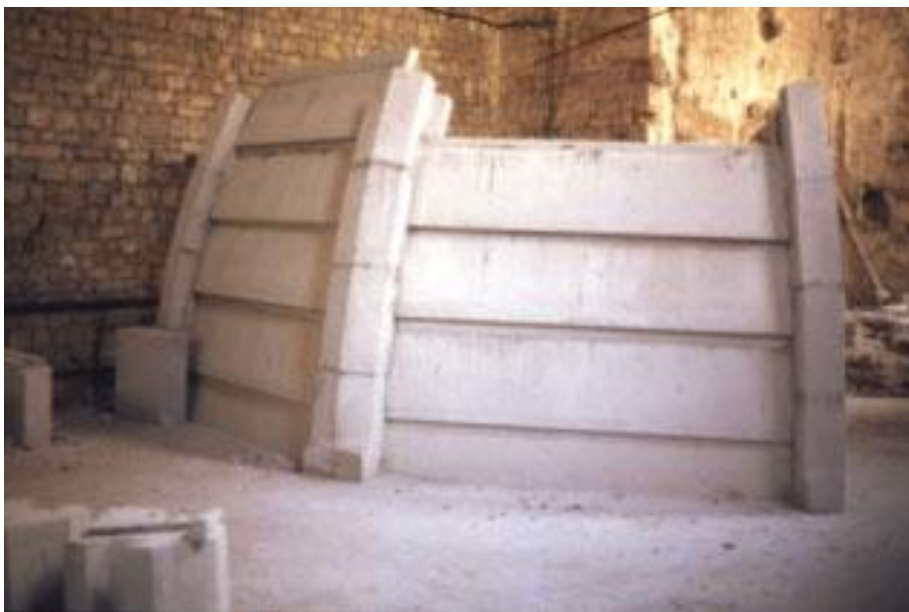
Figure 4: Construction of the dome model

The arches of the barrel and semi-barrel vaults, conceived with the analogous details, create together with thin stone slabs a "pre-fabricated system", designed to be "assembled" on the building site and thus to spare labor and material for scaffolding. Indeed, the construction of a real-scale model of the damaged dome proved that it was possible to assemble the dome without scaffolding. [3]

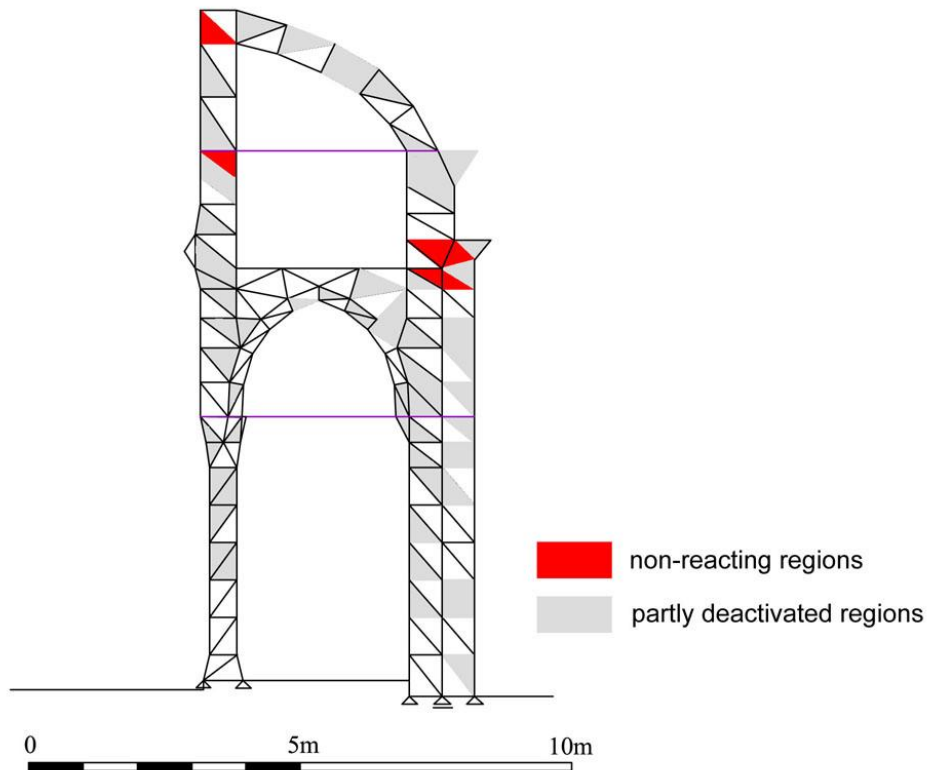
On the contrary, the structure tightened with iron ties at the level of the groin vault support and at the level of semi-barrel vault support is structurally much more resistant.

The Cathedral of Sibenik, constructed up to the semi-barrel vaults  
virtual experiment - structure with tie-rods

Figure 9: Critical regions in the structure completed up to the upper, semi-barrel vault of the aisles (structure tightened with tie-rods)

The inactivated zone is much smaller and it is not continuous, but it is limited only to several structurally unimportant points. There are no discontinuities of the active structure: it acts as a whole.

Thus, the structure, conceived and built by 1441, though more slender in its upper part than in its lower part, is stable and resistant. The purposeful, structurally logical concept proves that the constructor of the upper part of the northern façade planned the unique vault structure already when they were completing the aisles walls, the lower part of which was conceived by the first builders of the Sibenik cathedral. Whether the innovator was George the Dalmatian or his successor Nicholas the Florentine (*protomagister* since 1477), he designed an original and logical structure.
