Landslide Brus, translational block sliding in flysch rock mass

ABSTRACT: Landslide Brus was occurred in April 2005, near Brus village in Istria, Croatia. Landslide is typical block sliding and landslide body consists of practically unique flysch rock mass block, 150 m long and 35 m wide. Sliding was occurred momentary, without previous announcement signs of possible instability. The area of North Istria is composed of flysch deposits of Paleogene age. Superficial deposits are made of considerable thick packages, with alternating layers of siltstones, marls and sandstones. Landslide body is composed of flysch rock mass in thickness of 10 m. Sliding surface is formed through bedding planes of siltstone layers. The sliding was caused by the unfavorable dip orientation of deposit layers in the slope, and additionally by the river erosion in the toe in combination with unfavorable hydrogeological conditions.

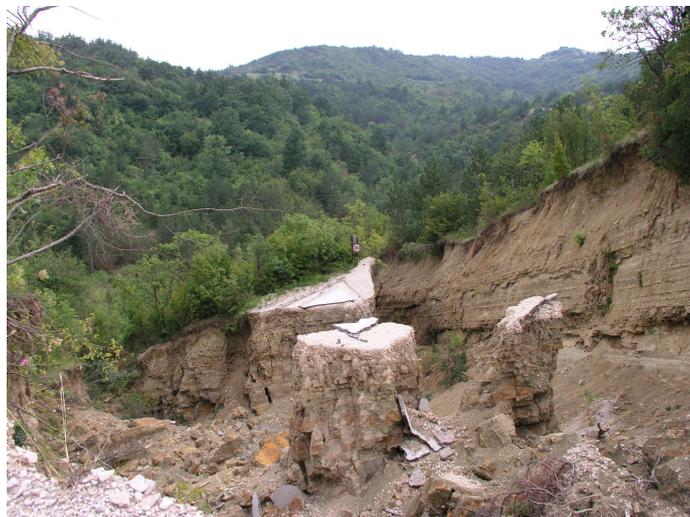
Figure 1. View on landslide body and lateral scarp from the crown of landslide (August 2005).

Engineering geological conditions of landslide area are determined on the basis of engineering geological mapping of the landslide area. The rock units found in the area of Brus slide consist of Paleogene flysch deposit, i.e. series of interbedded sandstone and marls, clearly visible in main as well as lateral scarps, Figure 1. Flysch bedrock is covered by thin superficial deposit of transported soil and residual soil.

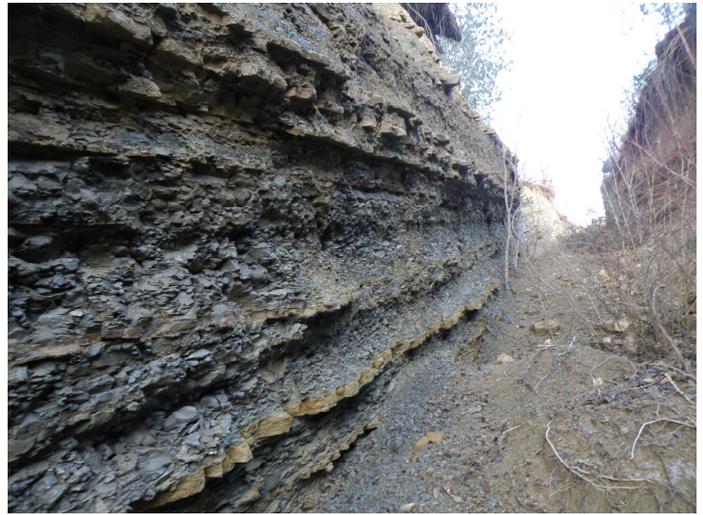
Figure 2. View thru the northwest lateral scarp (January 2010).

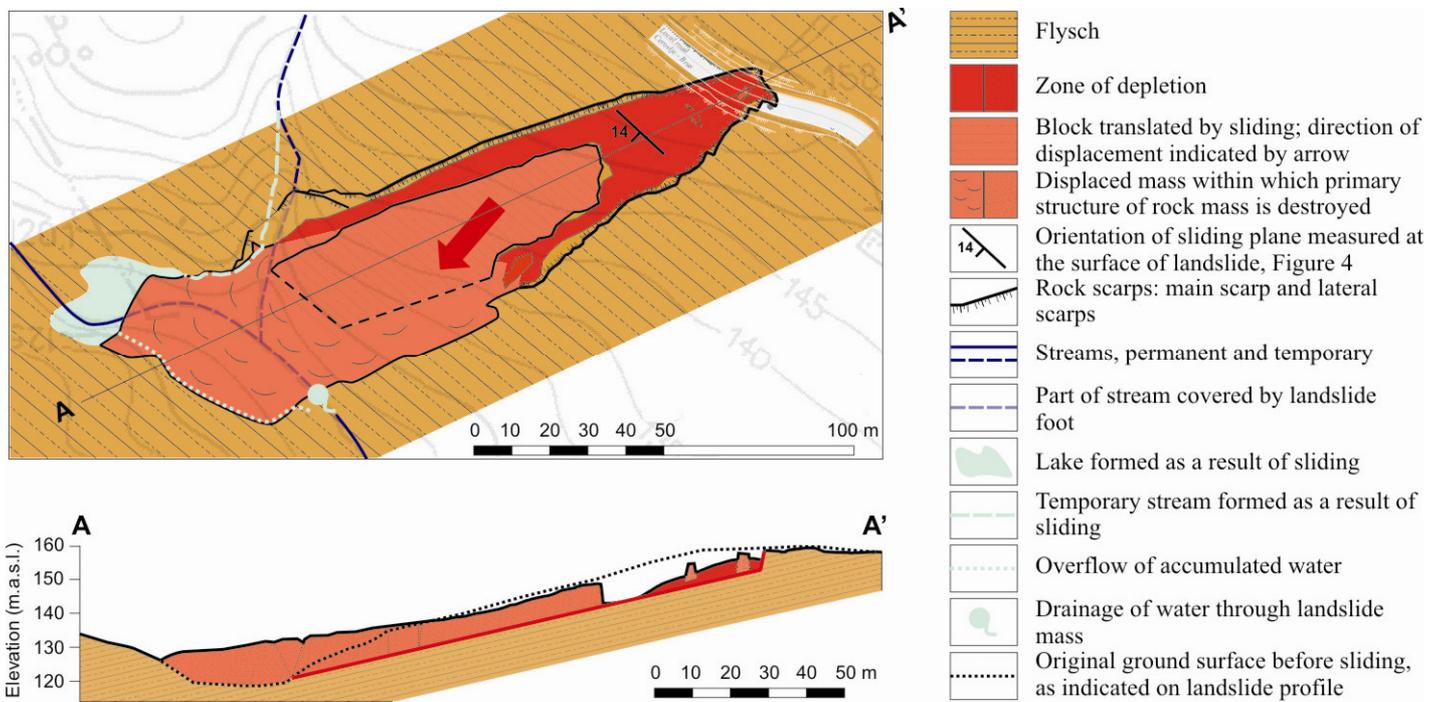
Figure 3. Engineering geological map and cross-section of the Brus Landslide.

Landslide dimensions can be precisely defined, regarding the fact that the slide body, as a whole, is clearly expressed, Figure 3. Dimensions of Brus landslide are listed in Table 1 (IAEG 1990).

Landslide features are shown in Figure 3. The average inclination of the slope before sliding was approximately 15° , while it ranges from 10° near the road to 35° in the lower parts of the slope. The general orientation of rock mass bedding planes varies from $220/13$ to $225/19$ with average value of $223/14$. Dip directions of bedding planes and slope are similar but not the same.

The slide surface was identified on the contact between slightly weathered and fresh siltstone rock mass, Figure 4. The direction of sliding along bedding plane resulted in spreading propagation of northwest lateral scarp and in embedment and shearing of displaced mass along southeast lateral scarp, Figure 3.

Landslide foot formed dam and caused formation of lake, Figure 3. The accumulated water drains through the landslide mass and, in a case of heavy rainfall and rapidly lake level rising, overflow landslide accumulation.

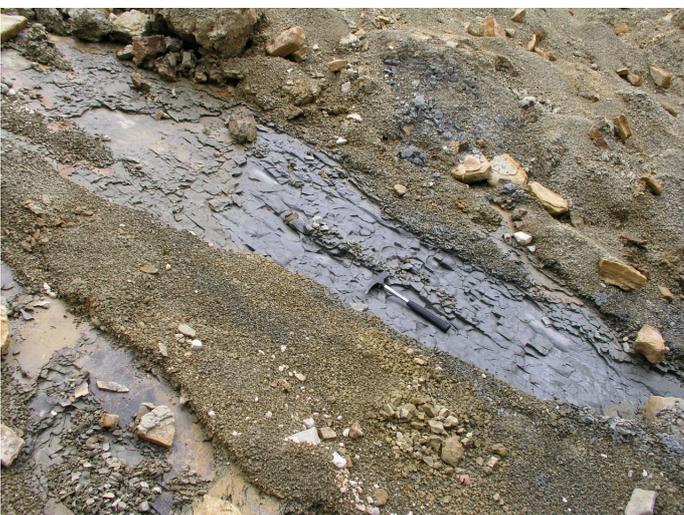
Figure 4. Picture of the sliding surface (August 2005).

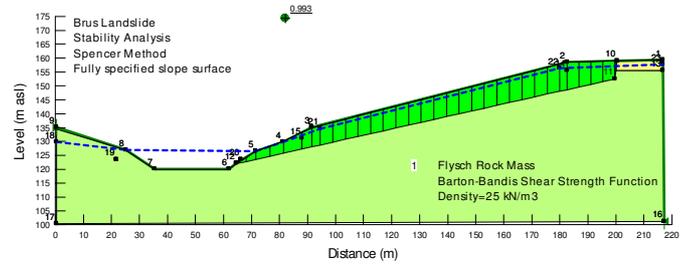
Figure 5. Brus Landslide slope stability analysis.

Based on adopted joint properties the back stability analysis using GEO Slope Slope/W software package was carried out. The analyses were conducted using fully defined slide surface, Spencer limit equilibrium method and Barton-Bandis shear strength criterion, Figure 5. The stability analysis was carried out to clarify condition that caused sliding event. It was determined that the sliding was appear with following joint parameters on sliding surface: $JRC = 0$; $JCS = 18$ MPa; and $\phi_r = 20^\circ$. In low ground water level conditions, the sliding is not possible. The decisive triggering factor was rising of ground water level affected by long term heavy rainfall and consequent shear strength decreasing.
