ANALYSIS OF TRAFFIC SAFETY ON ROUNDABOUT JADRANSKA AVENUE – AVENUE DUBROVNIK IN ZAGREB

University of Zagreb

Faculty of Transport and Traffic Sciences

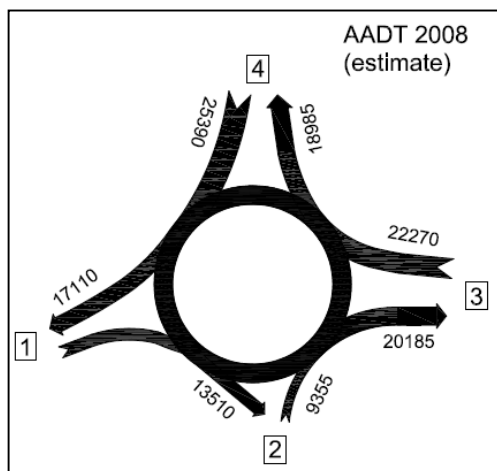
Figure 3: Traffic flows (AADT 2008 - estimate) [1]

In order to present the traffic load of the intersection the latest measurable data collected in 2008 (Figure 3) have been used. More marked load was registered at all

approaches except on approach 2. From the registered intersection traffic load in the value of $Q_k = 70230$ veh./day and estimated throughput power/capacity $C_k = 75,000$ veh./day, results the level of utilization $I_k = 0.94$ (94%). Quantitatively, the traffic consists of passenger cars (about 80%), and the rest are semi-freight or freight vehicles (about 15%), and vehicles of public urban transport (about 5%) [1, 4].

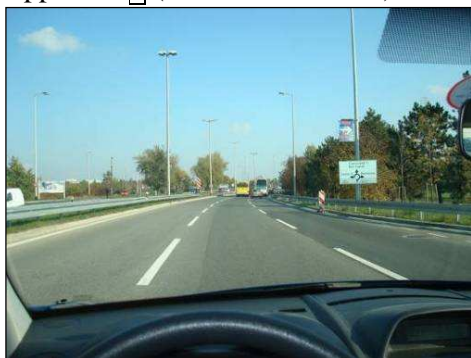
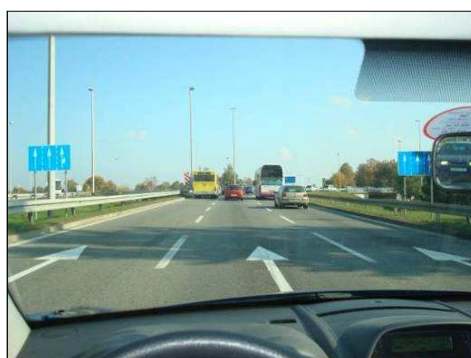
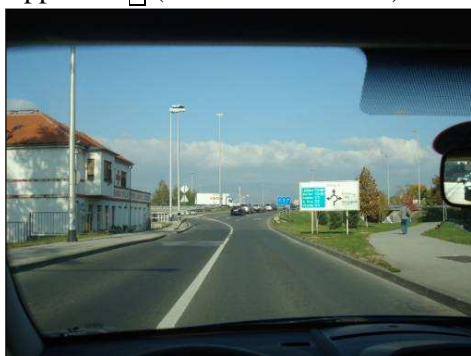
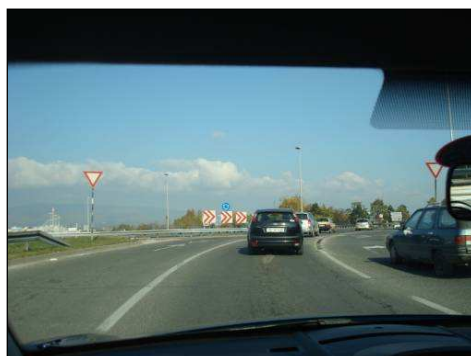
Figure 5: Registered recordings of visibility at approach 1 (Jadranska Avenue) and approach 2 (Remetinečka Road) [1, 4]

- The analysis of all types of visibility was done by means of a field inspection using video-recordings and recordings. The following has been checked: front visibility (Figures 5 and 6), visibility to the left, visibility in the roundabout, and all forms of traffic disturbances and visibility when exiting the intersection.

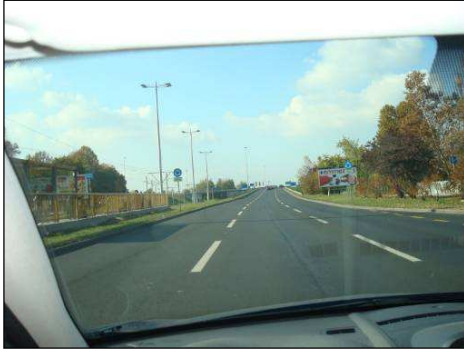
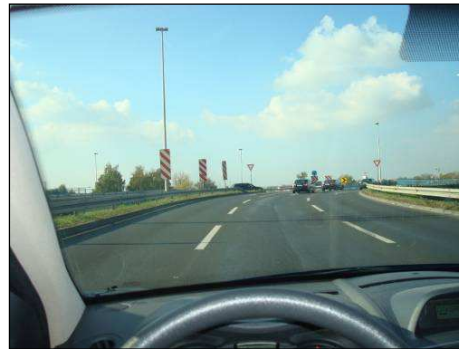
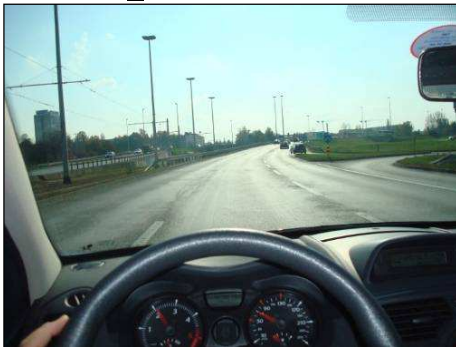
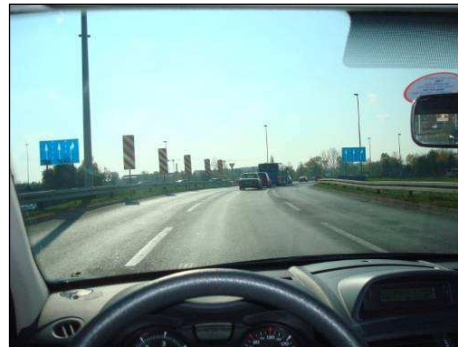
Figure 6: Registered recordings of visibility at approach 3 (Avenue Dubrovnik) and approach 4 (Jadranski Bridge) [1, 4]

Long sections in front of the roundabout (approaches 1, 3 and 4), and tangential merging from the approaches allows high approaching speed (Table 1), and the higher level of the intersection i.e. the gradients of the approaches in combination with safety fence and vertical signalization have caused reduced visibility at arrival and merging into the intersection (Figures 5 and 6). These design elements are the main cause of the majority of accidents – rear-end collisions (Table 3).
