13<sup>th</sup> International Symposium on Water Management and Hydraulic Engineering, September 9 - 12, 2013 Bratislava, Slovakia

## 2D NUMERICAL SIMULATIONS OF 2012 FLOOD WAVE PASSAGE THROUGH HPP SYSTEM ON THE RIVER DRAVA

### Abstract

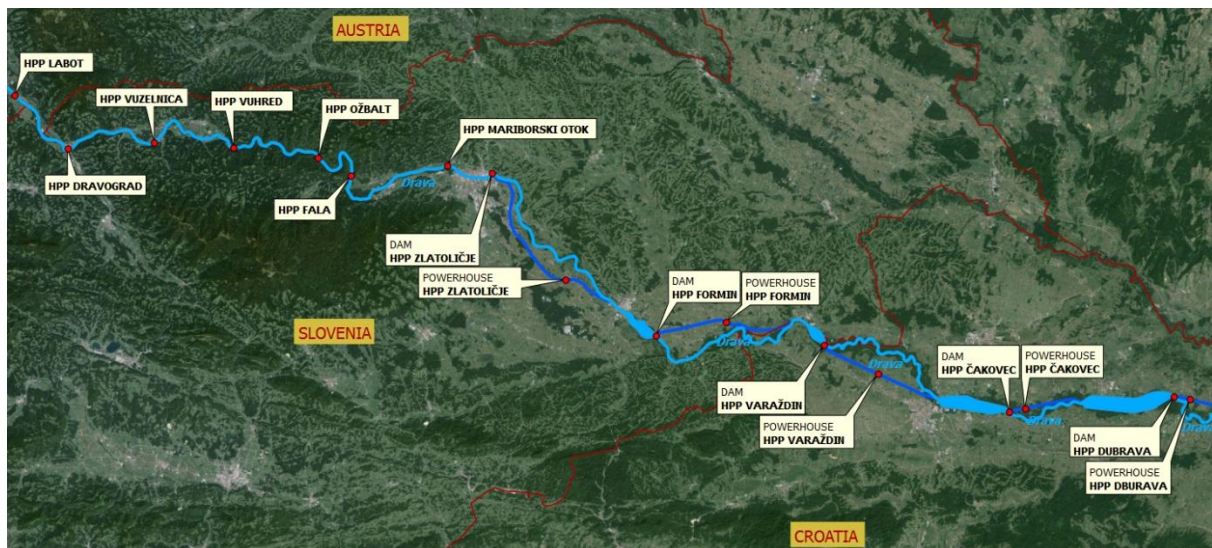
**Fig. 1** Chain of HPPs on the River Drava in Austria, Slovenia and Croatia

The first part of the paper shows the wave propagation from the Austrian HPP Labot through the Slovenian hydro power systems and the Croatian HPPs (**Fig. 1**). The flood wave entered the Slovenia area (HPP Labot) on the 5<sup>th</sup> Nov 2012 around 16:00 hrs and in the next 11 hours caused the flow increase by  $2060 \text{ m}^3/\text{s}$ , reaching the peak flow of  $2592 \text{ m}^3/\text{s}$  at 15:00 hrs. This

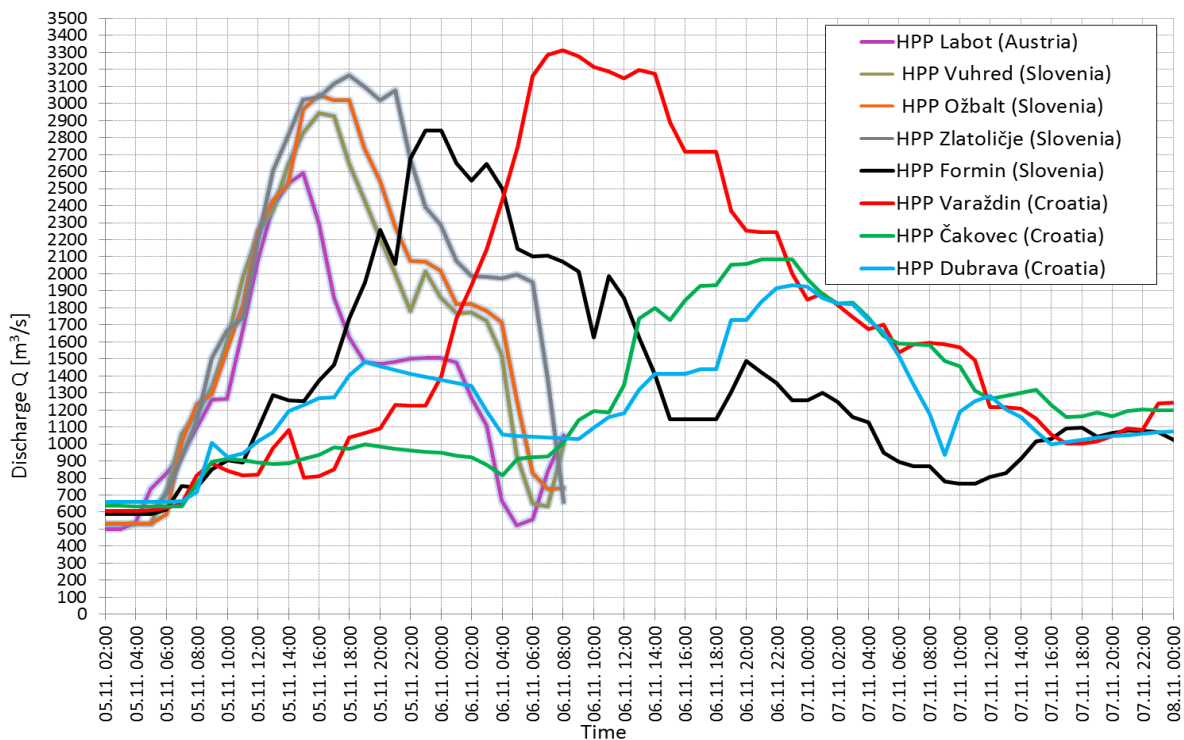
**Fig. 2** Flood event 5/Nov/2012 - Flow hydrographs on HPPs in Austria, Slovenia and Croatia

**Fig. 2** shows recorded hydrographs on HPP Labot in Austria, HPPs Vuhred, Ožbalt, Zaltoličje and Formin in Slovenia and also on HPPs Varaždin, Čakovec and Dubrava in Croatia during the 5/Nov/2012 flood wave (sources [1], [2], [3]). Considering the fact that the HPP system on Zlatoličje, Formin, Varaždin, Čakovec and Dubrava is a diversion type of the hydro power plant, the hydrograph of these systems represents a total discharge of a dam and a powerhouse.

The flow hydrographs show sudden, almost simultaneous flow increase on HPPs Labot, Vuhred, Ožbalt and Zlatoličje. The peak flows on these HPPs on the 5<sup>th</sup> Nov were 2592, 2945, 3040 and 3170 m<sup>3</sup>/s at 15:00, 16:00, 16:00 and 18:00 hrs. While passing through the reservoir of HPP Formin the first transformation of flood wave occurred. According to the hydrographs on **Fig. 2** it can be seen that:

- The peak flow of 2840 m<sup>3</sup>/s on HPP Formin (black line) occurred on the 5<sup>th</sup> Nov at 23:00 hrs, and it was 330 m<sup>3</sup>/s lower than the peak flow on HPP Zlatoličje.

- The peak flow of 3311 m<sup>3</sup>/s on HPP Varaždin (red line) occurred 9 hours later, on the 6<sup>th</sup> Nov at 08:00 hrs. The peak flow on HPP Varaždin was 471 m<sup>3</sup>/s higher than the peak flow on HPP Formin.

- The flow rates on HPP Čakovec were significantly reduced due to the combined water losses on levee over-spilling and breaching and on infiltration. The peak flow of 2085 m<sup>3</sup>/s on HPP Čakovec (green line) occurred 13 hours later than on HPP Varaždin, on the 6<sup>th</sup> Nov at 21:00 hrs. It was 1226 m<sup>3</sup>/s lower than the peak flow on HPP Varaždin.

- The peak flow of 1930 m<sup>3</sup>/s on HPP Dubrava occurred 2 hours later, on the 6<sup>th</sup> Nov at 23:00 hrs, and it was 155 m<sup>3</sup>/s lower than the peak flow on HPP Čakovec.

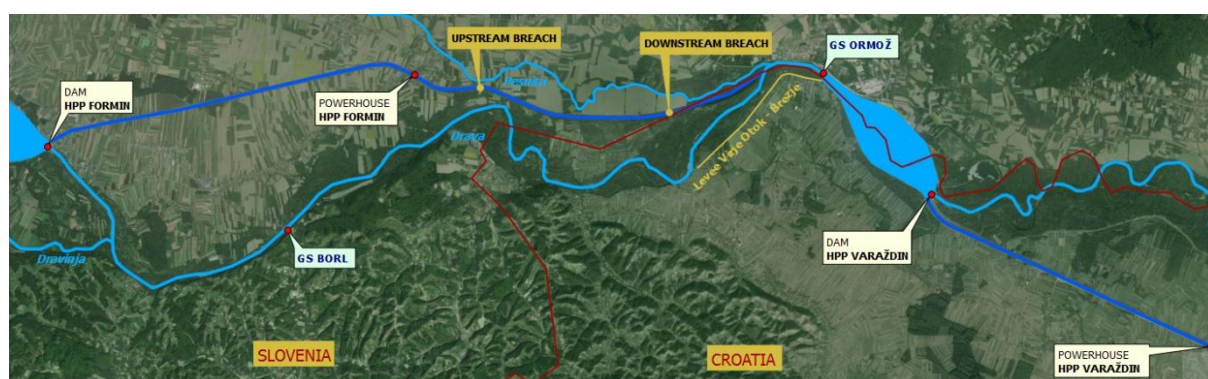
Fig. 3 The River Drava section between HPP Formin and HPP Varaždin

The area between HPP Formin and HPP Varaždin has complex hydrographic characteristics (Fig. 3). The area is bordered with the HPP Formin canal in the north and with the high terrain in the south. The inlet canal connects the reservoir and the powerhouse, whereas the outlet canal connects the powerhouse with the River Drava's old channel. During the low and the medium inflows the majority of the flow is diverted through the powerhouse and only a minor part (biological minimum) is discharged through the River Drava's old channel. An opposite split occurs during high inflows when the majority of flows are discharged over the dam to the River Drava's old channel. The installed flow capacity of HPP Formin powerhouse is  $500 \text{ m}^3/\text{s}$  and the spilling capacity of HPP Formin dam is  $4300 \text{ m}^3/\text{s}$ . Two main tributaries of the River Drava are the Dravinja stream (left tributary) and the Pesnica stream (right tributary). In the area there are four gauging stations: g.s. Borl and g.s. Ormož on the River Drava, g.s. Videm on the Dravinja stream and g.s. Zamušani on the Pesnica stream. An average flow of the River Drava near Varaždin is  $330 \text{ m}^3/\text{s}$ , and the average maximum annual flow is  $1286 \text{ m}^3/\text{s}$  [4].

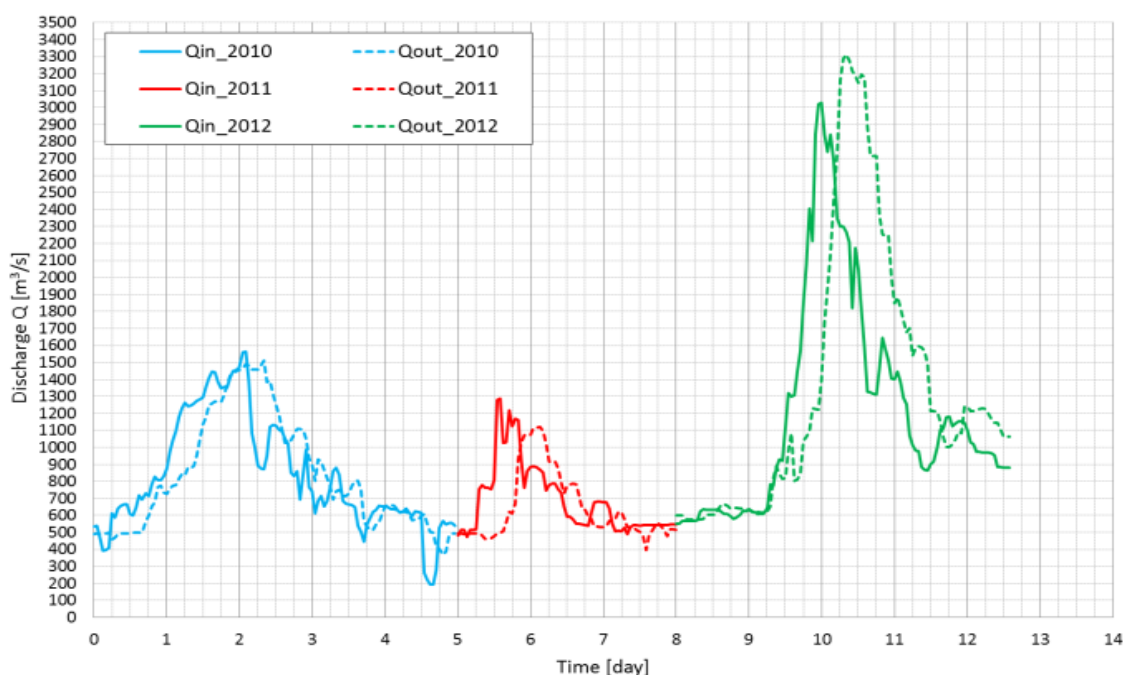
**Fig. 4** Comparison of flow hydrographs for flood events in 2010, 2011 and 2012

For a general overview of the unusual transformation of the 5/Nov/2012 flood wave, a comparison (**Fig. 4**) of input (solid line) and output (dashed line) hydrographs in the area between HPP Formin and HPP Varaždin is given for the flood waves in 2010, 2011 and 2012 (according to [1], [2]).

The discharge  $Q_{in}$  represents the sum of flows on the dam and the powerhouse of HPP Formin together with the Dravinja and Pesnica streams. The discharge  $Q_{out}$  represents the sum of flows on the dam and the powerhouse of HPP Varaždin. The flood wave hydrographs in 2010 and 2011 are actually typical in this area and show that the highest output flows from the area ( $Q_{out}$ ) are generally lower than the highest input flows ( $Q_{in}$ ). However, the highest output flow in November 2012 was  $300 \text{ m}^3/\text{s}$  (10%) higher than the highest input flow.

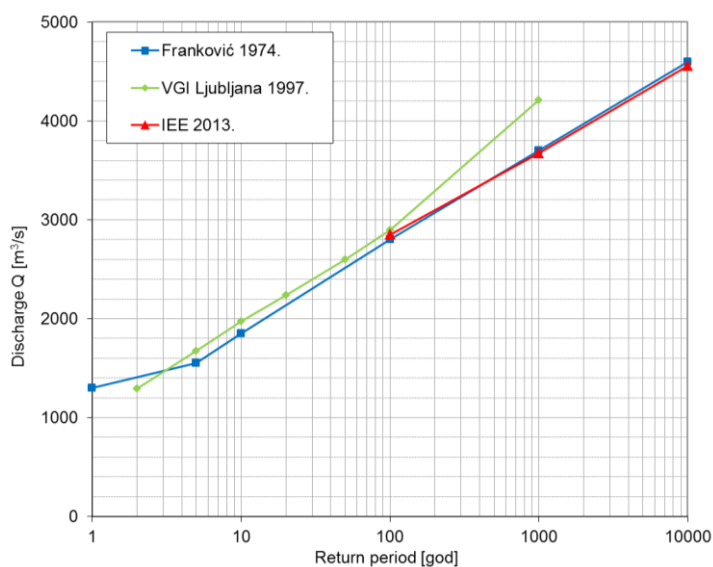
**Fig. 6** Comparison of estimated total flood inflows

The flood inflows of the River Drava and the Dravinja and Pesnica streams were estimated (**Tab. 3** and **Fig. 6**) in several previous and one recent study ([5], [6], [7]). The estimated discharges from 1974 and 2013 show relatively small differences of the total input flows, while the flows from VGI 1997 study are slightly higher. **Tab. 3** shows that the peak input flow of the 5/Nov/2012 flood wave ( $Q_{in}=3100 \text{ m}^3/\text{s}$ ) has 200 years return period.

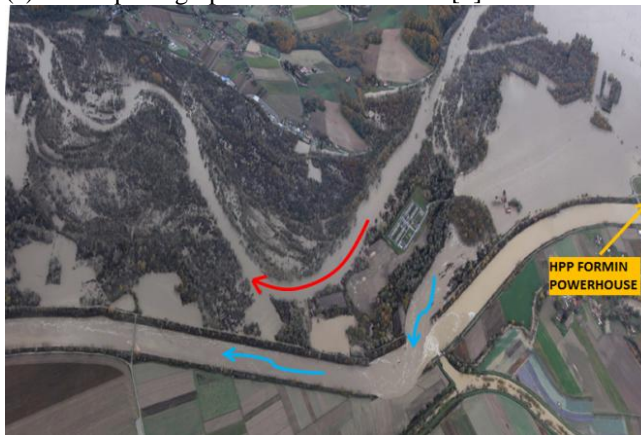
**Fig. 7** Upstream levee breach of HPP Formin outlet canal

During the 5/Nov/2012 flood wave the two levee breaches of the HPP Formin outlet canal occurred. The upstream breach was 150 m wide and is located 1.3 km downstream from the HPP Formin powerhouse. **Fig. 7** gives a comparison of the outlet canal geometry before (blue line) and after the breach (red line), and shows the extreme power of flow at the breach. The sudden flow of water washed away the right levee of the outlet canal and has left up to 12 m of sand and silt deposits in the outlet canal. The sudden flow of water also demolished the left bank of the canal, and eroded up to 50 m wide and 8 m tall part of the adjacent land.

(a) Aerial photograph of the levee breach [1]

(b) Canal before and after the breach [1]

The discharge through the HPP Formin powerhouse ( $Q_{ph}$ ) shows that on the 6<sup>th</sup> Nov between 00:00 and 02:00 hrs the powerhouse failure occurred. The failure is considered to be connected to the upstream levee breach of the HPP Formin outlet canal. The breach was located 1.3 km downstream from the powerhouse and caused backwater rising in the outlet canal and eventually the flooding of the powerhouse and the switchyard (**Fig. 7**).

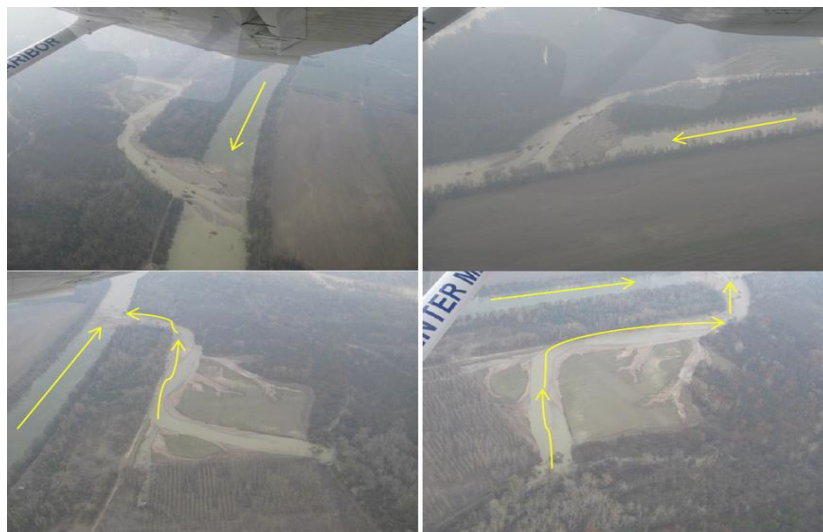
**Fig. 8** Downstream levee breach of HPP Formin outlet canal (photo taken 9/Nov/2012) [1]

The downstream breach was 200 m wide and is located 6.3 km downstream from the HPP Formin powerhouse (**Fig. 8**). According to the DEM report [1], the breach caused a 6 m tall levee damage leaving 300,000 m<sup>3</sup> of soil deposits in the outlet canal. The River Drava actually created a new riverbed through which diversion of flows to the outlet canal was evident even after the flood wave passage.

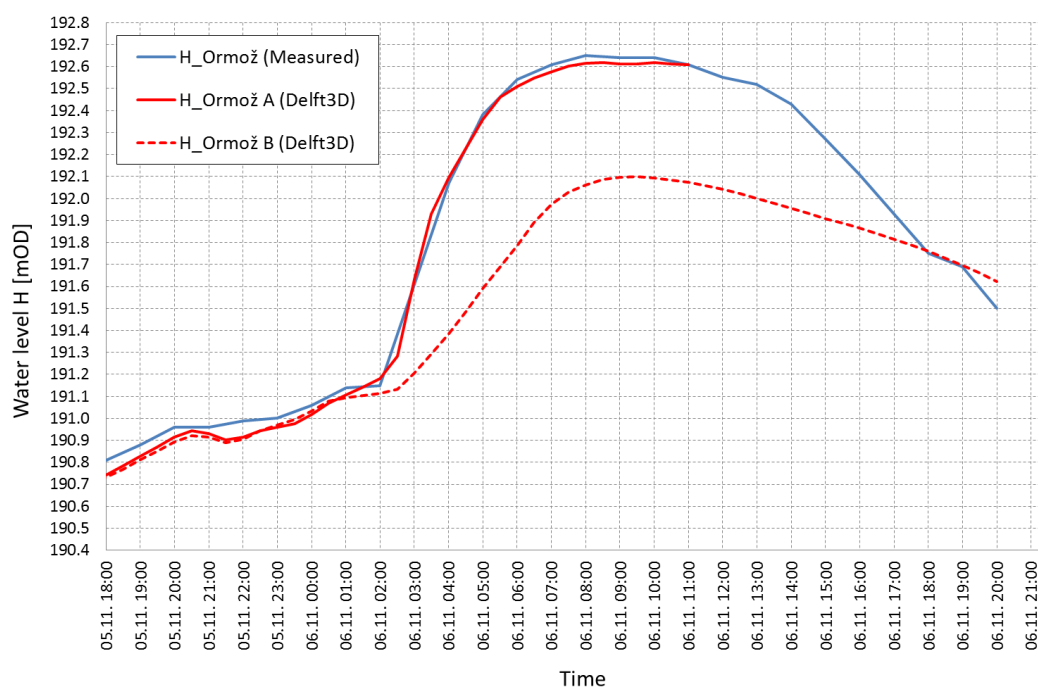
**Fig. 16** Comparison of measured and computed water levels values on g.s. Ormož

**Fig. 16** shows measured and calculated water levels on g.s. Ormož for simulations A and B. The simulation A includes the levee breaches of the outlet canal and the simulation B is without the breaches.

The model results show that the deviations of the measured and calculated water levels for the simulation A (red solid line) are within 10 cm. The results of the simulation A are given until the 6<sup>th</sup> Nov at 11:00 hrs, after which the Virje Otok-Breze levee breach occurred. In this way another unknown element was avoided but the quality of the hydraulic analysis was retained because the peak flow on the HPP Varaždin occurred before 11:00 hrs.

The results for the simulation B show that for the case without levee breaches, the water level rising on the g.s. Ormož (red dashed line) is significantly slower and the peak computed water level is -60 cm lower than the highest recorded water level.

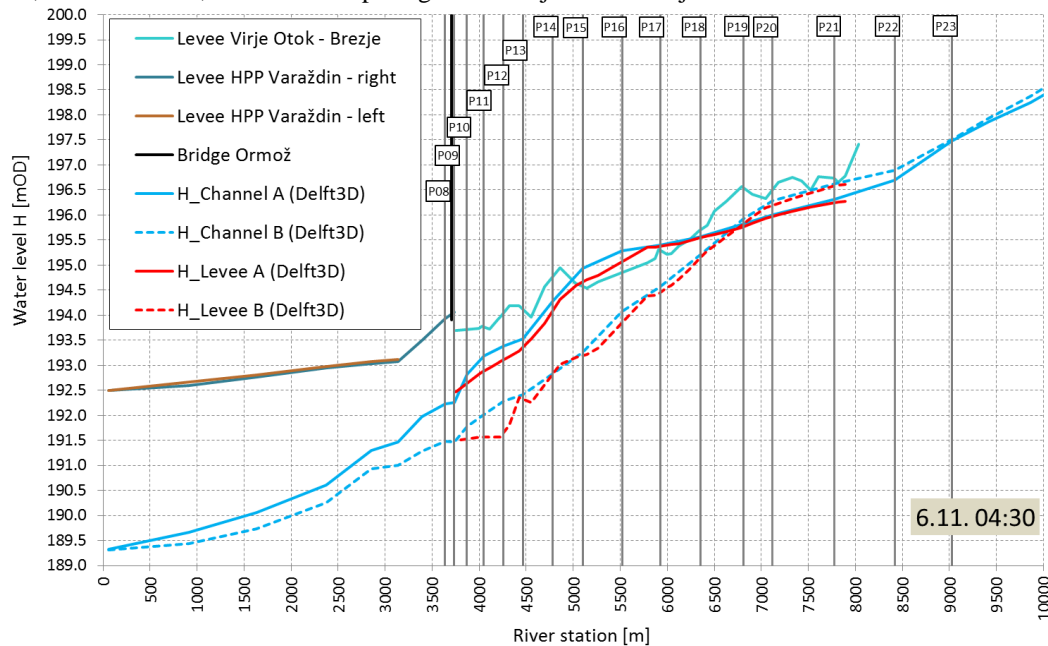
**Fig. 17** Longitudinal profile of computed water levels from simulations A and B with levee crest level and locations of control cross sections

The longitudinal water level profiles from simulations A and B are presented for two characteristic timings: for the beginning of over-spilling of the Virje Otok-Brezje levee on 6/Nov/2012 at 04:30 hrs (**Fig. 17a**) and for the peak flow on the HPP Varaždin on 6/Nov/2012 at 08:00 hrs (**Fig. 17b**). The computed water levels for simulation A show that over-spilling of the Virje Otok-Brezje levee begins at 04:30 hrs which fully corresponds to the actual event. At the time of the flow peaking on the HPP Varaždin, the over-spilling of the Virje Otok-Brezje levee occurs on a 1800 m long section between cross sections P0-14 and P0-19. This section has cca 50 cm higher flood levels than the levee crest levels (**Fig. 17b** and **Fig. 18**). The simulation B results show that the overtopping of the Virje Otok-Brezje levee is significantly lower in comparison to the simulation A.

(a) 6/Nov, time 04:30 hrs, start of over-spilling of the Virje Otok-Brezje levee

(b) 6/Nov, time 08:00 hrs, time of peaking on HPP Varaždin

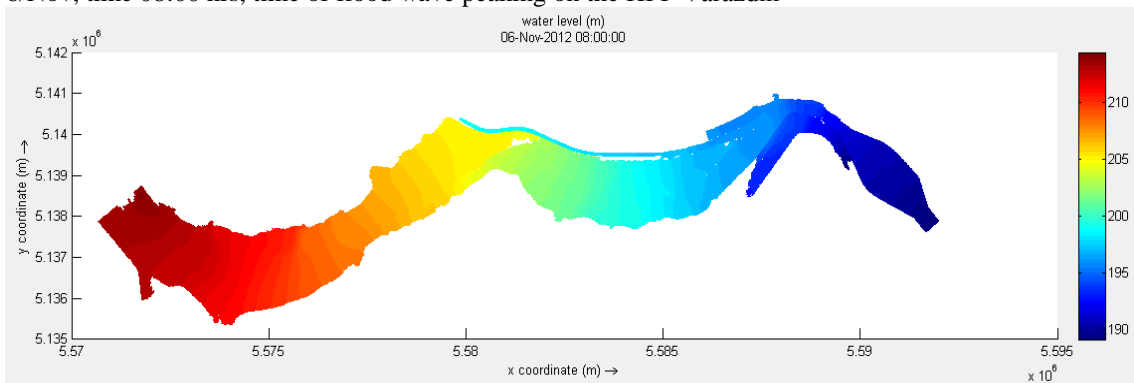
**Fig. 19** Spatial view of computed water levels from simulation A

The spatial views of flood extents are given for simulations A for the beginning of the over-spilling of the Virje Otok-Brezje levee (**Fig. 19a**) and for the peak flow on the HPP Varaždin (**Fig. 19b**). On the longitudinal profiles the over-spilling of the Virje Otok-Brezje levee is visible at 04:30 hrs but on the flood extent it is visible at 05:00 hrs.

(a) 6/Nov, time 05:00 hrs, over-spilling of the Virje Otok-Brezje levee is spatially visible

(b) 6/Nov, time 08:00 hrs, time of flood wave peaking on the HPP Varaždin

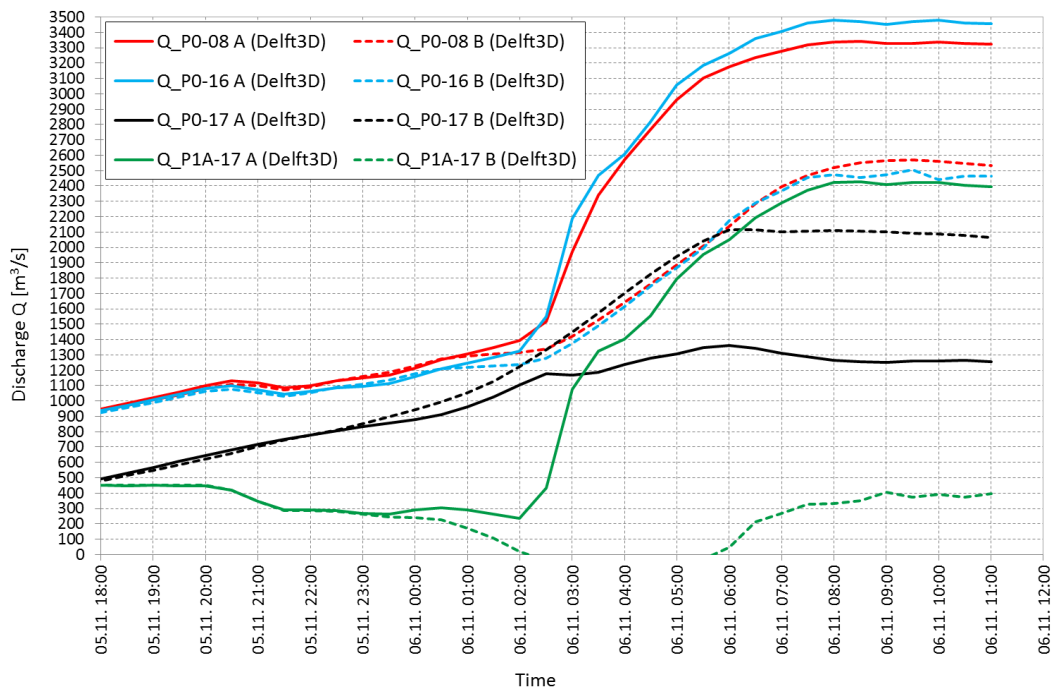
**Fig. 20** Computed discharges at control cross sections

**Fig. 20** shows the discharges on cross sections P0-17, P1A-17, P0-16 and P0-08 from simulation A (solid line) and from simulation B (dashed line). The measured peak flow on HPP Varaždin was 3311 m<sup>3</sup>/s on the 6<sup>th</sup> Nov at 08:00 hrs. The peak flow on g.s. Ormož (P0-08) is 3335 m<sup>3</sup>/s on the simulation A (6<sup>th</sup> Nov at 08:00 hrs), and is 2600 m<sup>3</sup>/s on simulation B (6<sup>th</sup> Nov at 09:00 hrs). In order to achieve the measured water level on g.s. Ormož, the discharge separation at the peak is 2400 m<sup>3</sup>/s through the HPP Formin outlet canal (P1A-17) and 1270 m<sup>3</sup>/s through the River Drava's old channel (P0-17). At the peak flow the over-spilling of the Virje Otok-Brezje levee reaches a value of 520 m<sup>3</sup>/s (**Fig. 21**).

The results for simulation B show that the over-topping of the outlet canal occurs in the downstream part even without levee breaching. The discharge separation at the peak is 400 m<sup>3</sup>/s in outlet canal (P1A-17) and 2100 m<sup>3</sup>/s through the River Drava's old channel (P0-17).
