RUNWAY END SAFETY AREA

Stanislav PAVLIN¹ – Matija BRAČIĆ²

Keywords: runway end safety area, airport, safety

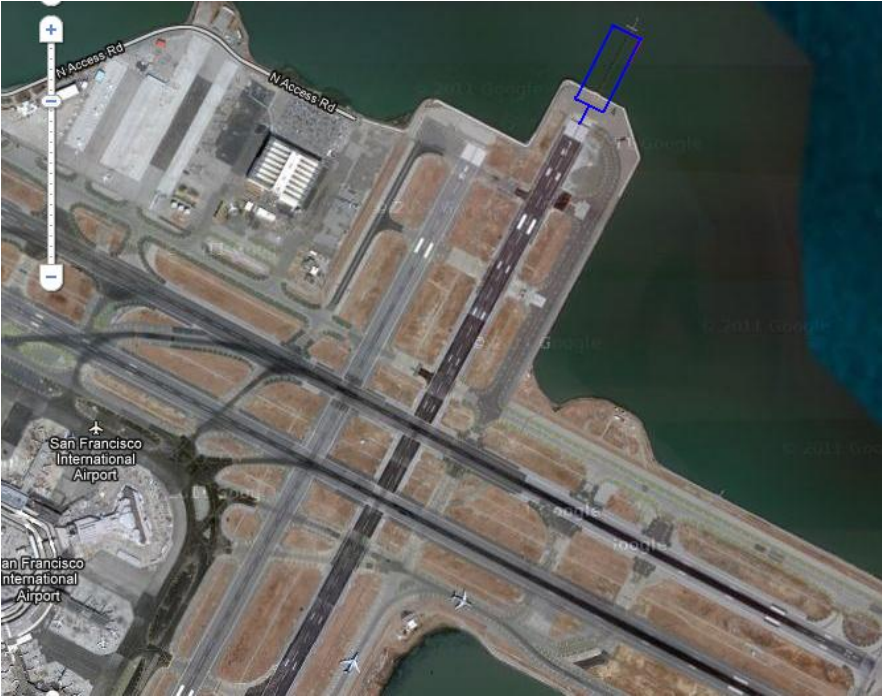
Figure 2 RESA according to Annex 14 at the threshold 19 at San Francisco Airport

Figures 2 and 3 show cases where it is not possible to use the recommended size of RESA because of physical limitations beyond the runway. In both cases the dimensions of RESA are 240m of length and 90m of width.

Figure 2 shows that RESA is not implemented at San Francisco Airport. Figure 3 shows that at Lisbon airport RESA has not been applied. Possible solutions for the implementation of RESA are described in the next chapter.

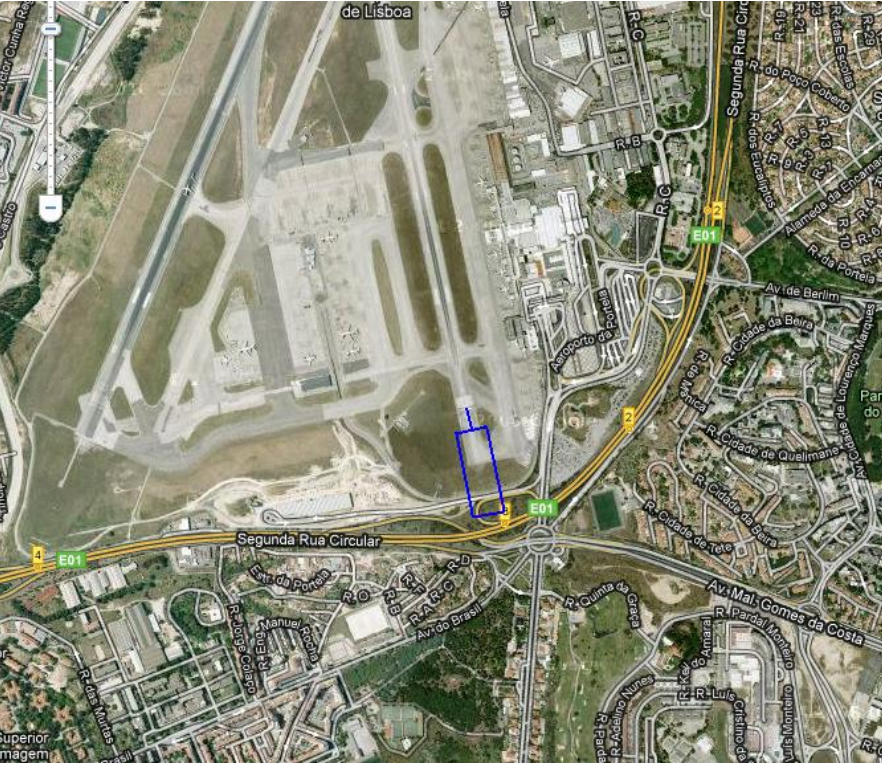
Figure 3 RESA according to Annex 14 at the threshold 19 at Lisbon Airport

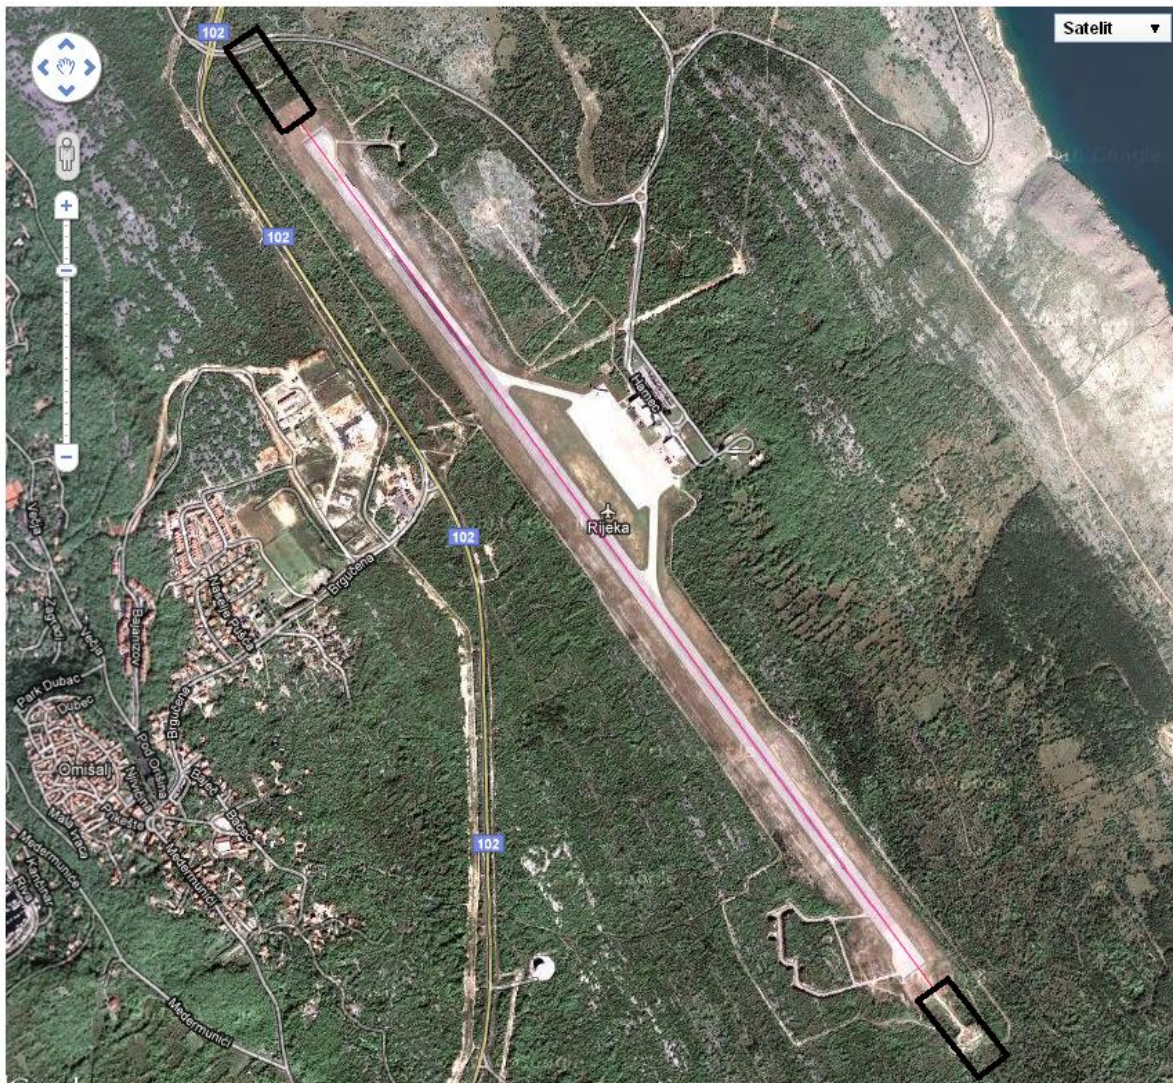
Figure 4 RESA according to Annex 14 at both ends of Rijeka Airport

The Rijeka Airport on both sides of runway does not have enough space within the fence for the application of the recommended dimensions of RESA (see Figure 4). The simplest solution that could be applied to Rijeka Airport is shortening of the length of runway. However, the implementation of this solution should take into account the critical airplane that operationally use Rijeka Airport which requires the maximum length of runway, Boeing 757 – 300. The results suggest that shortening of the runway may cause that aircraft flying at distances of over 2,000NM in particular configuration of the engine and certain atmospheric conditions potentially require the length of runway that exceeds the length of the reduced runway.

Filling up the terrain is also one of the possible solutions in order to implement the recommended dimensions of RESA at the Rijeka Airport. This technical solution is applied on the threshold 32 on the way to purchase land and flatten the terrain behind the paved runway that the longitudinal slope would not exceed 5%. On the threshold 14 it is necessary to build a road underpass which is located 300 meters behind the end of the runway that could be applied for the recommended dimensions of RESA.
