The influence of clay wetting on geomembrane-clay interface strength

Tomislav Ivšić, Franjo Verić & Hrvoje D. Zlatoper

Department of Geotechnics, Faculty of Civil Engineering, University of Zagreb, Kaciceva 26, HR-10000 Zagreb, Croatia

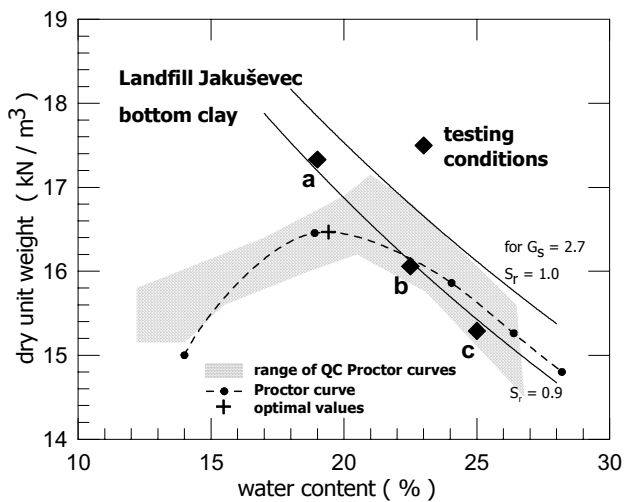
Figure 5. Compaction properties of tested clay ($w_{opt} = 19.42\%$; $\gamma_{dry} = 16.47 \text{ kN / m}^3$)

Case a) water content: 19% dry unit weight: 17.3 kN / m³
 Case b) water content: 22.5% dry unit weight: 16.1 kN / m³
 Case c) water content: 25% dry unit weight: 15.3 kN / m³

These cases are presented in Fig.5 with laboratory Proctor curve for particular clay samples, taken for laboratory testing.

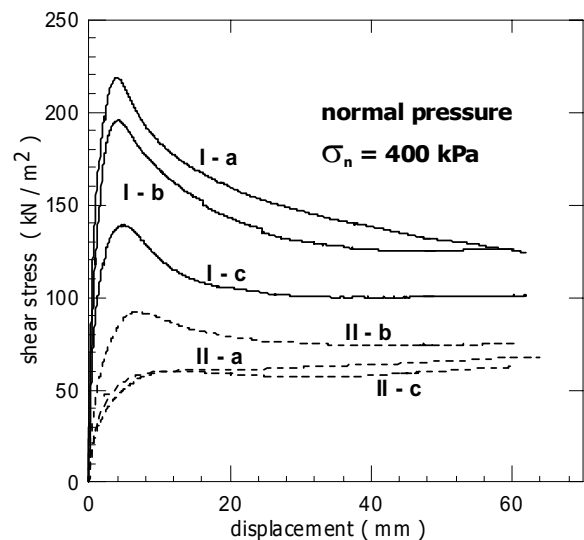
Figure 7. Interface shear testing-normal pressure 400 kPa

The results of tests are presented in following figures. The complete shear stress-displacement curves are presented for each normal pressure and all testing conditions in Figs 7-9. In Figs. 10 and 11 the residual strength parameters (apparent adhesion, a , and friction angle, ϕ), of each series was obtained.

The presented test results show that the interface clay-geomembrane strength is significantly affected by moisture and density conditions of clay before testing.
