# LARGE DISTURBANCE IN CROATIAN POWER SYSTEM RESULTING IN TRANSIENT INSTABILITY AND OUTAGES OF THREE MAJOR THERMAL UNITS

M. Stojšavljević\*, D. Nemeć\*, Š. Radić\*\*, Z. Čerina\*\*, R. Rubeša\*\*, N. Cvjetković\*\*

\*Energy Institute, Croatia

\*\*HEP - Croatian Electricity Utility, Croatia

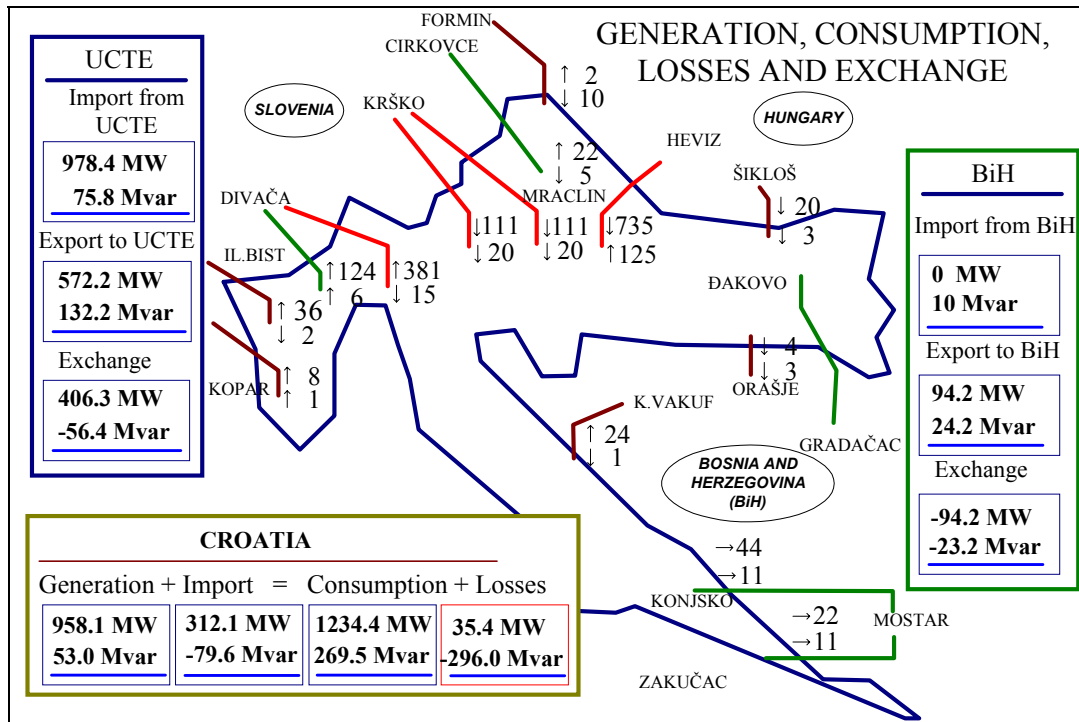
As already mentioned, the disturbance started on September, 20th 2002 at 00:19:02. According to the snapshot obtained from the DAM (Dispatcher Network Analysis System) at the National Dispatching Centre in Zagreb, the steady state of Croatian power system at 00:17:28, i.e. immediately before the disturbance, was as shown in Fig. 1. Croatian power system is operating as a part of UCTE interconnection.

**Figure 1** Totals and tie-line power flows of Croatian power system on 20th September 2002 at 00:17:28, i.e. immediately before the disturbance

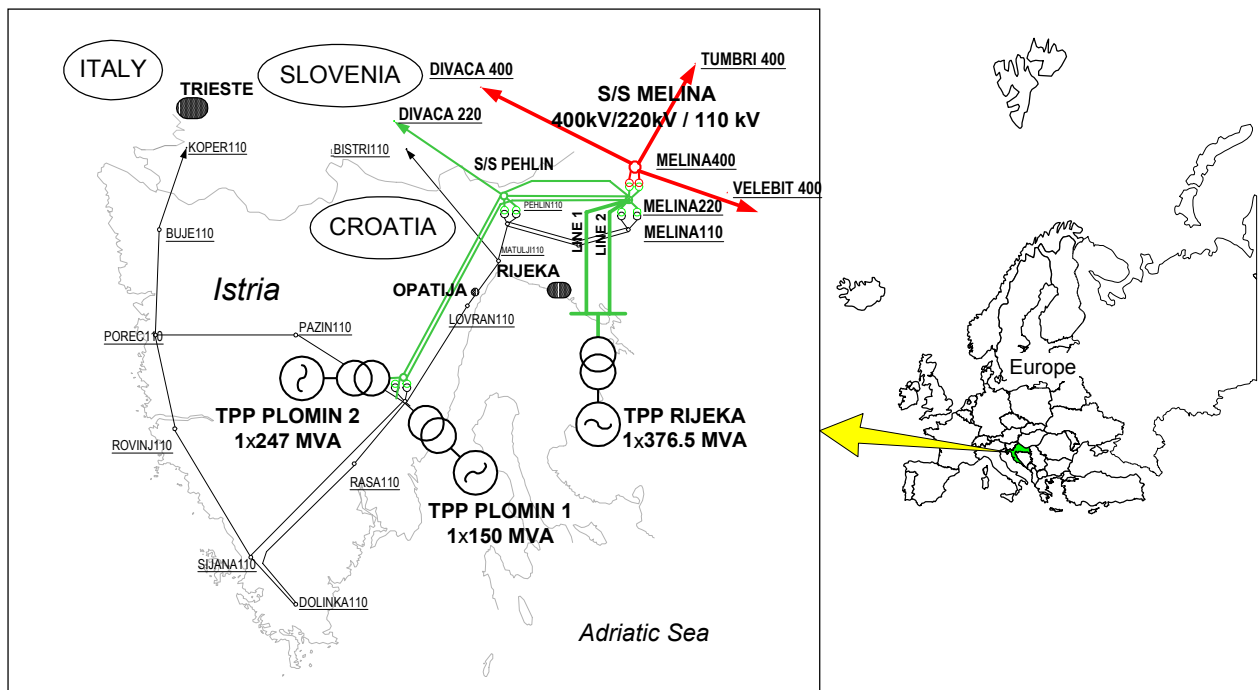
Three thermal units were in operation in the Istria and Northern Adriatic area of Croatian power system: TPP Rijeka (with 202 MW or 63% of the unit's rated active power), TPP Plomin 1 (with 108 MW or 90% of its rated MW) and TPP Plomin 2 (with 195 MW or 94% of the unit's rated active power). Total production of those three units was 505 MW or 53% of total generation in Croatian system.

Connection of the three above mentioned thermal units to the power system is shown in Fig. 2.

**Figure 2** Connection of three thermal units in the Istria and Northern Adriatic to the power system
