Damage Assessment of Concrete Column using Combination of Nondestructive Methods

Dalibor Sekulic, Irina Stipanovic Oslakovic and Emilija Barisic³

Civil Engineering Institute of Croatia, Department for Concrete and Masonry Structures
J. Rakuse 1, 10000 Zagreb, Croatia, Europe, (+385) 6125-134, dalibor.sekulic@igh.hr

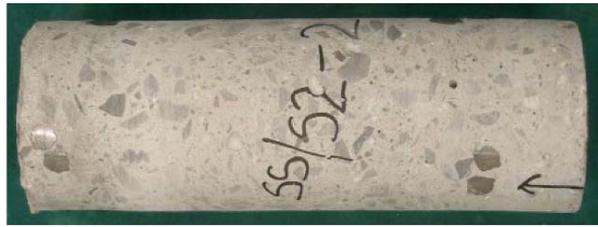
Figure 5: A cylinder drilled from no damaged position.

Ultrasonic pulse velocity, necessary for depth of flaws detection was determined on drilled no damaged concrete cylinder shown in Figure 5 by impact echo method and time of flight method by “PUNDIT” device.

P-wave speed, v_p is calculated according to relation 1 from impact-echo frequency f_p and measured cylinder height D . P-wave velocity from time of flight measured by Pundit device is calculated applying Equation 5. Both methods gave average ultrasonic speed of about 5300 m/s.

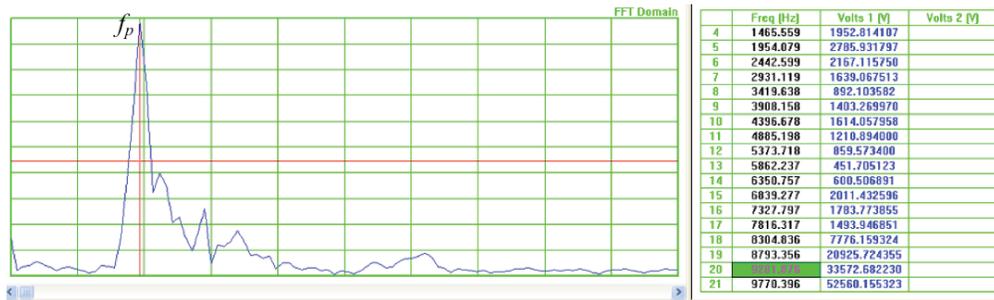
Measurement results obtained by Impact – echo are converted into frequency domain by FFT algorithm. On frequency – intensity graphs different patterns of measured signal was recognized, which can be classified according to [2, 3, 4]. Non-damaged concrete is characterized with one sharp peak at frequency corresponding to element thickness. Such example is shown in Figure 6, for measurement point (3, 9) from mesh (Figure 2(b)), where peak on frequency of 9,281 kHz corresponds to thickness of structural element of 26 cm. No other peaks with similar or greater intensity exist, so it can be concluded that concrete at a point (3, 9) is no damaged. Similar patterns appeared at other points characterizing undamaged concrete.

Figure 6: Example of waveform for no damaged concrete (point (3, 9) on a measurement mesh).
