# REHABILITATION OF CONCRETE BEAM BRIDGES IN CROATIAN STATE ROAD NETWORK

Danijel Tenžera, Krešimir Futivić, Boris Ukrainczyk

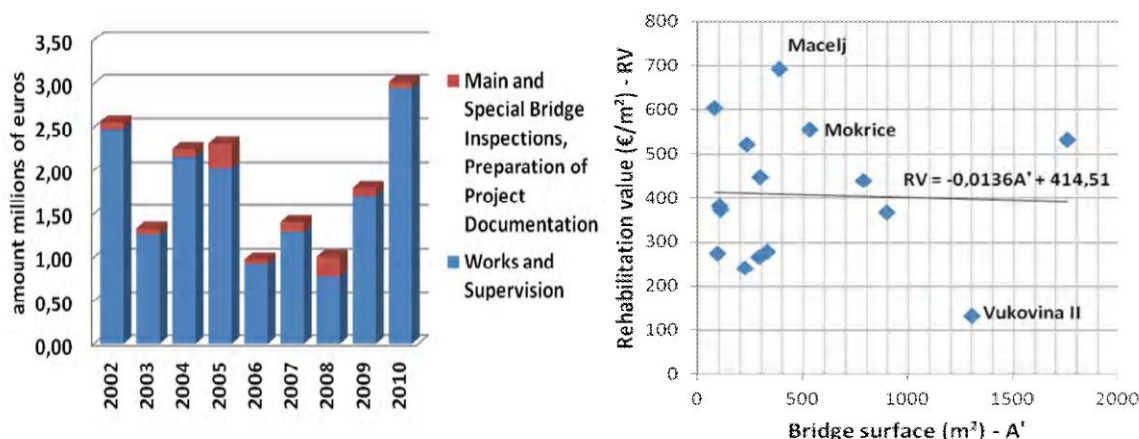
**Fig. 6** Periodic maintenance expenditure (2002-2010) and a diagram showing costs of rehabilitation for bridge groups

Data analysis shows that 7% of total expenditure was spent on the main and special bridge inspections, while 93% of expenditure went into works and supervision of works. In the 2002-2010 period the expenditure on the bridges on state roads in Croatia, for the total bridge area of 514.185 m<sup>2</sup> (1538 bridges with span larger than 2 meters) was approximately 32.5 €/m<sup>2</sup>. The expenditure for main and special bridge inspections and preparation of design documents was 2,1 €/m<sup>2</sup>, while for periodic maintenance works and supervision of works the average expenditure was 30,4 €/m<sup>2</sup>.

In the Republic of Croatia, periodic maintenance works on the state road network have been planned and implemented on the basis of Public Road Standard and road condition assessment and recommendations made by engineers within Hrvatske ceste d.o.o. Figure 6 shows the relation of expenditure levels for rehabilitation of bridges (€/m<sup>2</sup>) and the corresponding area (m<sup>2</sup>) for fifteen similar rehabilitation models selected. Rehabilitation costs for the selected group of bridges ranges from 133 €/m<sup>2</sup> to 693 €/m<sup>2</sup>. Applying the regression model of rehabilitation cost trend compared to the area of the structure, it can be concluded that the maximum deviation from extreme values in relation to estimated value of regression direction for this group is  $\pm 40\%$ . This data tells us that this methodology of estimated costs for periodic maintenance of bridges requires more accurate differentiation of the model in order to be applied. The authors recommend further development of this management model according to types of rehabilitation treatments for homogenous groups of works. When supplemented by data taken in annual and main inspections, this approach enables sufficient accuracy in preliminary assessment of the needed expenditure levels for periodic maintenance of bridges within the network.
