## Pilot location

As a typical example of this situation, an abandoned quarry Majdan (Croatia) in flysch rock mass was selected, as it is intended to be reused as a recreation area. On the eastern side of the quarry slopes are up to 50 meters high and inclined more than 70 degrees, with large sandstone layers overhanging on the top. Considering that a solution with minimum investment was requested, that would ensure both maximum space for recreation area, and sufficient safety factor for rockfall hazard, multiple scenarios and types of remediation measures were investigated. Detailed survey by terrestrial laser scanner was made to ensure detailed profiles for 2D kinematic analysis, as well as to detect the erosion intensity and rate of scree accumulation at the bottom of the slope. Ground parameters necessary for kinematic analysis of future rockfalls were obtained by retrograde analysis of previously detected rockfalls on this and couple of other sites in the nearby area.

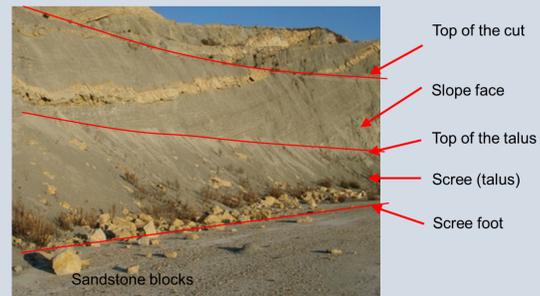
Flysch is a typical example of heterogeneous rock mass with layers of different mechanical properties. Even though they are formed by sedimentation and originally were horizontal, since flysch was suitable for tectonic shaping, layers that are often bent or inclined at various dip angles from 0 to 90 degrees can be encountered. While for homogeneous rock masses the process of weathering and erosion on cut slope is relatively predictable, and it can be well described by mathematical models of recession, for heterogeneous profiles this task is significantly more complex and sometimes unpredictable. Flysch members which are more resistant to weathering,

depending on the dip and dip angle of the layer, usually remain for longer time on the slope face and overhang like a "console". When the console becomes sufficiently long, the bending moment separates the blocks create rockfall that threatens the space below the slope (Mišević and Vlastelica, 2014). At the same time less resistant members, which are previously eroded from under or above more resistant members, create a scree (talus) at the bottom of the slope, thus making a very specific slope profile of different rapid changing of geometry of the slope (Vlastelica et al., 2016a). Talus is prone to sliding in case of extreme loading conditions. loading and calculation of stability to sliding are made, considering influences (rainfall, earthquakes, etc.).

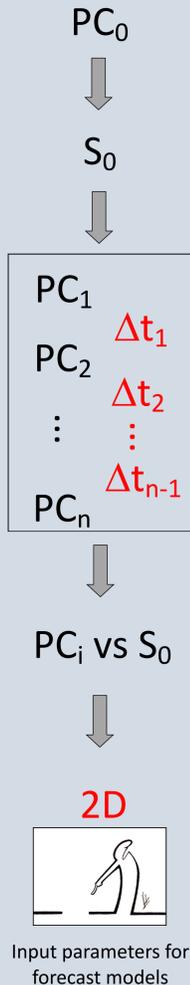
## Terrestrial laser scanning

Result: Point cloud

Valuable results: (x, y, z) and Intensity of return-beam

Also important: 3D comparison
