# Disbonding of underwater-cured epoxy coating caused by cathodic

# protection current

Sanja Martinez<sup>a\*</sup>, Lidija Valek Žulj<sup>a</sup>, Frankica Kapor<sup>b</sup>

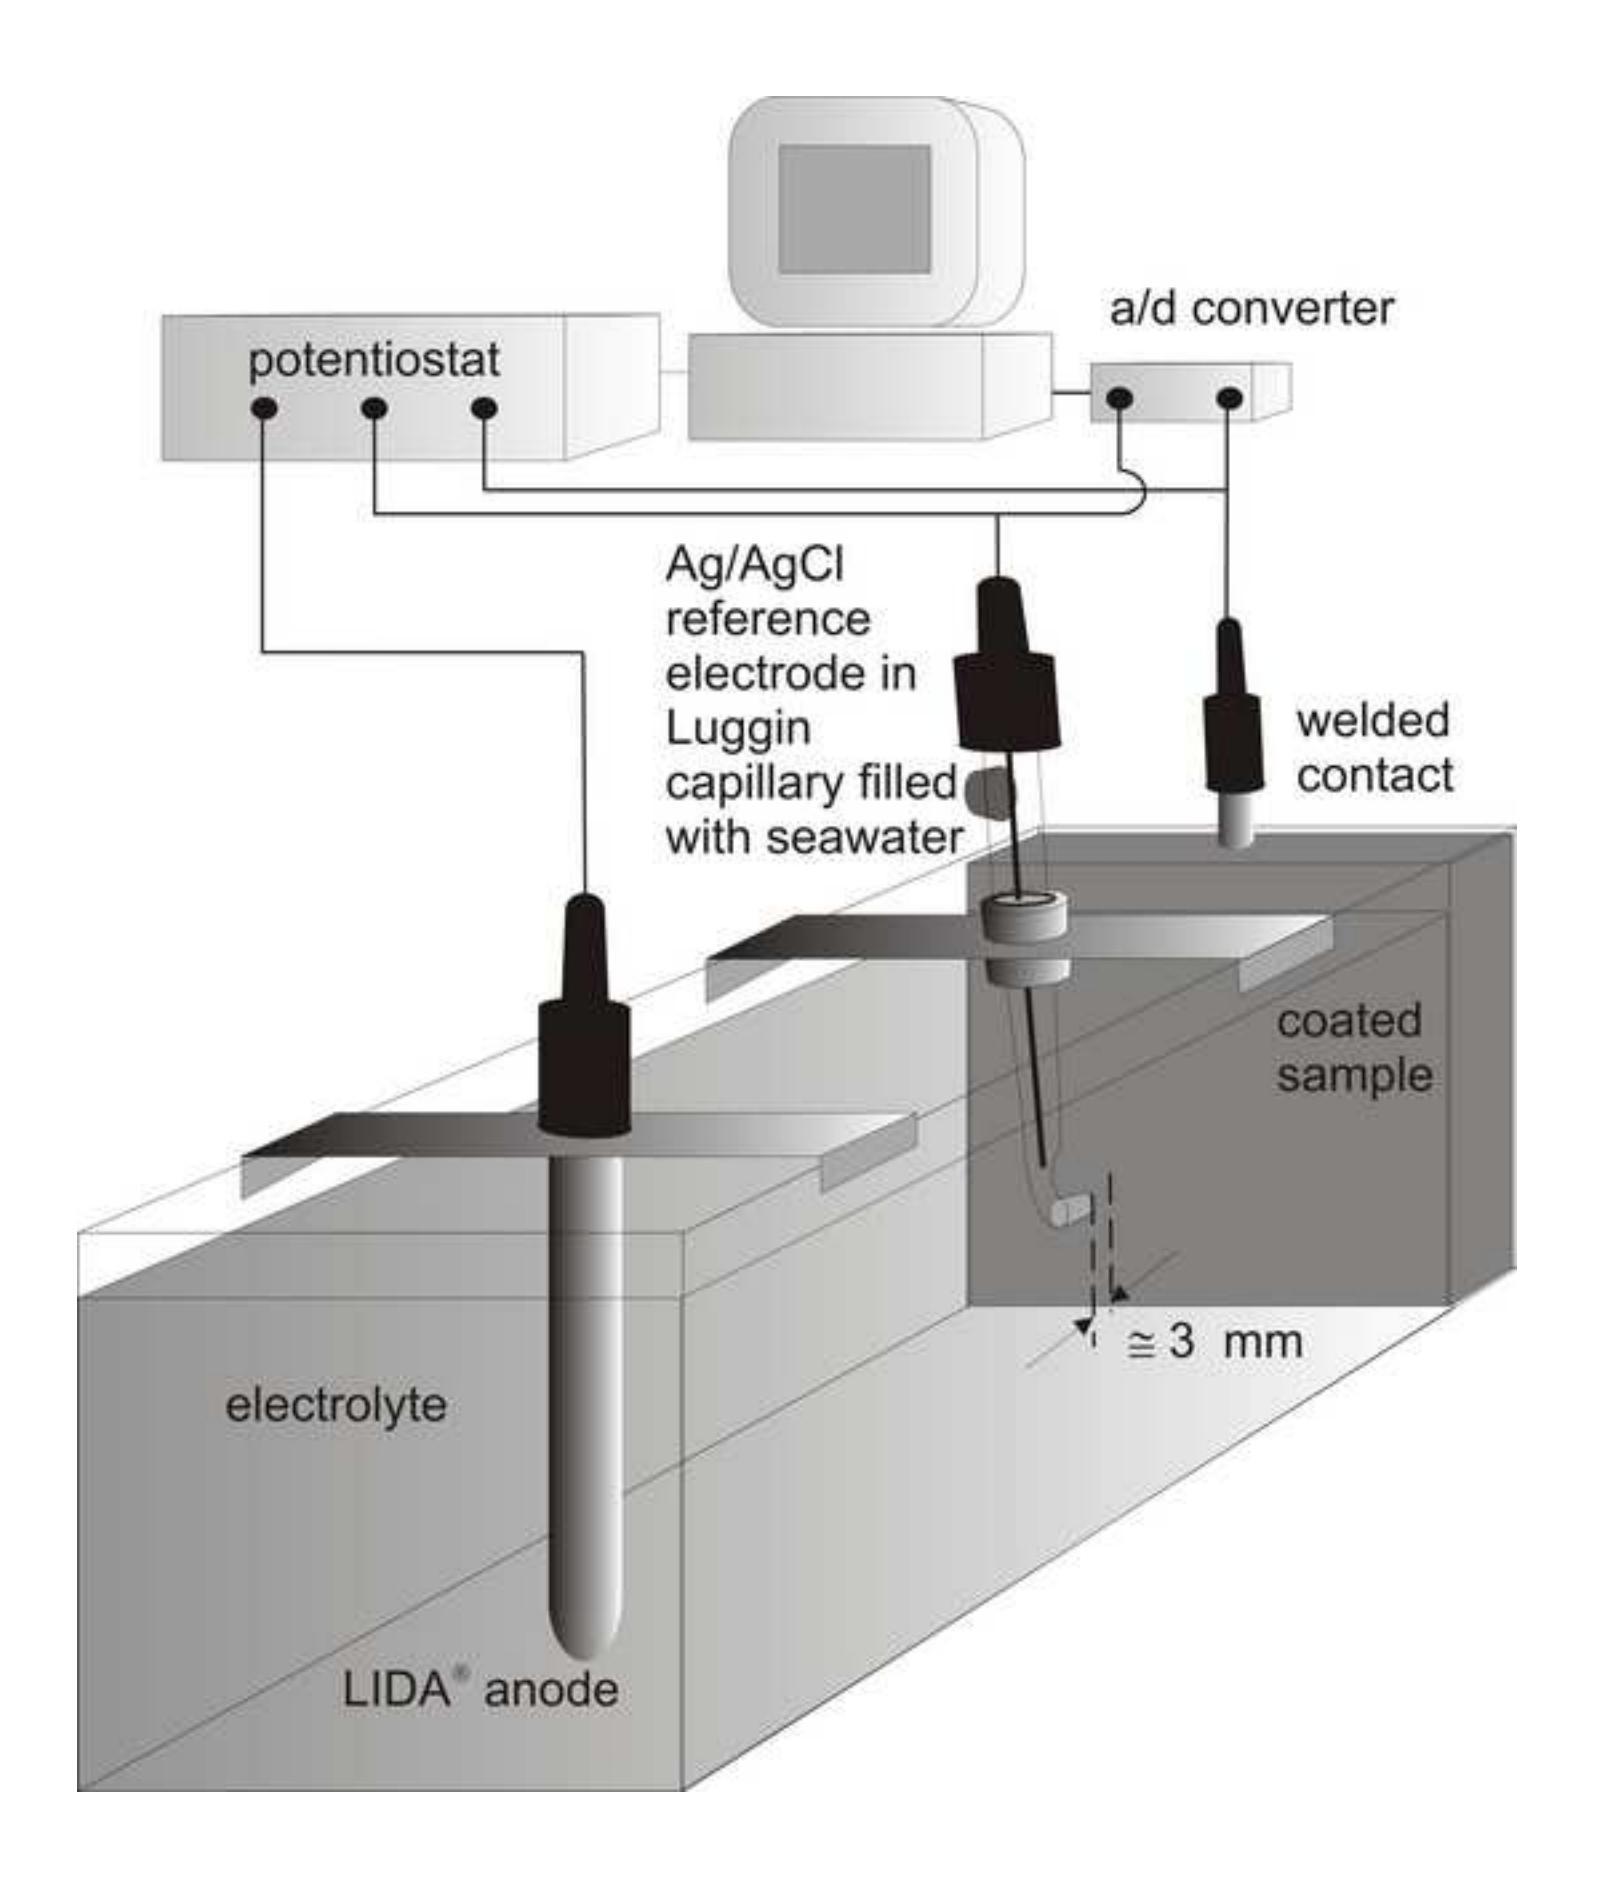
Figure 1. Cell setup for polarization experiments.

Electrochemical experiments were carried out in three-electrode cell shown in Figure 1. The working electrode was constructed of UNS 5L X52 steel plate (15 cm x 15 cm x 0, 6 cm) with a steel rod attached at the edge as a contact. Prior to all experiments, the plates were blast-cleaned with aluminium silicate to Sa 2 <sup>1</sup>/<sub>2</sub> according to EN ISO 8501-1 [11]. The counter electrode was a commercial titanium based/mixed metal oxide type electrode (Lida®). The reference electrode was an Ag/AgCl electrode in seawater (Ag/AgCl/sw). All the reported potentials refer to Ag/AgCl electrode in seawater. The electrolyte was natural seawater (58 mScm<sup>-1</sup>).

(i) Linear polarization measurements were carried out on PAR 273 potentiostat. Luggin capillary tip of the reference electrode was placed close to the coating surface (Fig. 1) and away from the edge and the artificial defect (if present). Both, the coated and the uncoated samples were immersed for 24 hours before the beginning of the measurements. For each point of the polarization curve, the current was stabilized for 5 minutes at a certain cathodic potential and then the potential-time transient was measured after switching off the current in order to obtain the off-potential readings (off-potential method) [15]. The transient data acquisition was done by a separate electronic circuit that included A/D converter connected to a computer. The potential sampling frequency after the current switch-off was 100 Hz. In accordance to the common cathodic protection practice, the polarization potential before the current switch-off is denoted by  $E_{on}$  and after the current switch-off, by  $E_{off}$  [13, 14]. The off-potential is known as the polarised potential i.e. the potential across the structure/electrolyte interface that is the sum of the corrosion potential and the cathodic polarization, and is indicative of the level of cathodic protection achieved [15]. Comparative

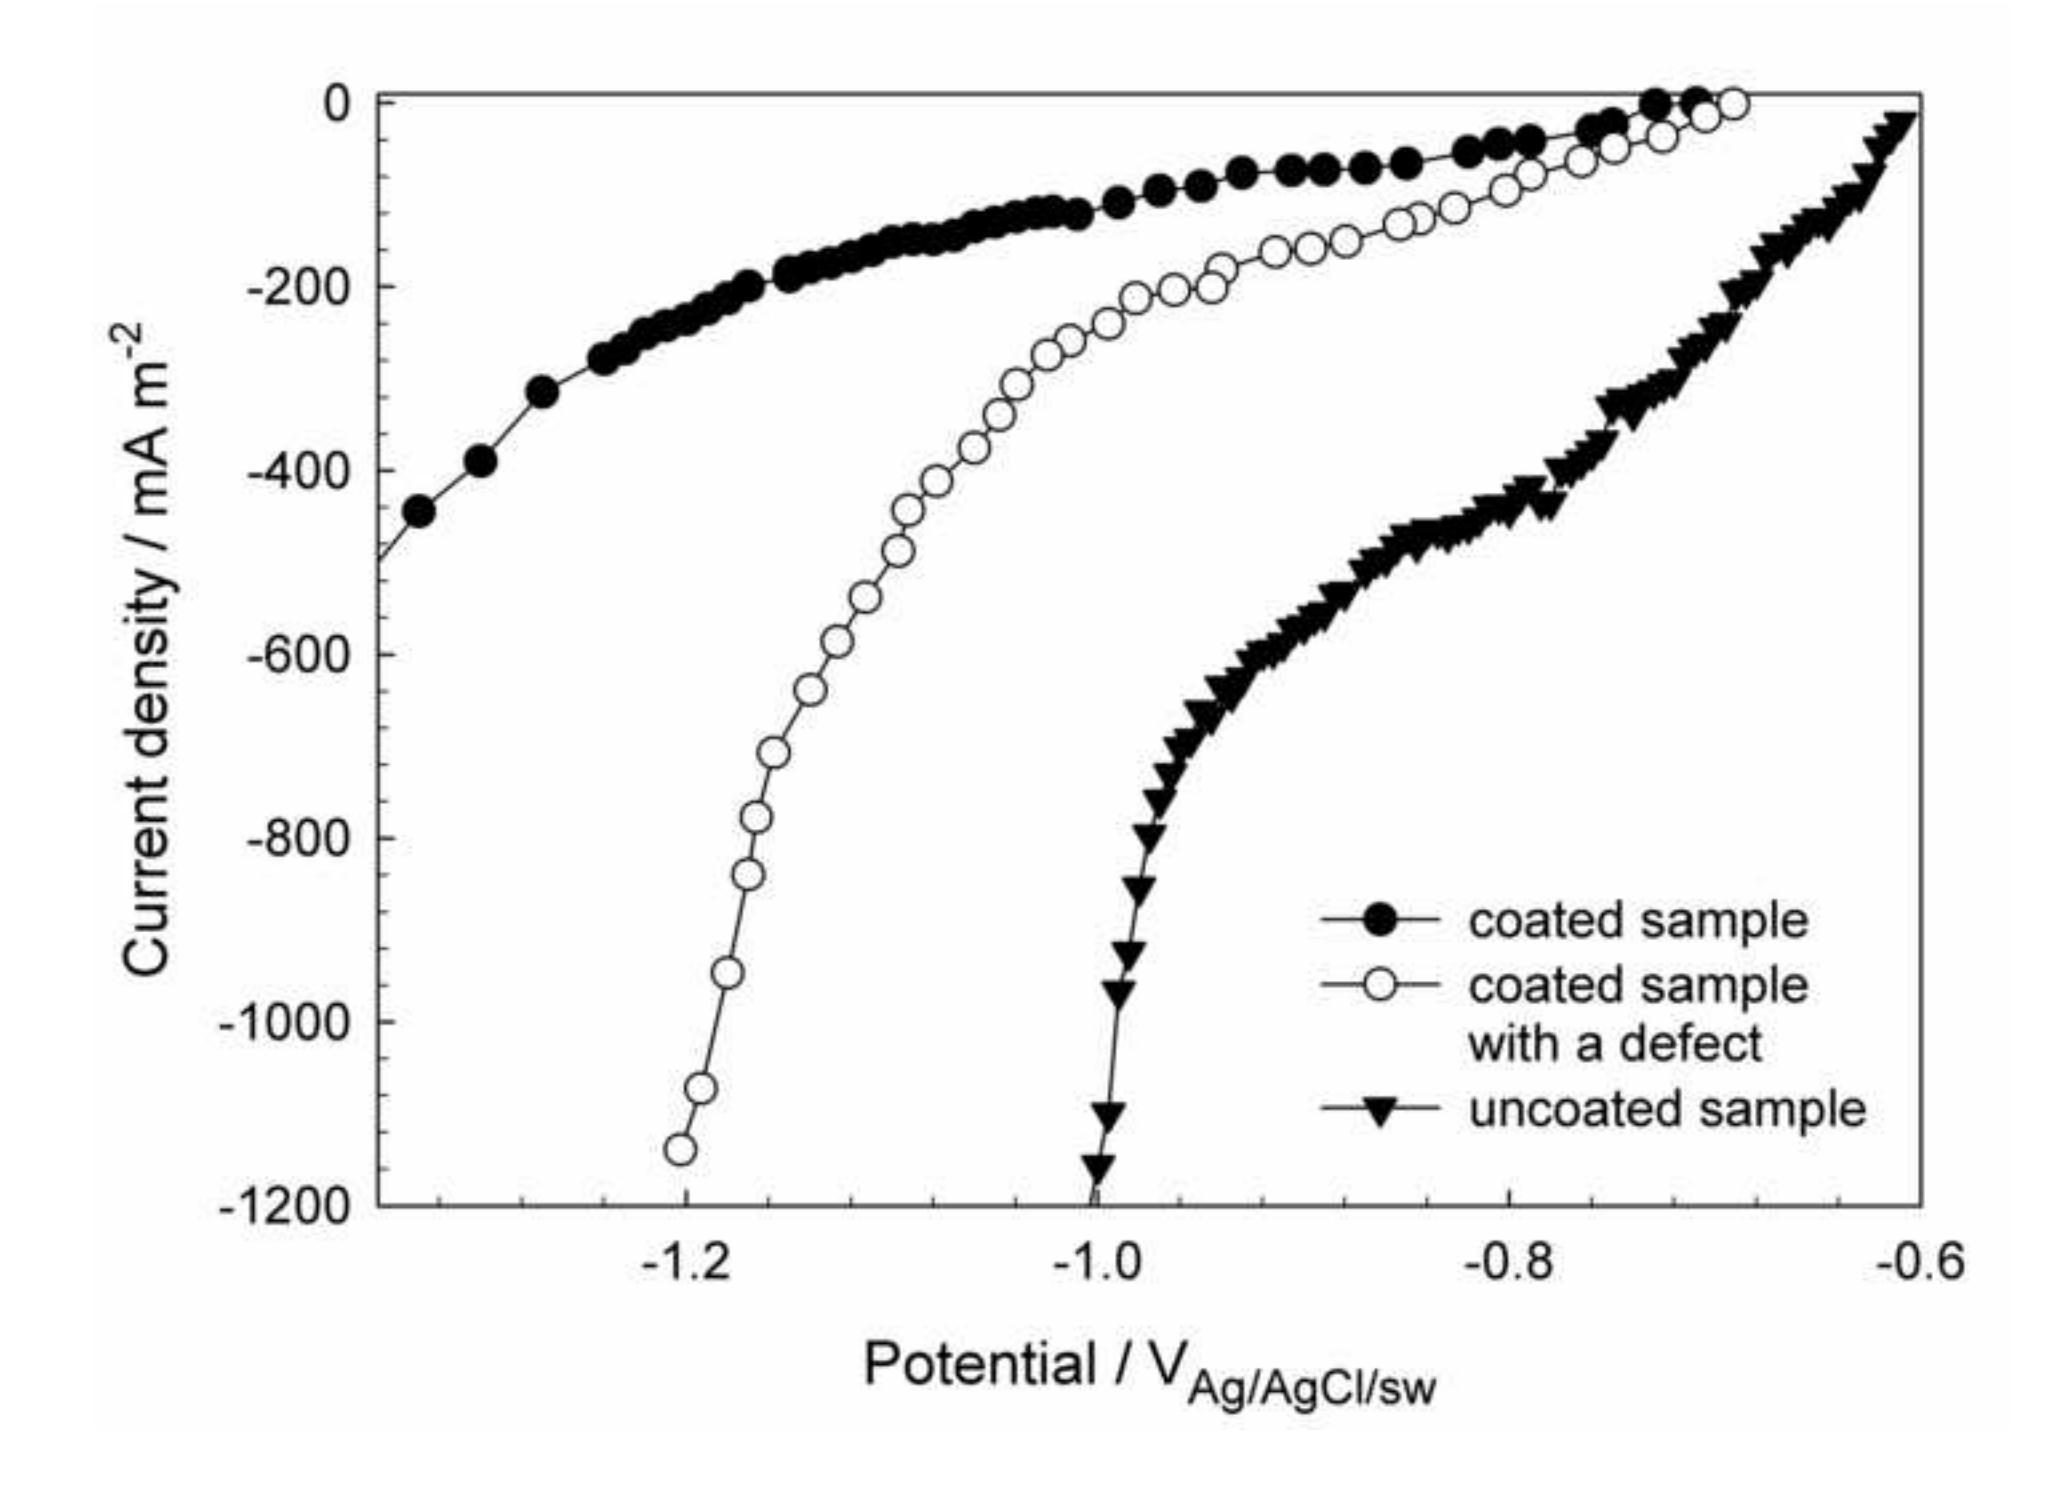
Figure 2. IR corrected cathodic polarization curves measured on coated samples with and

without a circular defect (6 mm in diameter) and on an uncoated sample.

In order to exclude the influence of the IR drop on the polarization potentials, resulting from the coating resistance, each point of the polarization curves in Figure 2 was measured by the off-potential method. As expected, the lowest currents were obtained at the coated electrode (for  $E_{off} = -0.9 \text{ V}_{Ag/AgCl/sw}$ ,  $j = 90.4 \text{ mA m}^{-2}$ ). At the coated electrode with a circular defect ( $\phi$  6 mm) the currents were somewhat higher compared to the undamaged electrode (for  $E_{off} = -0.9 \text{ V}_{Ag/AgCl/sw}$ ,  $j = 154.6 \text{ mA m}^{-2}$ ), while the highest currents were obtained at the uncoated electrode (for  $E_{off} = -0.9 \text{ V}_{Ag/AgCl/sw}$ ,  $j = 568.72 \text{ mA m}^{-2}$ ). The shape of the curves and the current densities are comparable to those found in literature for thick epoxypolyamine coatings with artificial defects [17]. The increase in the current caused by the defect existence was significantly higher than that calculated for the increase in the bare metal area (i.e. the area of the defect multiplied by the current density obtained on a bare electrode). Margarit et al. [17] have shown that for a coating with artificial defect, instead of what would be expected, the electric field may not be completely concentrated in the area of metal exposure. Higher currents were found to flow in the system with failure causing higher polarization at weak areas of the coating, changes of the electrolyte at the coating/metal interface and the appearance of blisters. Hence, the disproportional increase in the current may partly be attributed to the increased passage of the current through the coating itself. Generally, whenever the polarization of steel is changed, the polarization level at various spots of the sample also changes, but not homogenously. The local properties of the coating, that define the level of the current passing through those points, determine the polarization level.

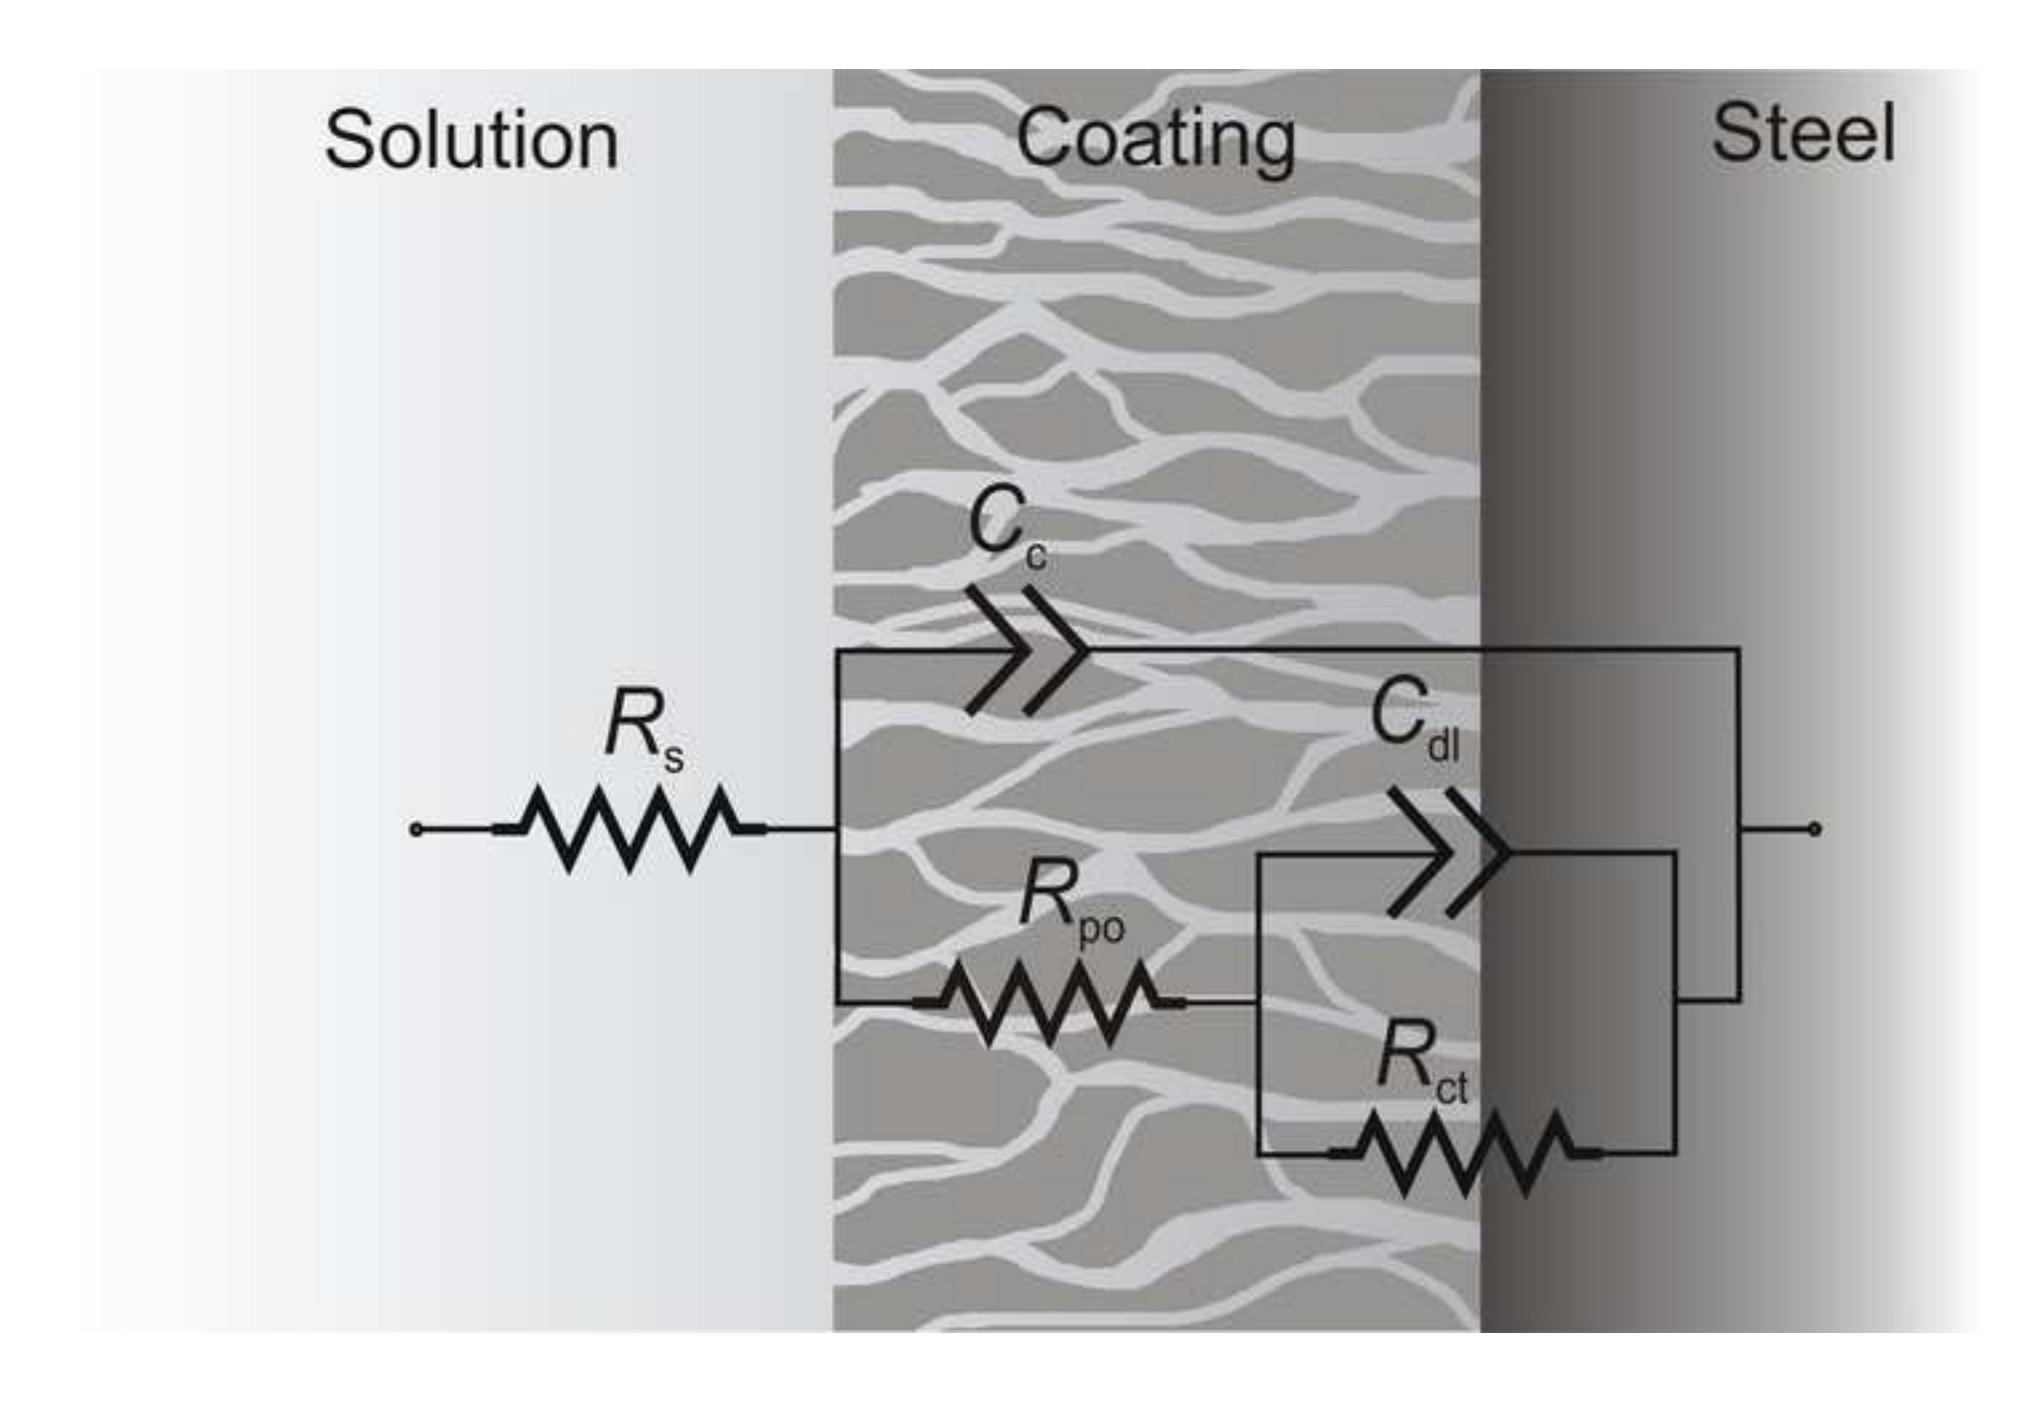
Figure 3. Equivalent circuit of a coating without or far from the artificial defect.

Off-potential measurements may be understood through the analysis of the equivalent circuit of the electrolyte/coating/metal interface. The impedance of coated metals has been extensively studied and the interpretation of the impedance data exhibits various degrees of complexity [4, 7, 18 - 24 ]. However, the impedance of the continuous coating without an artificial defect may be approximated by a simple equivalent circuit shown in Figure 3.  $C_{\rm e}$  represents the capacitance of the intact coating. Typically, its value has been shown to be much lower than that of a double layer capacitance  $C_{\rm dl}$  and its units are pF or nF, not  $\mu$ F [9, 22].  $R_{\rm po}$  (pore resistance) is the resistance of the ion conducting paths that develop in the coating. It should be noted that these paths may not be physical pores filled with electrolyte.  $R_{\rm s}$  is the uncompensated solution resistance between the reference electrode tip and the coating. In the present study, the Luggin capillary tip of the reference electrode was positioned in the immediate vicinity of the coating, away from the artificial defect and the plate edges. Taking into account the high conductivity of the electrolyte, it is reasonable to

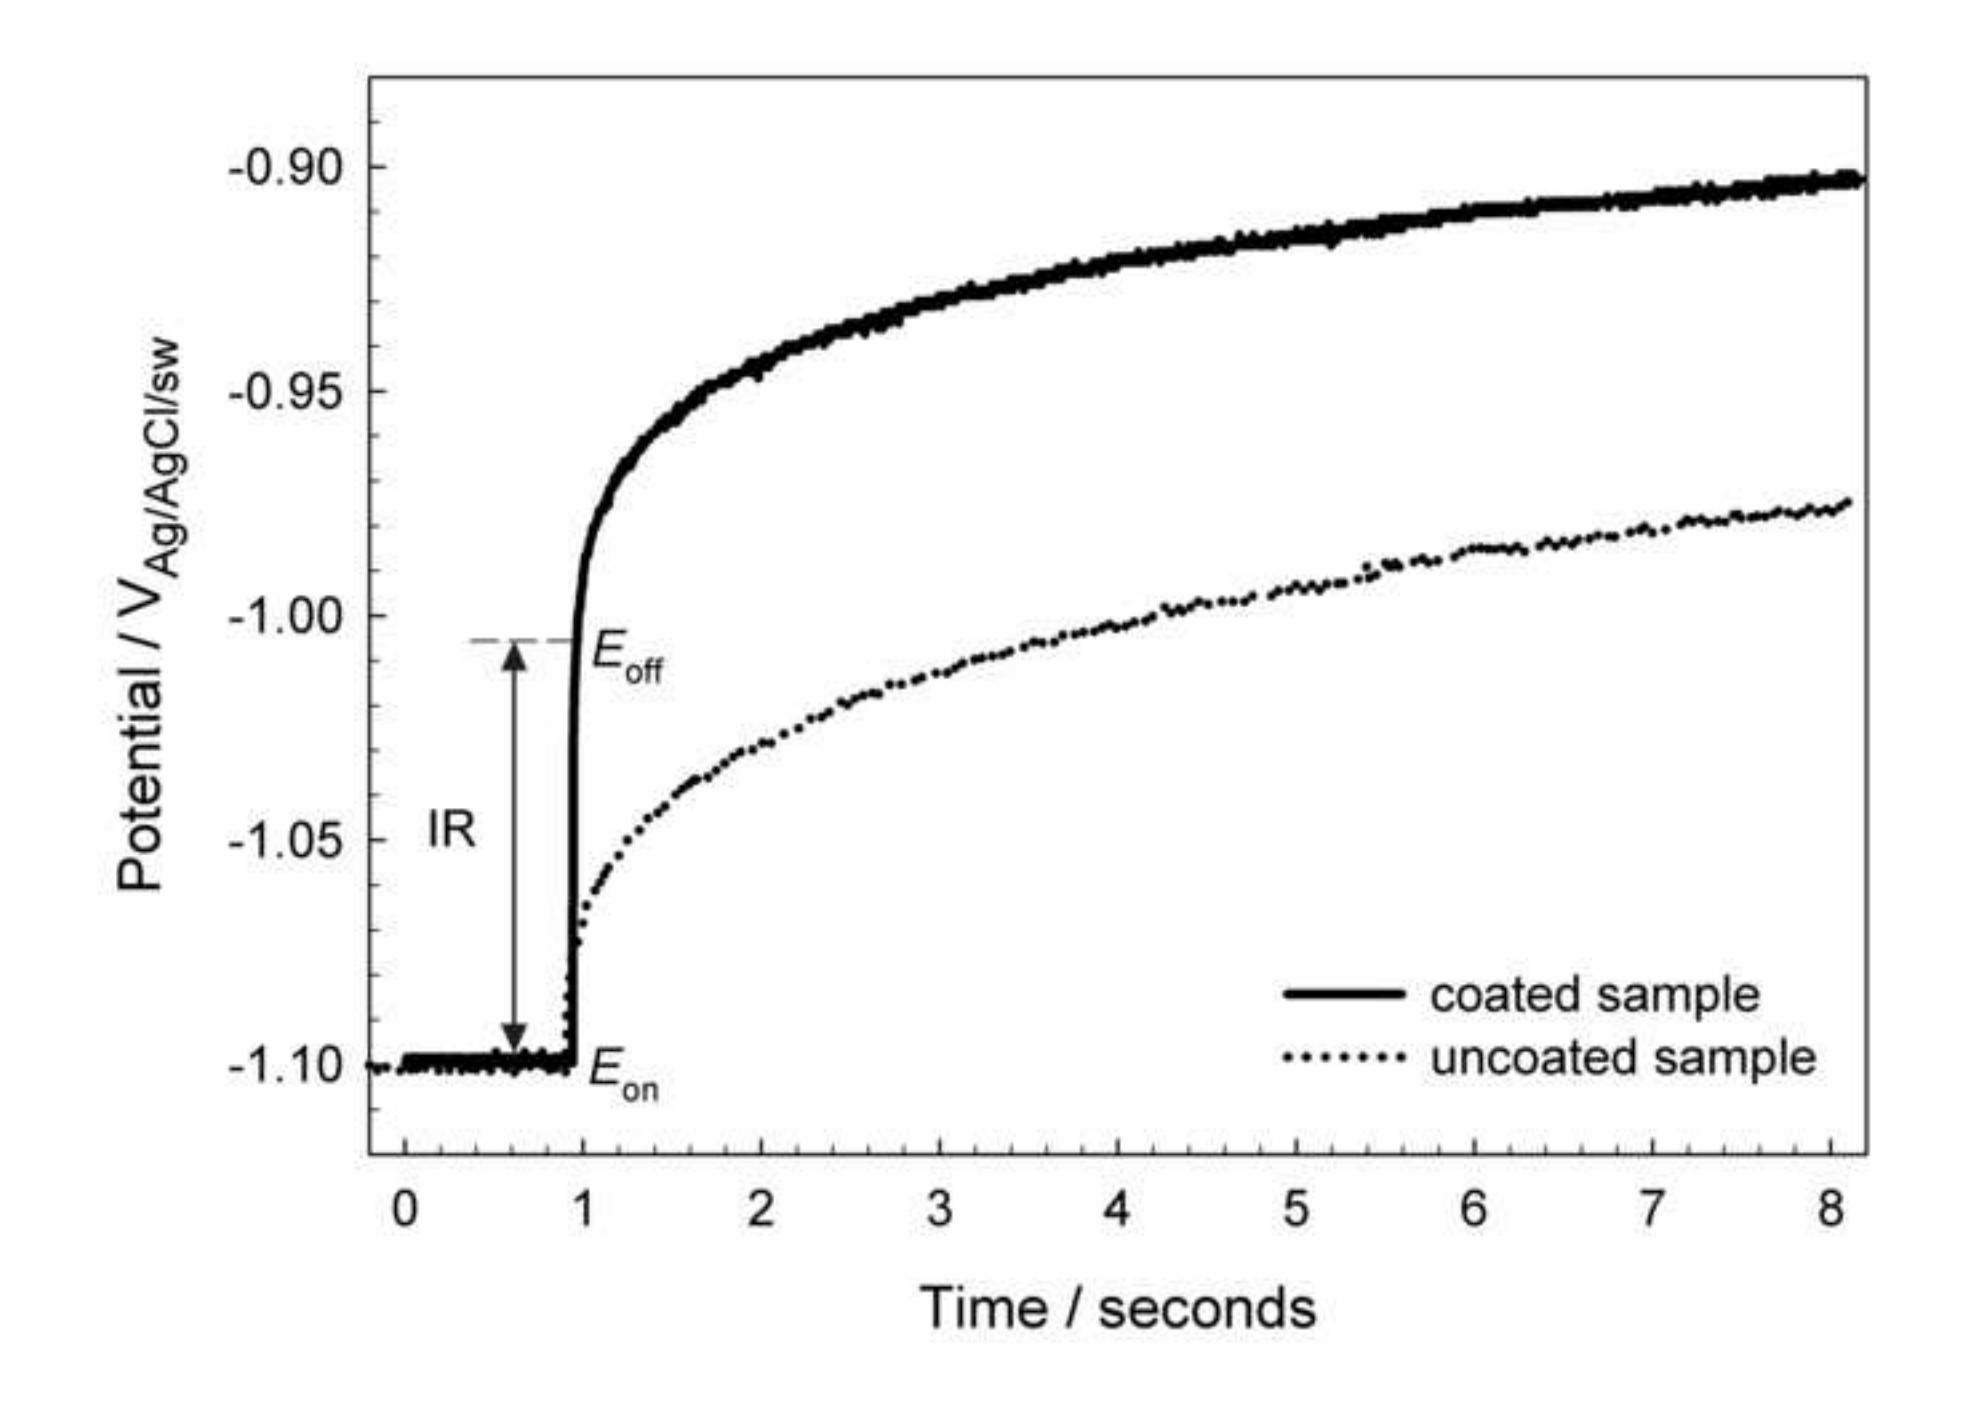
Figure 4. Off-potential measurements on a coated sample and an uncoated sample polarized to

the  $E_{\rm on} = -1.1 V_{\rm Ag/AgCl/sw}$ .

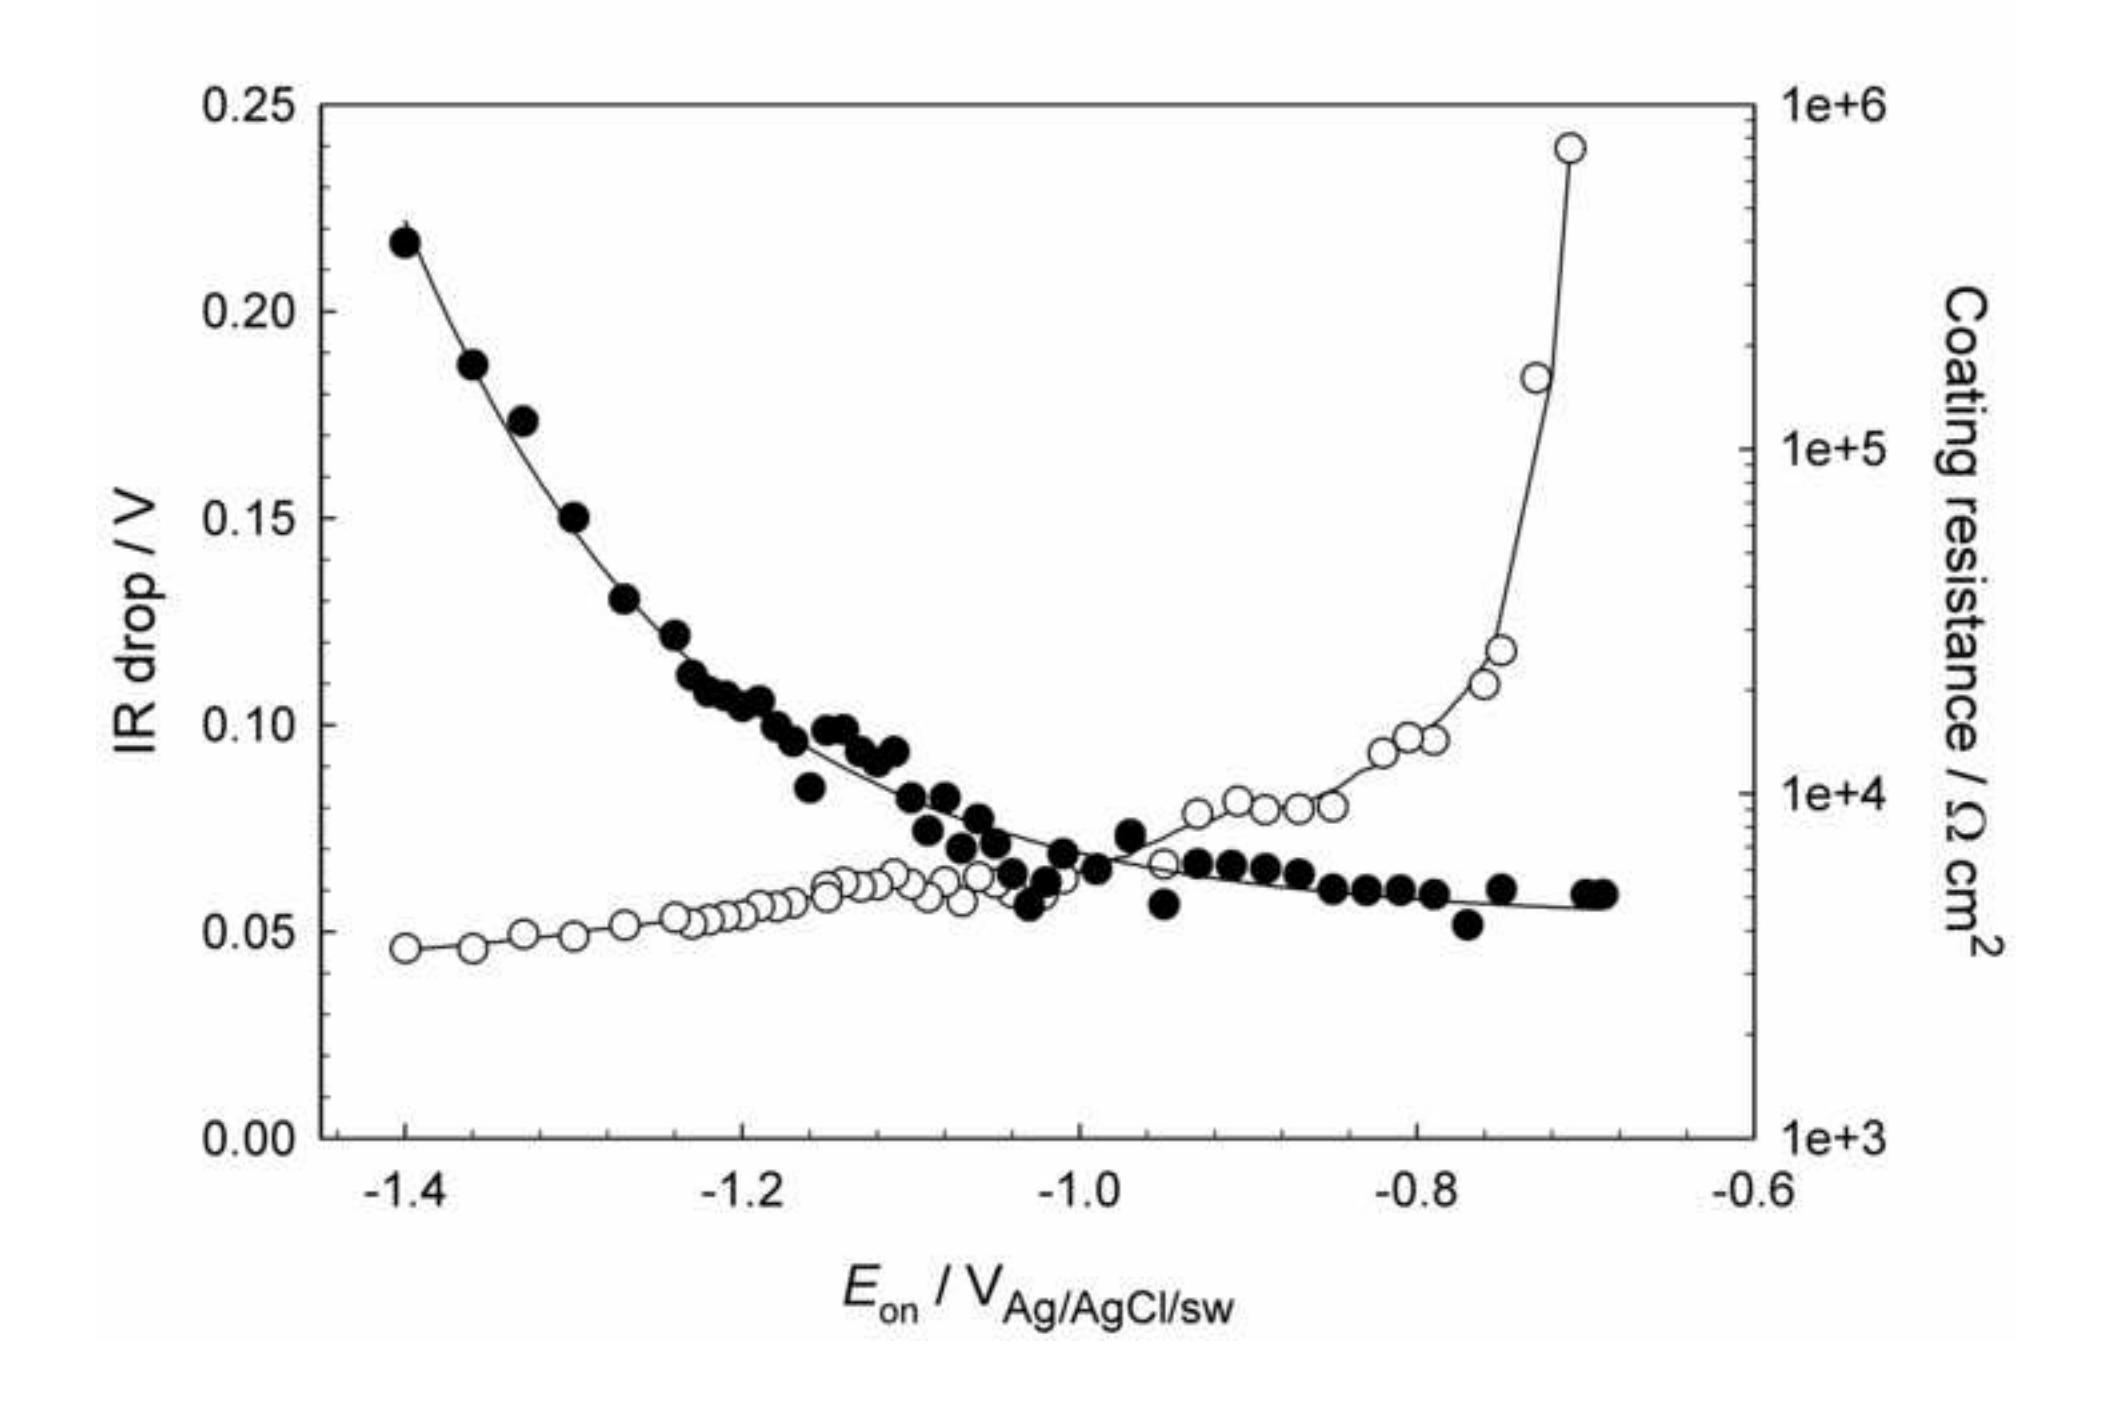
Figure 5. IR drop ( $\bullet$ ) and coating resistivity ( $\circ$ ) as a function of potential on coated samples without a circular defect.

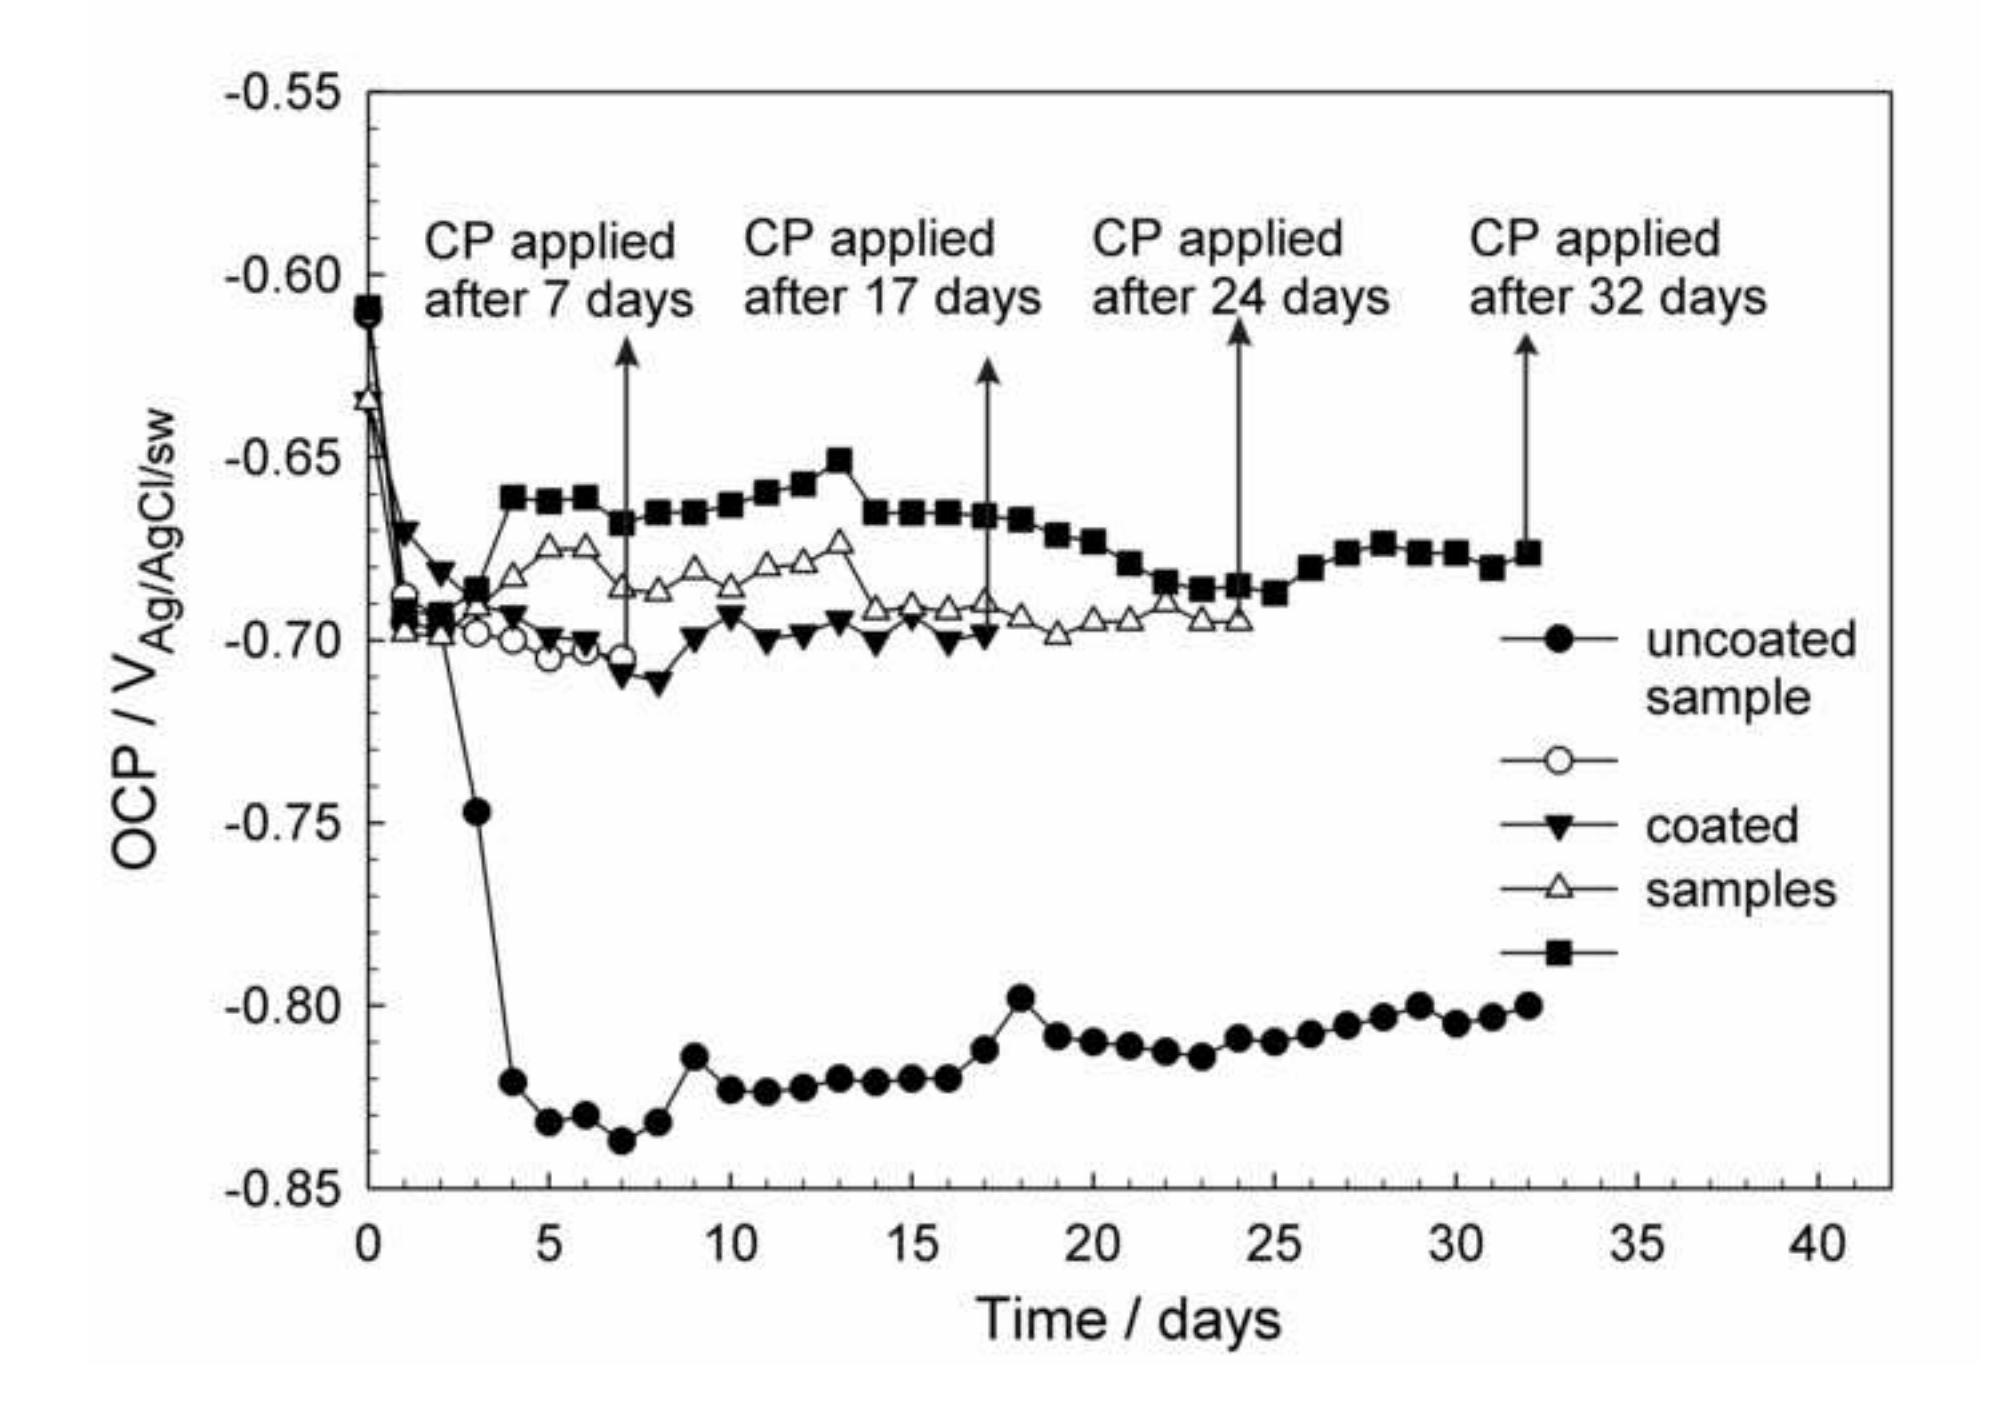
Figure 6. Representative time dependence of the OCP of the uncoated samples and of the four coated samples used for subsequent polarization measurements.

The measurement of the OCP was performed at the uncoated steel plates (representative curve shown in Figure 6) and the four coated samples that were used for further polarization experiments. Stationary state was attained at least 4 days after the immersion. The OCPs of the coated samples were, on average, 0.110 V more positive than the OCP of the uncoated sample, indicating relatively high porosity. Typically, a positive shift of few hundred milivolts between the uncoated and the coated samples could be observed for nonporous, highly-resistive (> M $\Omega$  cm<sup>2</sup>) coatings [7, 26, 27]. Furthermore, a clearly visible discharging of the structure-to-electrolyte boundary on a coated sample in Figure 4, supports the assumption of high porosity, as resistive and nonporous coatings almost exclusively show a sharp increase in potential corresponding to the IR drop due to their high resistance and low capacitance. In such systems, discharging of  $C_{dl}$  is not observed on transient off-potential measurements as the coating resistance is much higher compared to the electrochemical parameters  $R_{ct}$  and  $C_{dl}$ . Consequently, it is impossible to determine a time constant related to the faradaic process at the metal/highly resistive coating interface by fitting the impedance data [24].

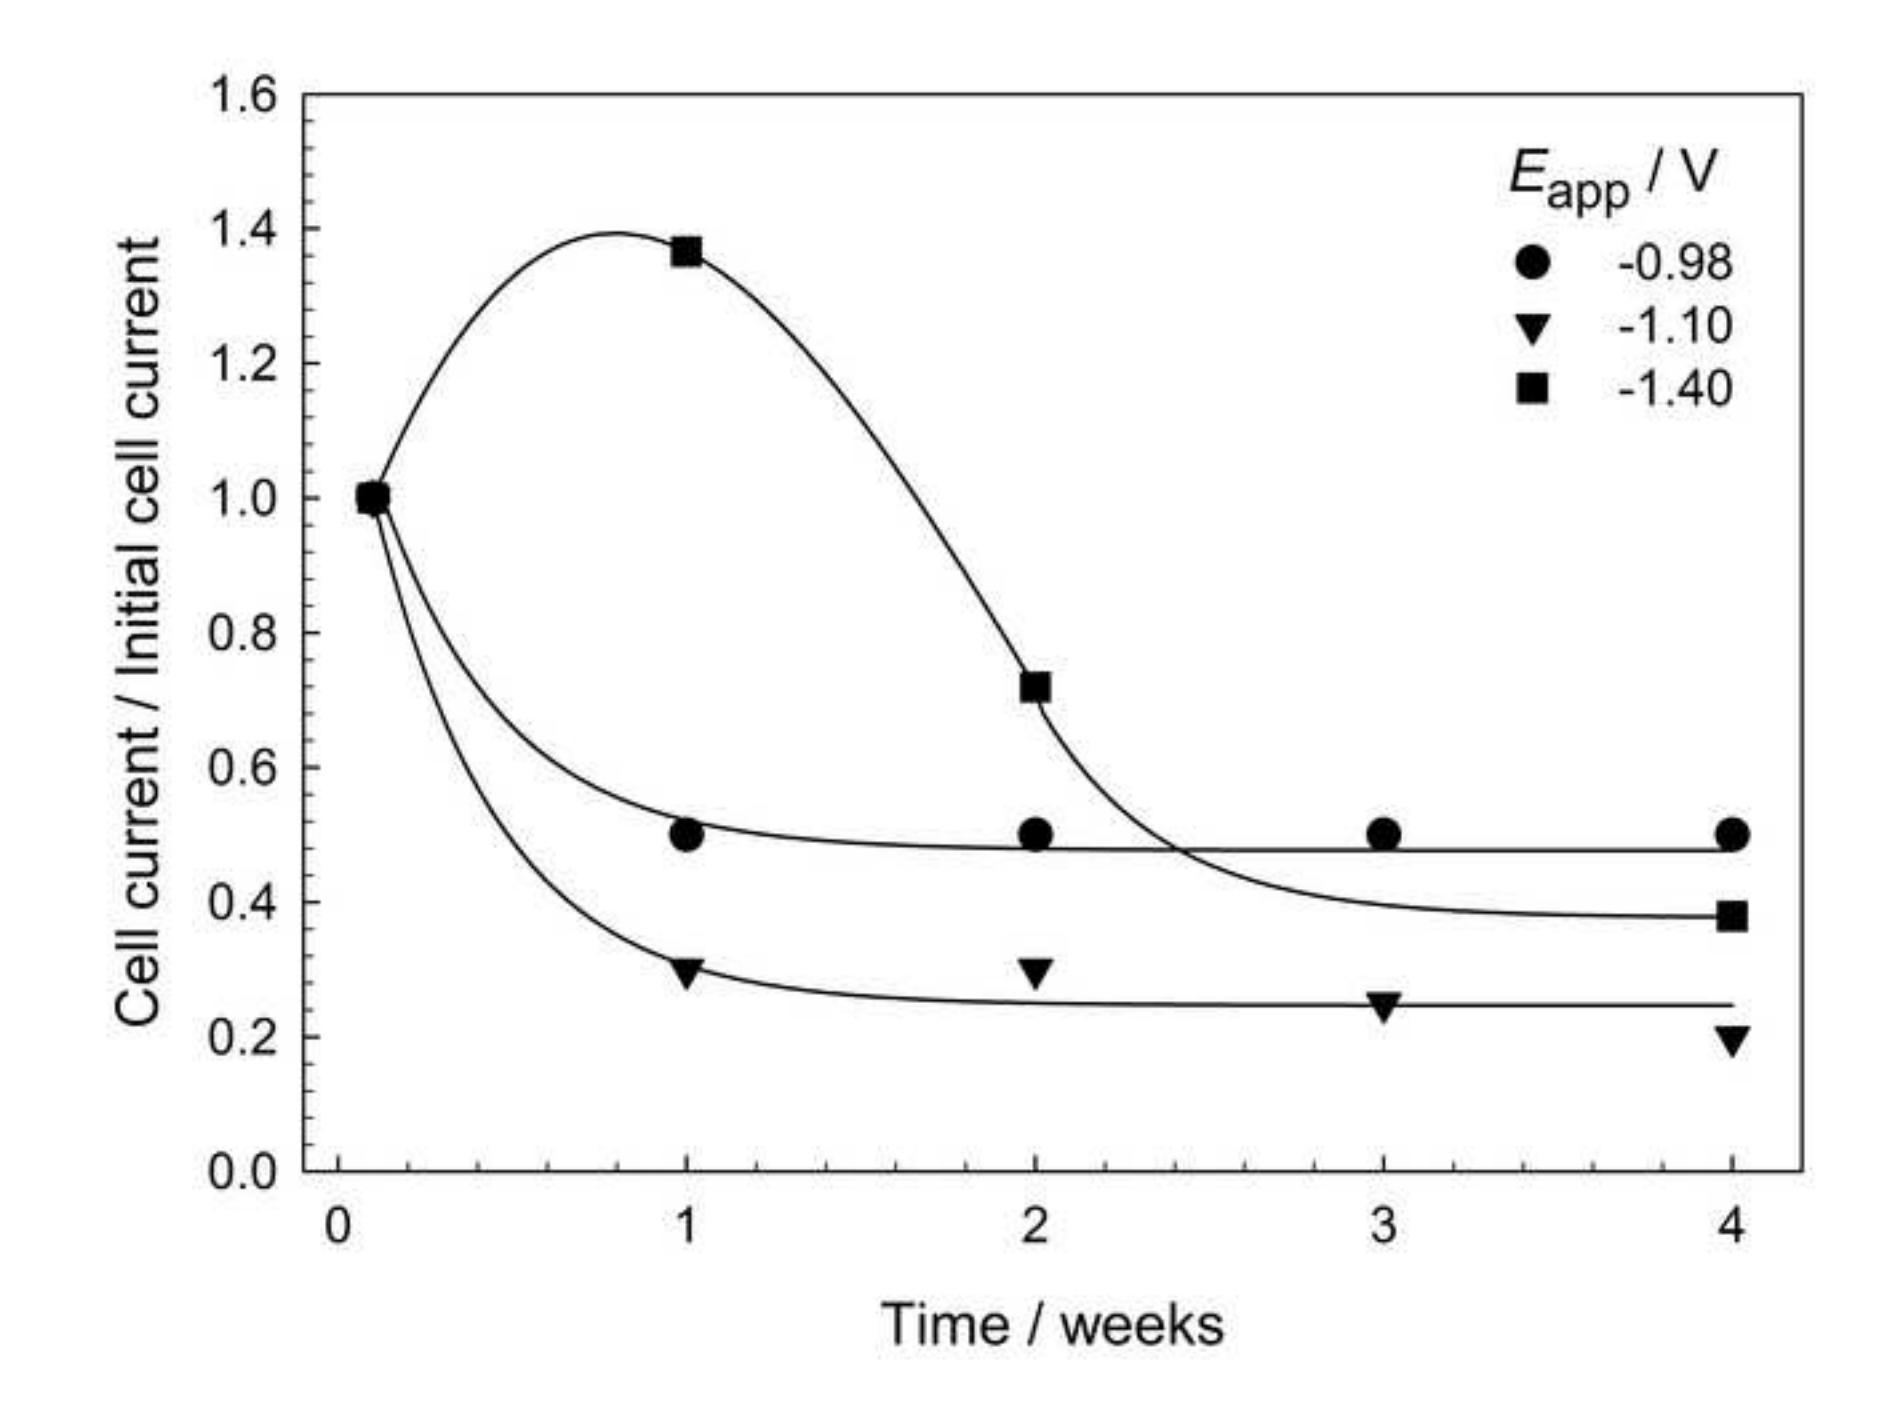
Figure 7. Ratio of the measured and the initial protection current as a function of time for the

$E_{\rm on} = -0.98$ , -1.1 and -1.4 V<sub>Ag/AgCl/sw</sub>.

The protection current was recorded after 2 h, 24 h, 1, 2, 3 and 4 weeks, and the results are presented in Figure 7. Samples polarized to  $E_{on} = -0.98$  and  $-1.1 V_{Ag/AgCl/sw}$  with time showed a continuous drop in the protection current from the initial values of 95.2 and 238.0 mA m<sup>-2</sup>, respectively. Within the first two weeks, the sample polarized to  $E_{\rm on}$  = -1.4 VAg/AgCl/sw showed an increase of the protection current compared to the initial value of 3641.4 mA m<sup>-2</sup> followed by a continuous decrease until the final value was attained. For the sample polarized to  $E_{on} = -1.4 V_{Ag/AgCl/sw}$ , it may be observed that the weak zones within the coating constitute a source of blister initiation [17, 23]. It has been shown by Le Thua et al. [18], by measurements made on the modified wire beam electrode, that the local protection current reflects well the weak zones within the coating. On the other hand, due to the enhanced alkalinity of the steel environment during the cathodic polarization, calcareous layers deposit on the exposed steel surface [28 - 30]. The presence of the calcareous layer reduces the oxygen diffusion rate thereby lowering the cathodic protection current. It may be concluded that the variation of the cell current resulted from the competition of the two opposite processes - the increase of the bare metal area due to the cathodic disbonding and the decrease of the bare metal area due to the formation of a visible calcareous layer having limited protective properties. Hence, the ratio of the cathodic current measured after a certain period of time and the cathodic current at the beginning of the experiment may be considered as indicative of the prevalence of either of the two processes. The ratio >1 indicates a predominant influence of the cathodic disbonding while the ratio <1, indicates a predominant influence of the calcareous deposit formation on the protection current.
