# Disbonding of underwater-cured epoxy coating caused by cathodic

# protection current

Sanja Martinez<sup>a\*</sup>, Lidija Valek Žulj<sup>a</sup>, Frankica Kapor<sup>b</sup>

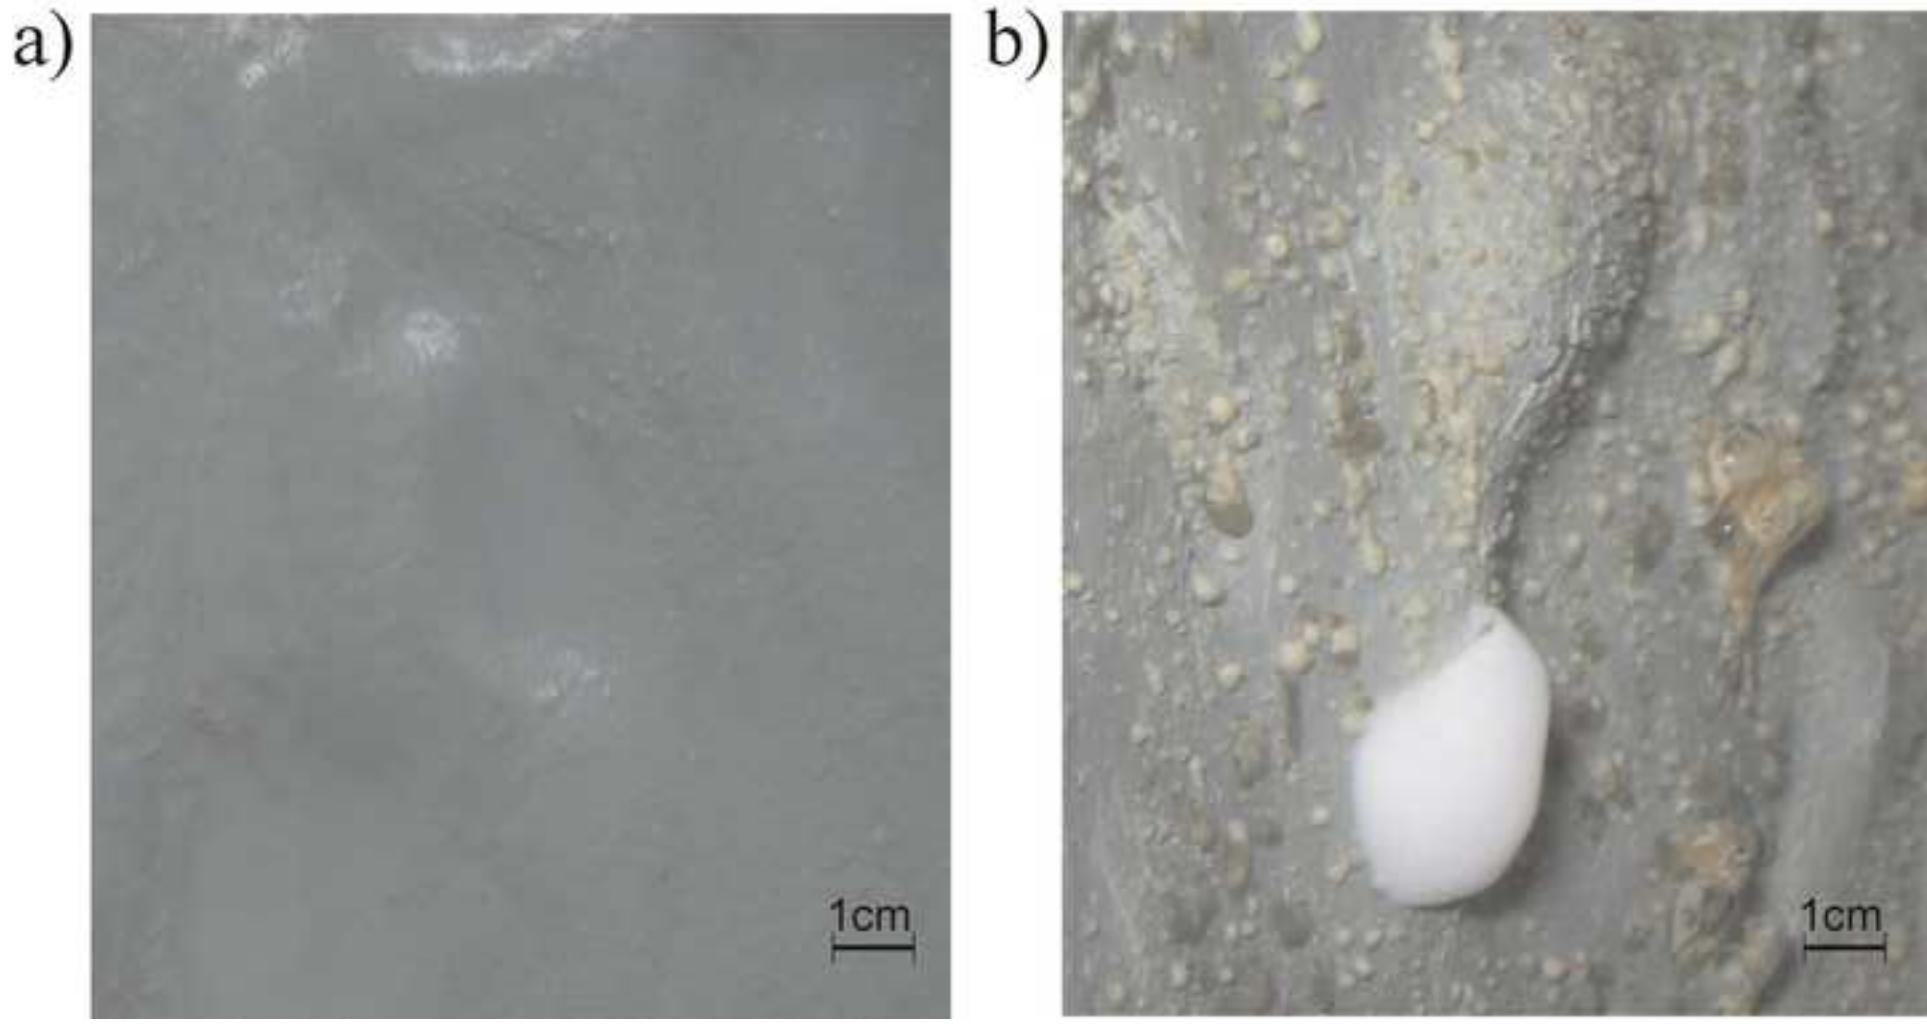
Figure 8. Final appearance of the samples after 30 days of polarization to: a)  $E_{on} = -0.98$  or -

1.1  $V_{Ag/AgCl/sw}$  and b)  $E_{on} = -1.4 V_{Ag/AgCl/sw}$ .

The final appearance of the samples polarized to  $E_{on} = -0.98$  or  $-1.1 V_{Ag/AgCl/sw}$ potential is shown in Figure 8a) and of the sample polarized to  $E_{on} = -1.4 V_{Ag/AgCl/sw}$  is shown in Figure 8b). Laboratory and field tests [28, 29] have shown that a rapid polarization of a steel cathode upon immersion to potentials of -0.9 to -1.05  $V_{Ag/AgCI/sw}$  generates a more protective calcareous deposit compared to the deposit generated by a slower polarization to potentials of -0.8 to -0.9  $V_{Ag/AgCI/sw}$ . This is consistent with the observation in this study; the highest decrease of the protection current was observed for the sample polarized to  $E_{on} = -1.1$   $V_{Ag/AgCI/sw}$  ( $E_{off} = -1.02 V_{Ag/AgCI/sw}$ ). After 30 days, at the sample polarized to  $E_{on} = -1.4 V_{Ag/AgCI/sw}$ , the coating was detached from the metal base at approximately 60 % of the sample surface, forming cracks and blisters. Calcareous layers were observed in the form of thick, white deposits in the areas of cracks or near the rim of a blister, at the site of its puncture (Figure 8b) [30]. At the sample polarized to  $E_{on} = -1.1 V_{Ag/AgCI/sw}$ , coating was only marginally cracked at the edges (probably due to the insufficient coating thickness) while at the sample polarized to  $E_{on} = -0.98 V_{Ag/AgCI/sw}$  none of the above phenomena were observed.

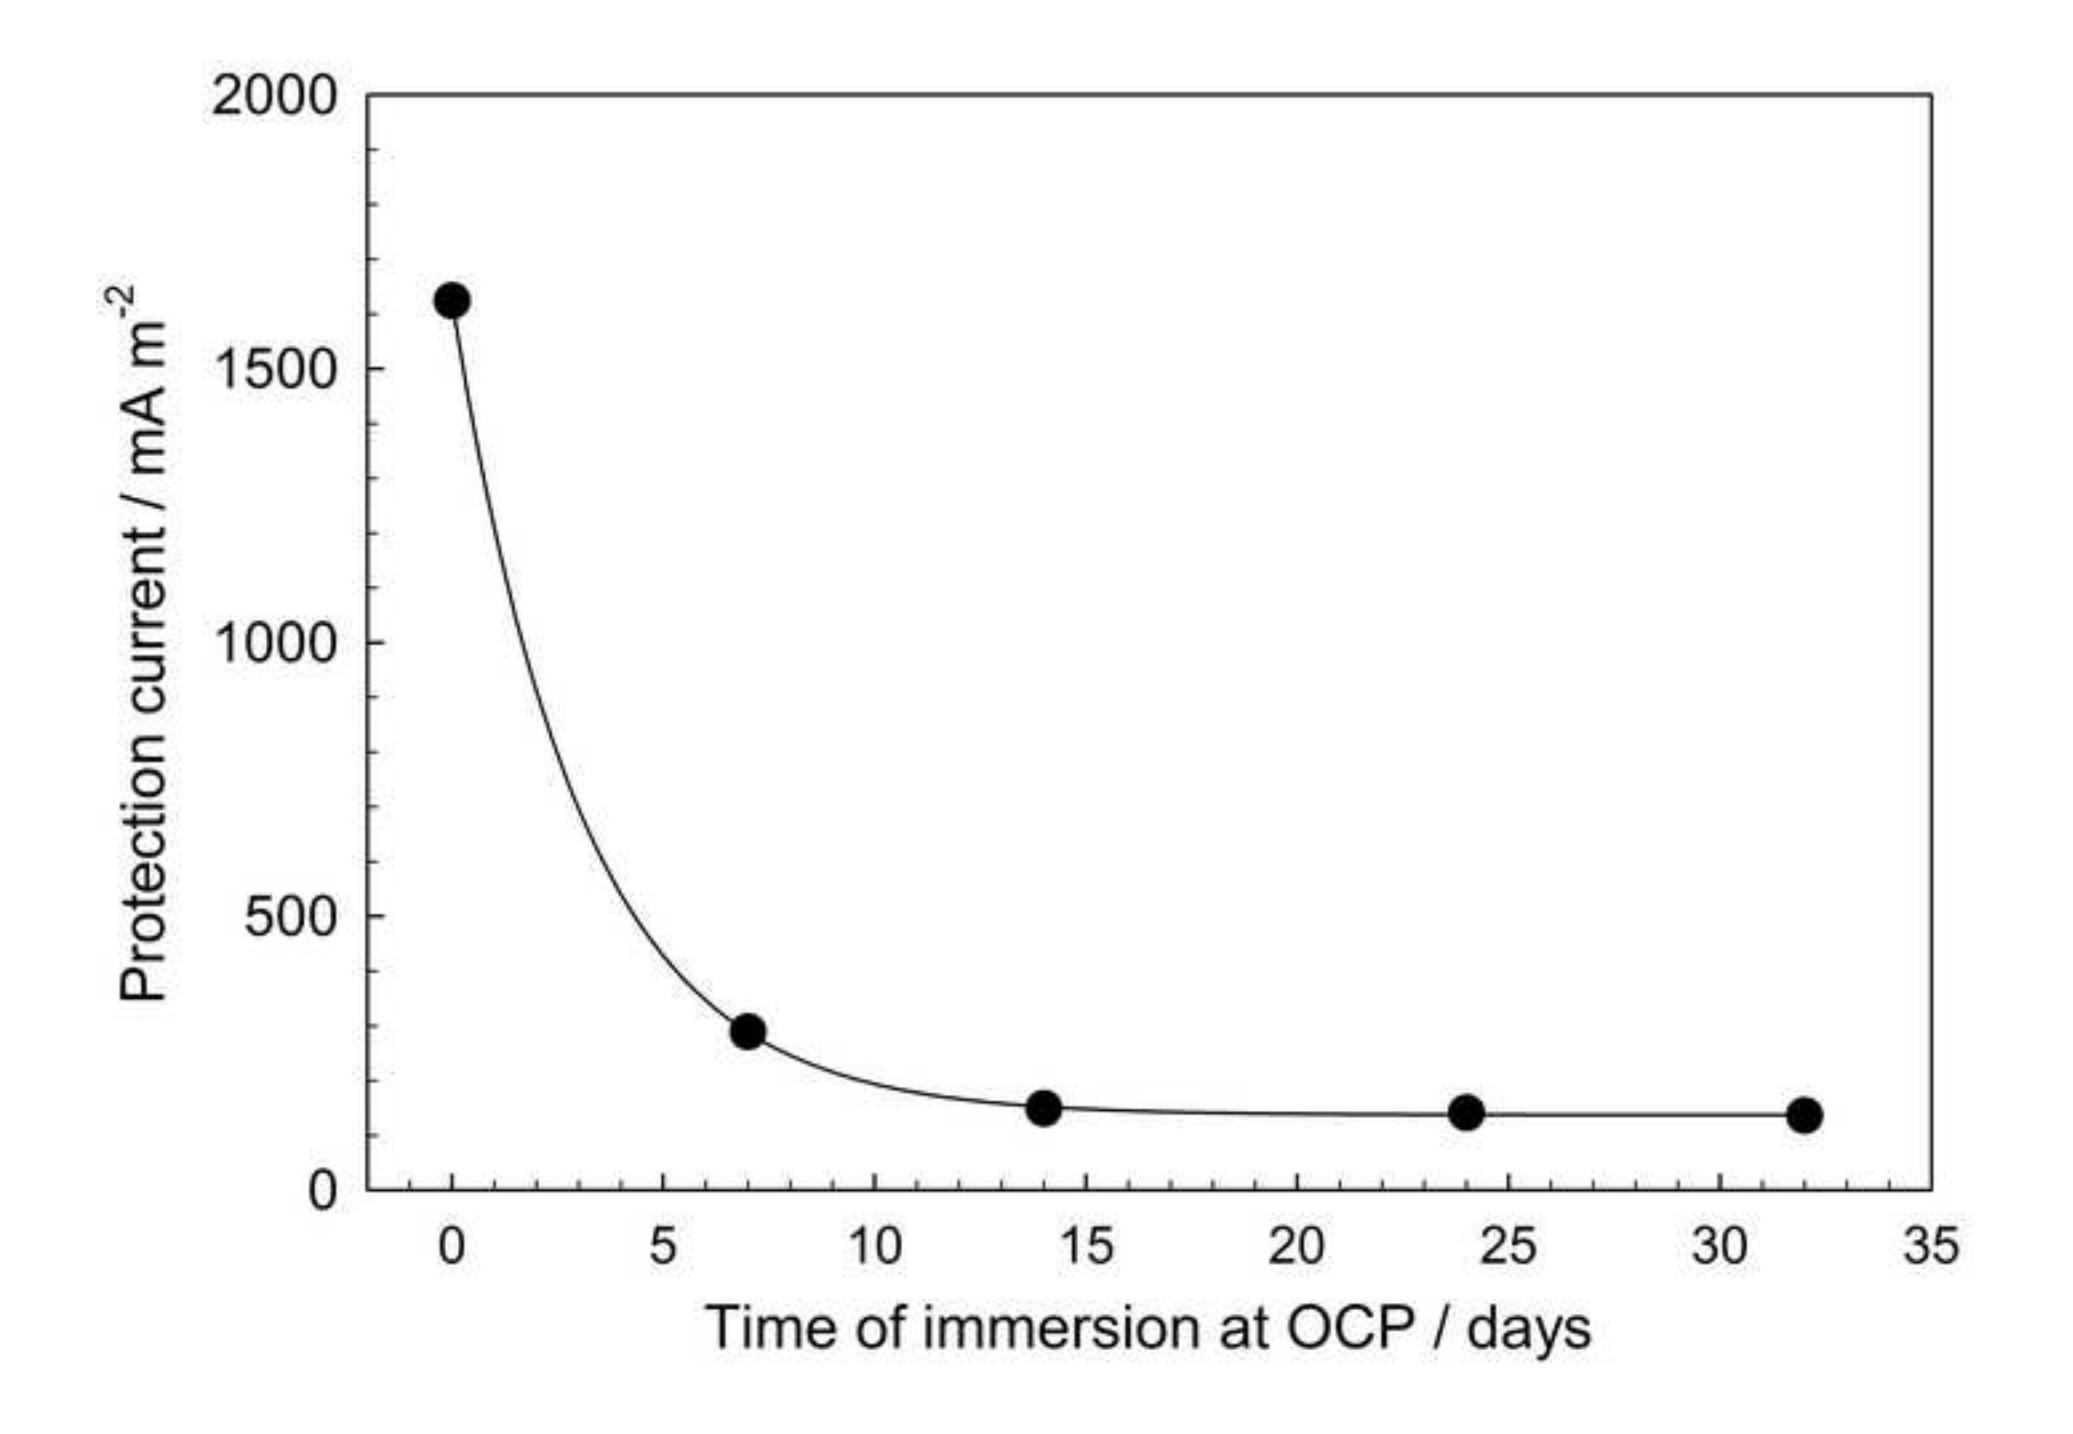
Figure 9. Cathodic protection currents after various times of sample immersion at the OCP and subsequent 24 h polarization to  $E_{on} = \text{ of } -1.2 \text{ V}_{Ag/AgCl/sw}$ .

Influence of the time of the coating cure at the OCP, on the appearance of the cathodic disbonding, was tested.  $E_{on} = -1.2 V_{Ag/AgCV/sw}$  ( $E_{off} = -1.1 V_{Ag/AgCV/sw}$ ) was chosen as a marginal potential of cathodic protection [12 - 15] and 24 h polarization was performed after 7, 14, 24 and 32 days of coating cure at the OCP (Figure 6). The initial currents, after various times of sample immersion at the OCP (Figure 9), decreased with the time of immersion, showing that either the gradual solidification of the coating and/or the accumulation of the corrosion products in the coating pores [7, 25, 26] affected the protection current. Relatively stable values were attained after approximately 15 days of immersion.
