# EXPERIMENTAL ANALYSIS OF COMBINED ACTION OF BENDING, SHEAR AND TORSION ON TIMBER BEAMS

*Tihomir Štefić, Aleksandar Jurić, Pavao Marović*

Preliminary notes

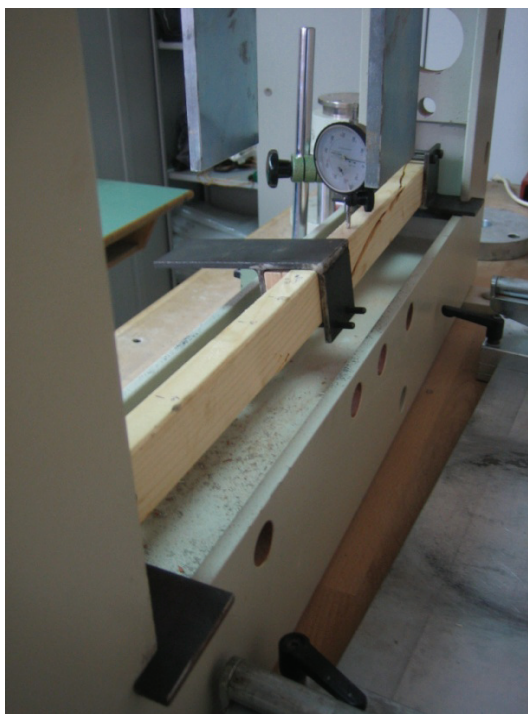
Figure 6 The failure of the sample

The failure of the tested beams occurred through a spiral longitudinal (fibre direction) crack, as shown in Figs. 6, 7 and 8. It can be assumed that the breaking happened from the influence of the combined shear stress in the longitudinal direction and normal tensile stress perpendicular to the fibres. Due to natural curvature of the fibres and sawing of wood some fibres do not extend throughout the entire beam. Because of this they cannot transfer stresses (load) further and at this point the crack begins. In this manner the cross section begins to weaken and break, as shown in Fig. 8.

It can be seen that the concentration of stresses occurs near the support (both perpendicular normal stresses and shear stresses) and that was confirmed with the results of the experiment, Figs. 6, 7 and 8, i.e., the failure of the specimen.
